# ASHE / PennDOT District 9

## Bridge Topics

April 17, 2018

# MSE Wall Panel Distress

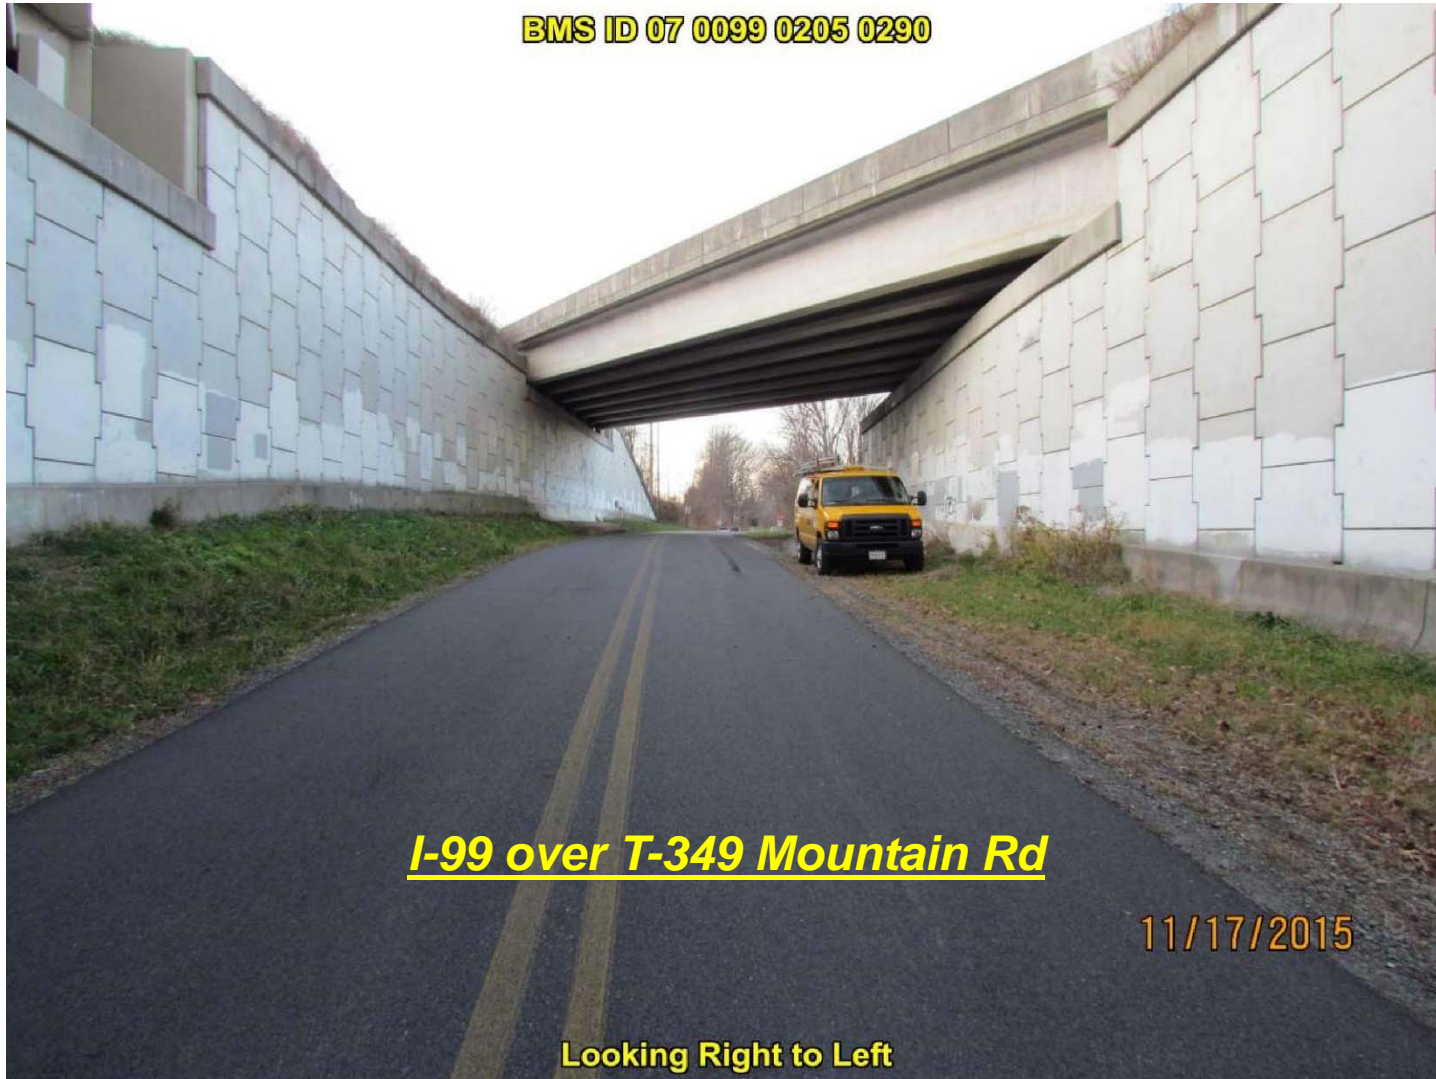
**BMS ID 07 0099 0205 0290**

**I-99 over T-349 Mountain Rd**

**Looking Right to Left**

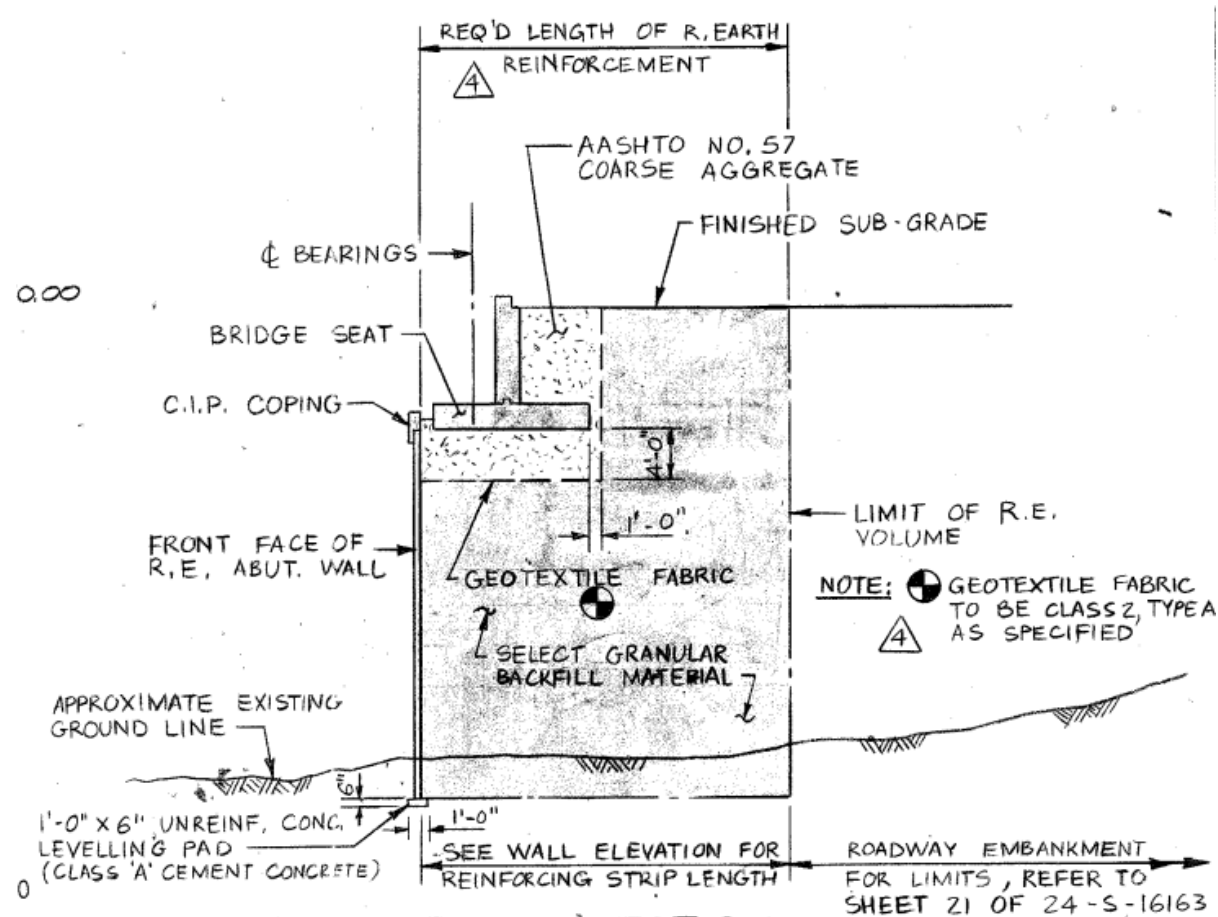
TYPICAL SECTION  
THROUGH R.E.<sup>®</sup> ABUTMENT

**I-99 over T-349 Mountain Rd**

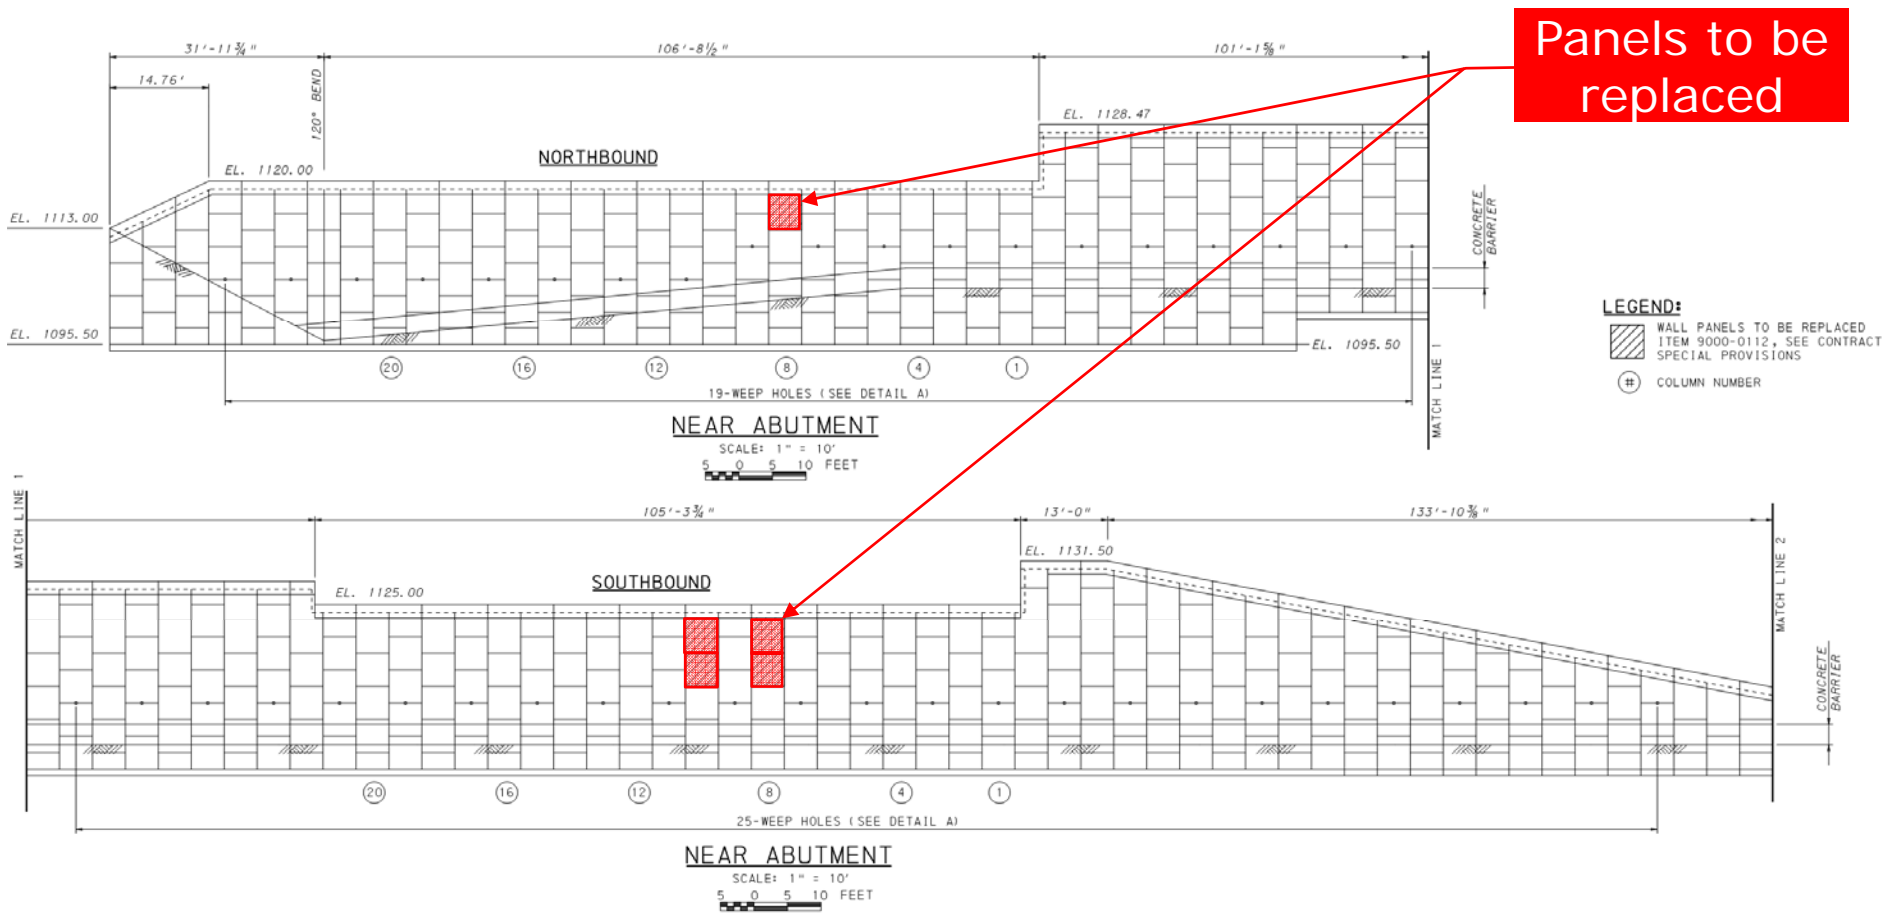
**I-99 NB & SB over T-349 Mountain Rd (SOUTH ABUTMENT)**

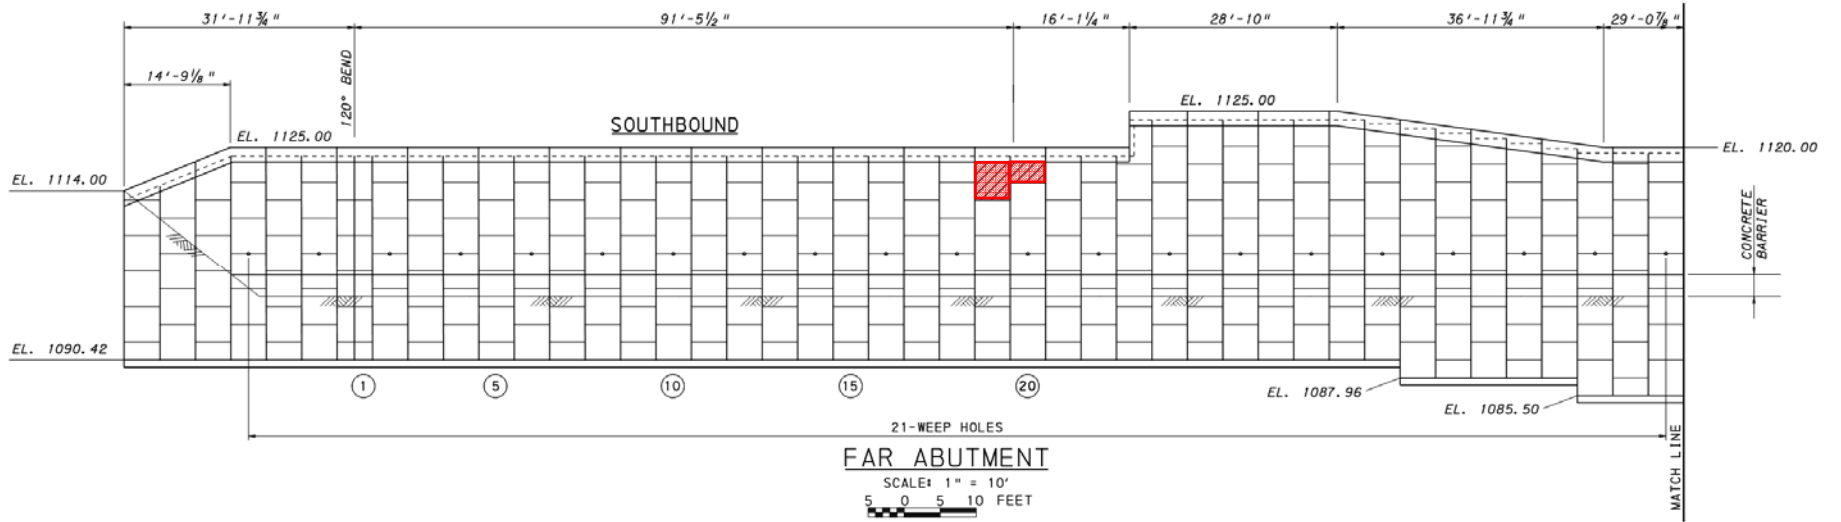
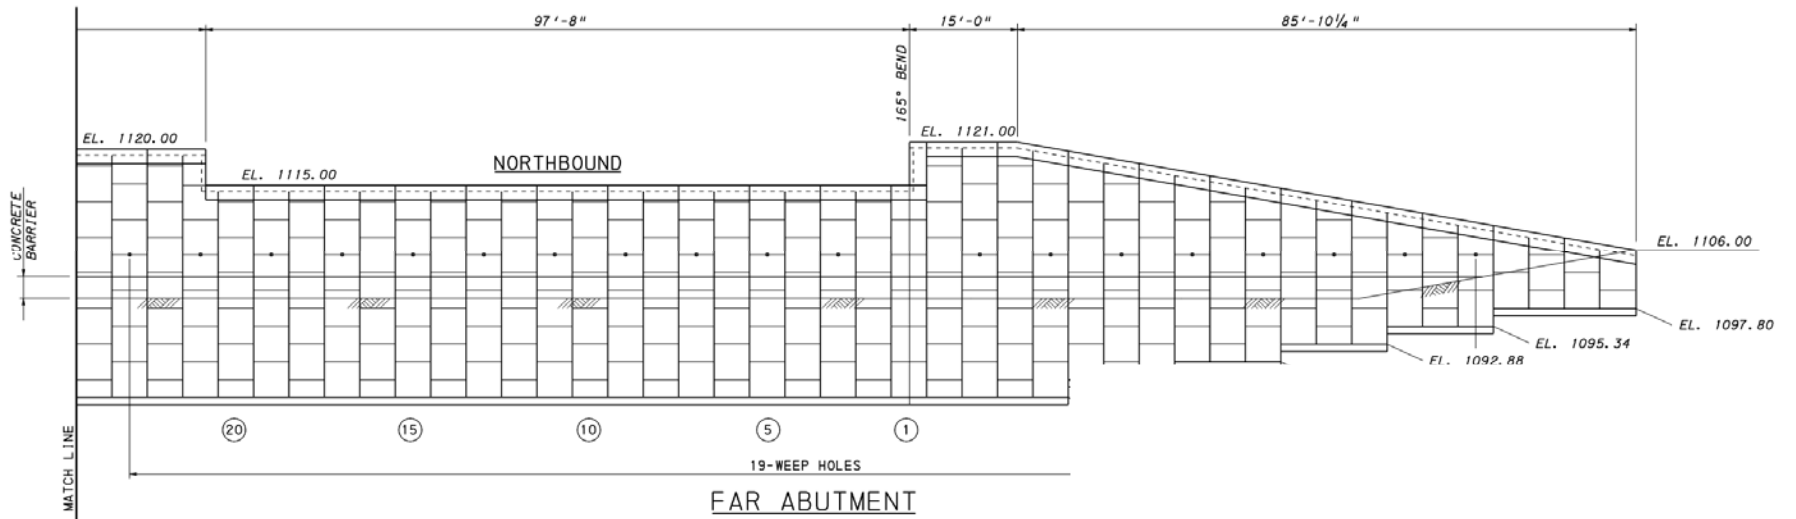
**I-99 NB & SB over T-349 Mountain Rd (NORTH ABUTMENT)**

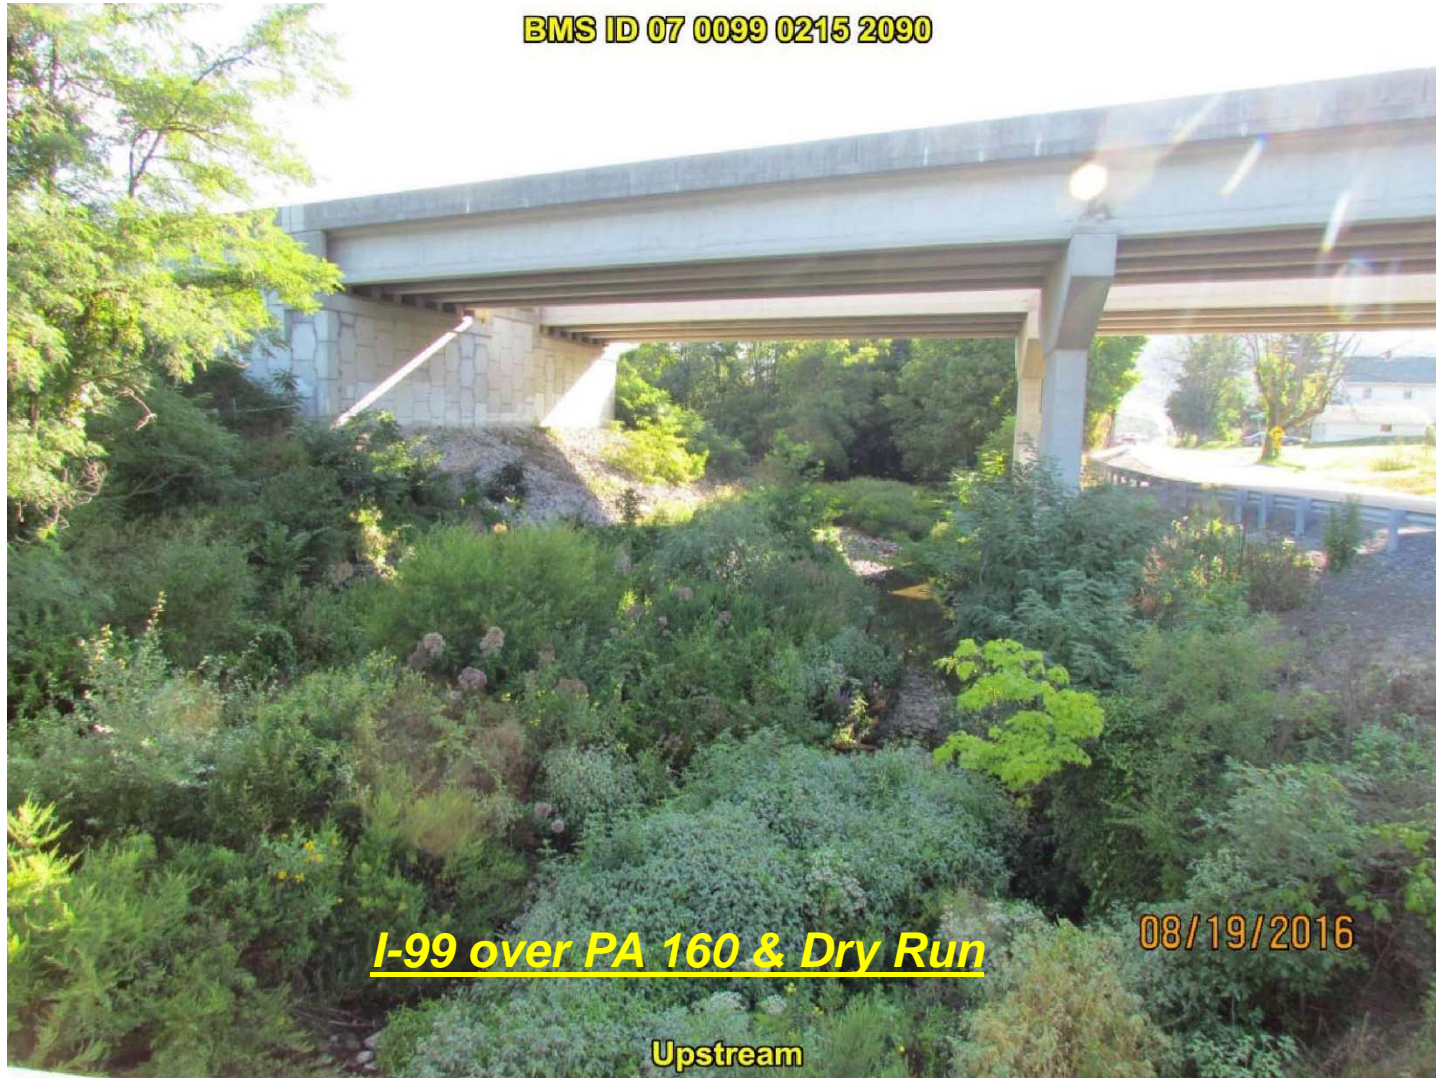
**BMS ID 07 0099 0215 2090**

**I-99 over PA 160 & Dry Run**

**Upstream**

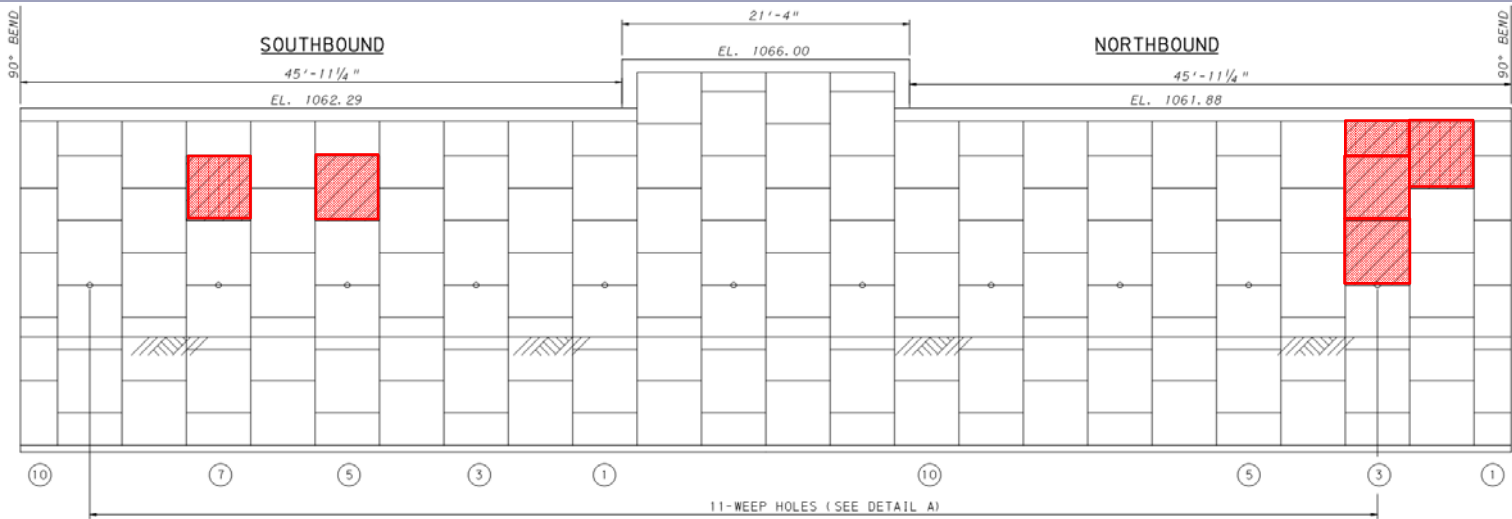
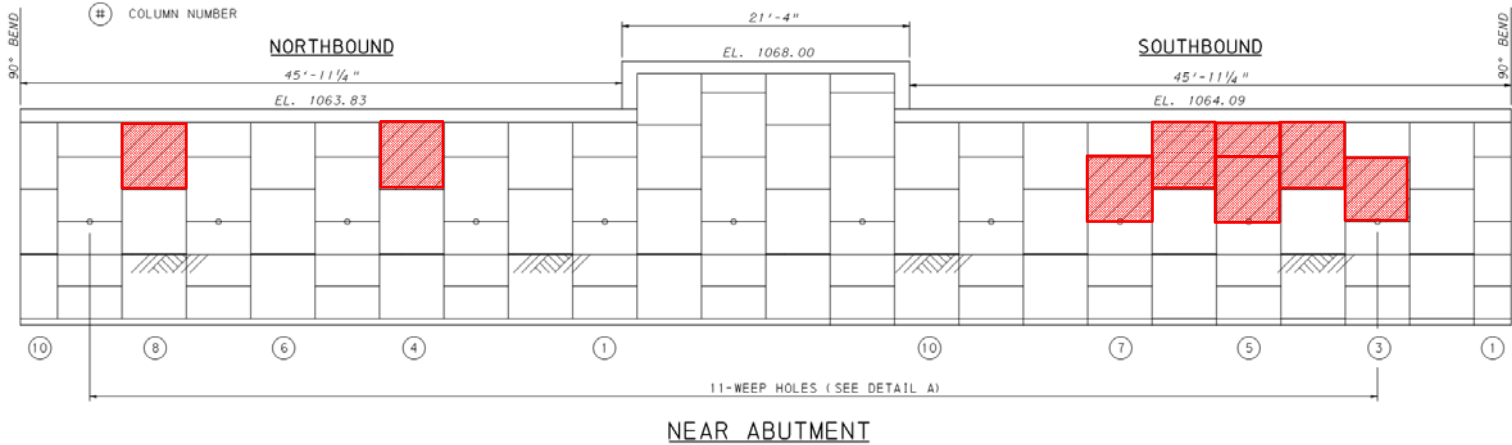
## **I-99 NB & SB over PA 164 & Dry Run Creek**

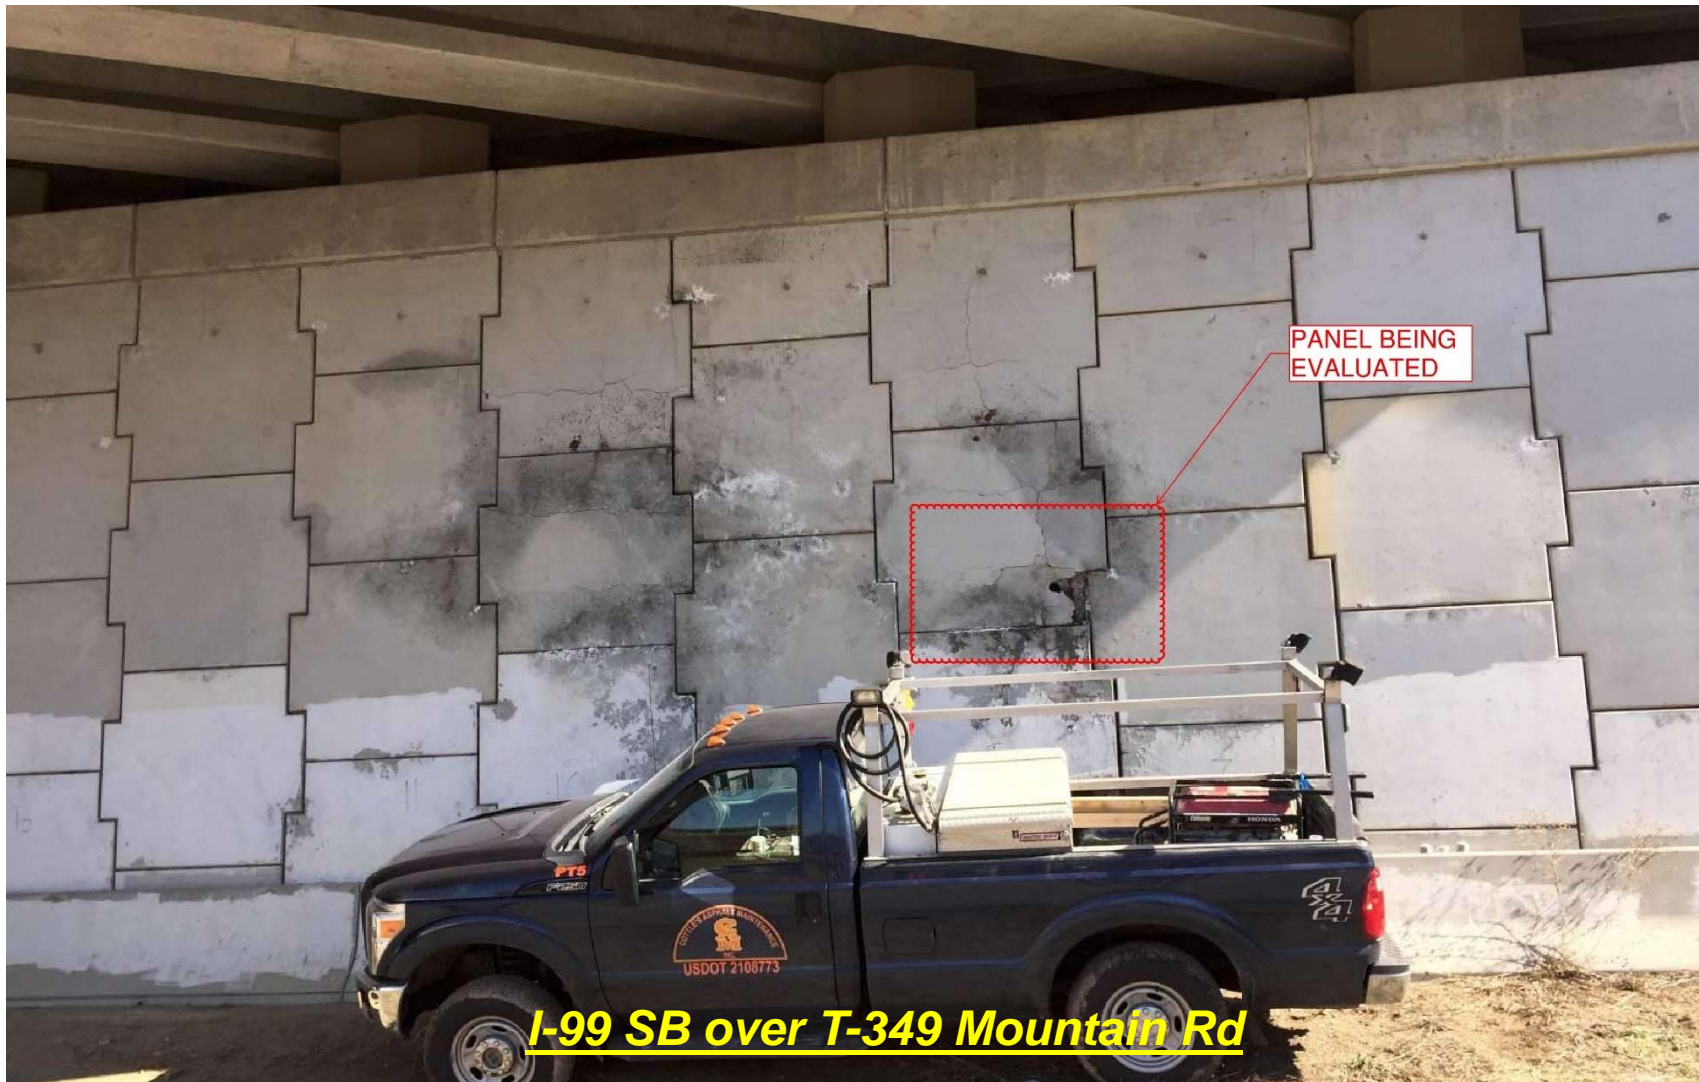
**I-99 SB over T-349 Mountain Rd**

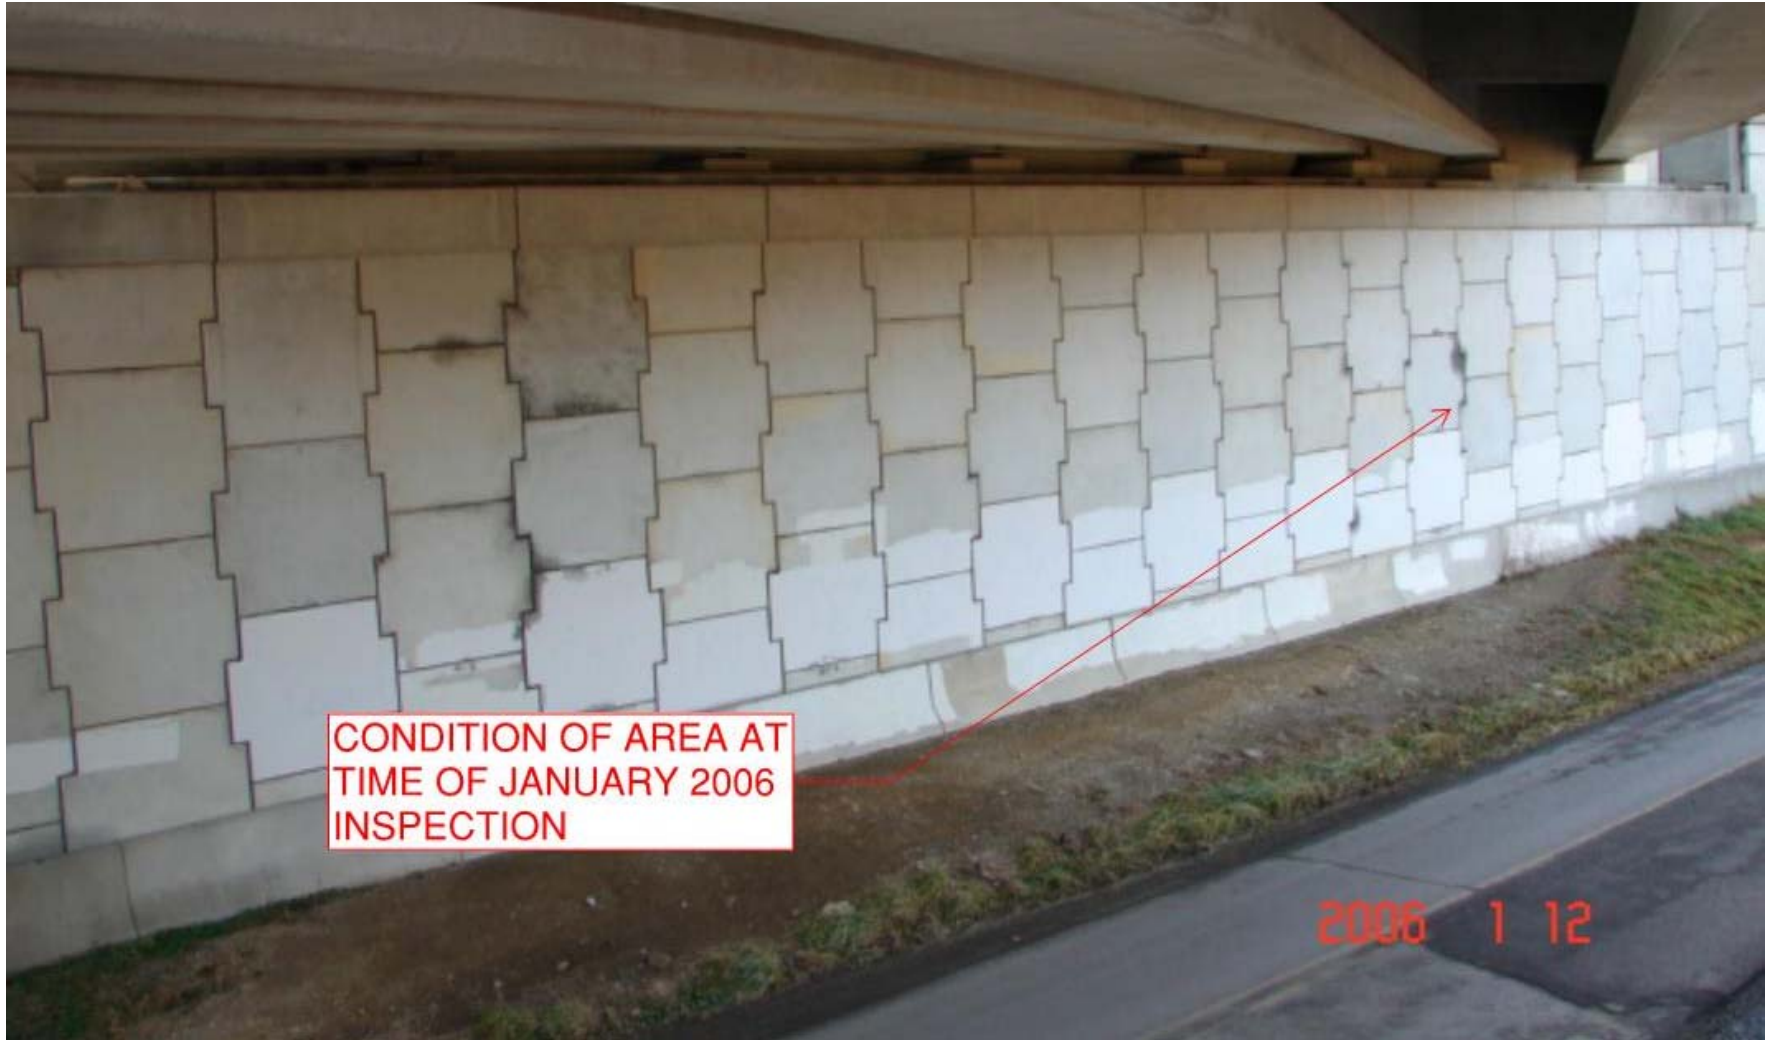
CONDITION OF AREA AT  
TIME OF JANUARY 2006  
INSPECTION

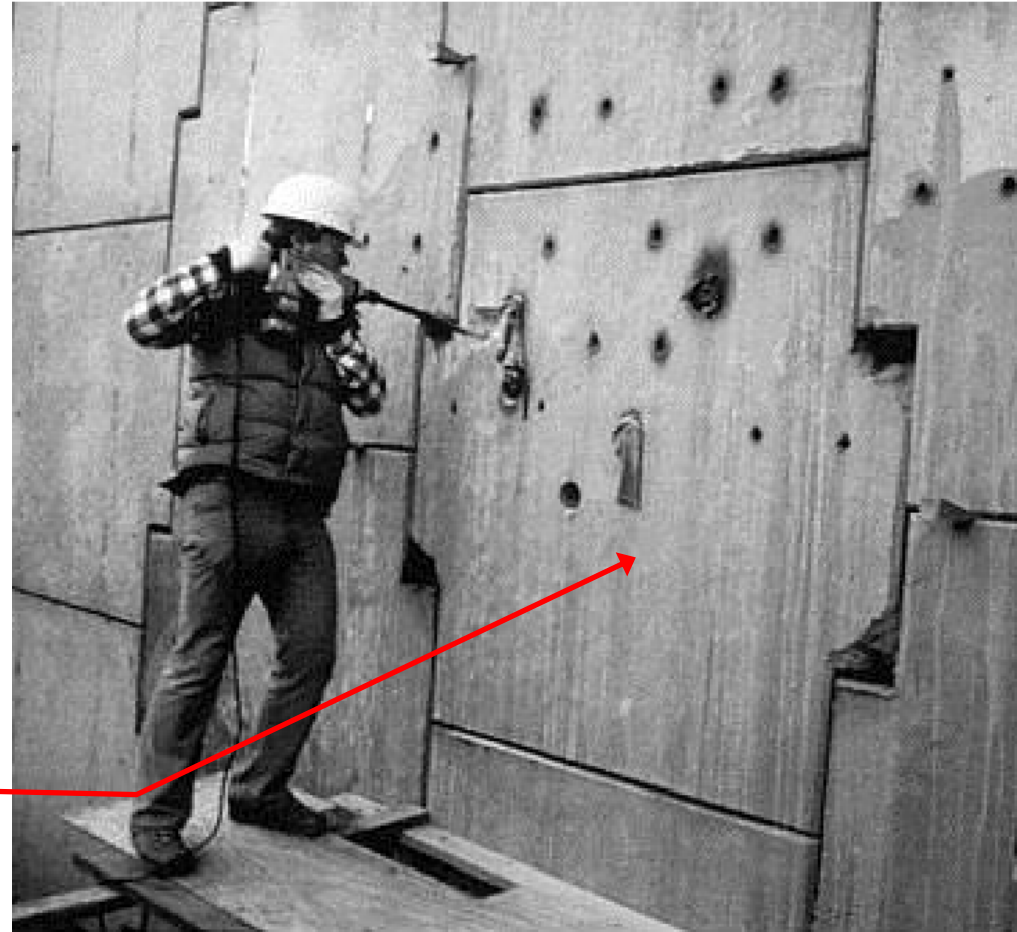
**Panel Appears to be In  
Much Better Condition than  
District 9 I-99 MSE Walls**

**19 Step Panel  
Replacement  
Procedure Provided  
by Reinforced Earth**
