Safe Harbor Trestle Bridge

Deck Design

Steel Evaluation

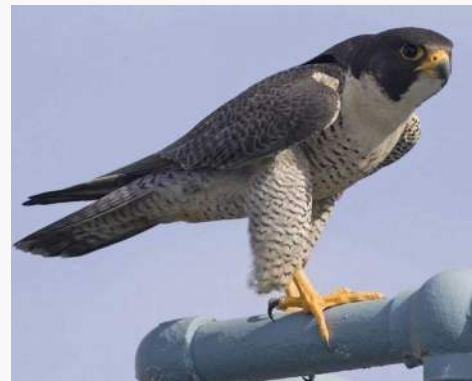
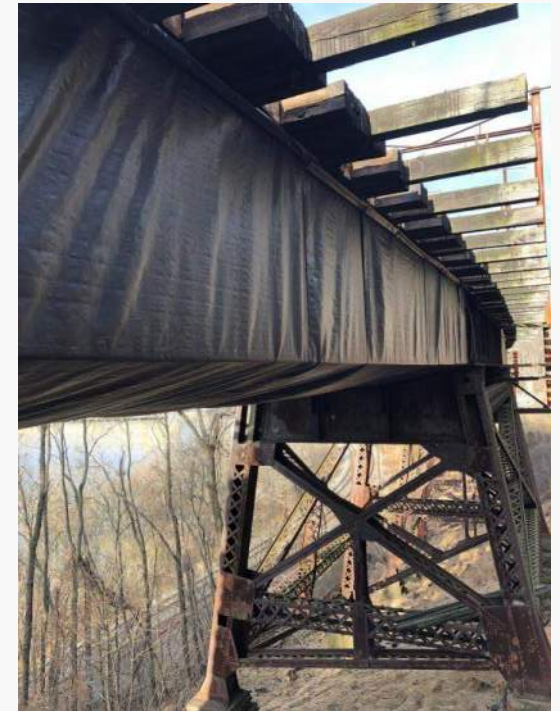
Peregrine Falcons

- Endangered Species
- We needed to inspect bridge during falcon restriction season to keep schedule
- Met with Game Commission and local officials to get special monitoring
- Inspected at the beginning of July after the falcons fledged.
- Needed to keep them off bridge permanently so we could start construction.
- Couldn't use federal funds for construction purposes yet, so we used our DCNR money to advertise a contract to install falcon screening.
- Contractor had 45 days to install screening.

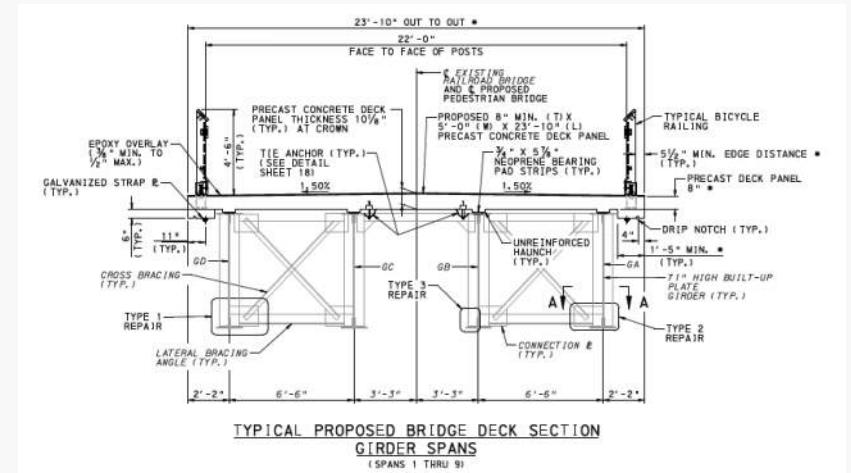
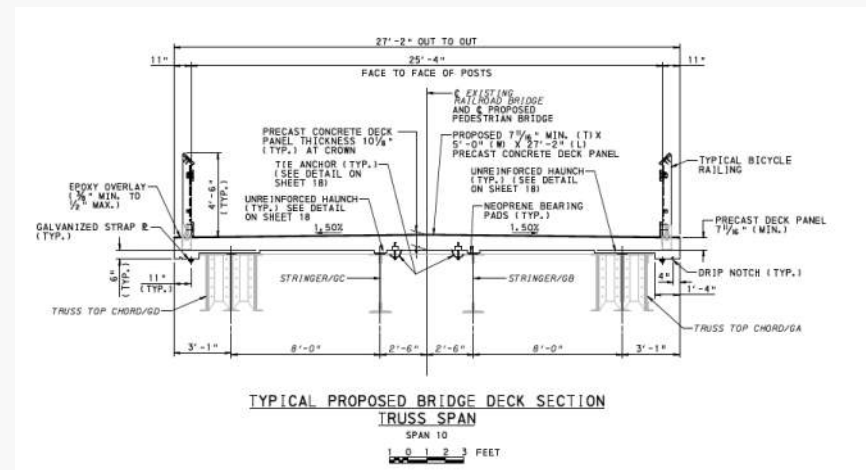
- We had to squeeze all deck work into one season outside of falcon restriction.
- Can't wait for concrete to cure.
- Can't erect from below. Need to set from above.
- Can't overload girders or the deck.

Non-composite precast concrete deck panels

Still... with steel survey, shop drawings, fabrication, delivery and setting, there was not enough time to get it done in one season.

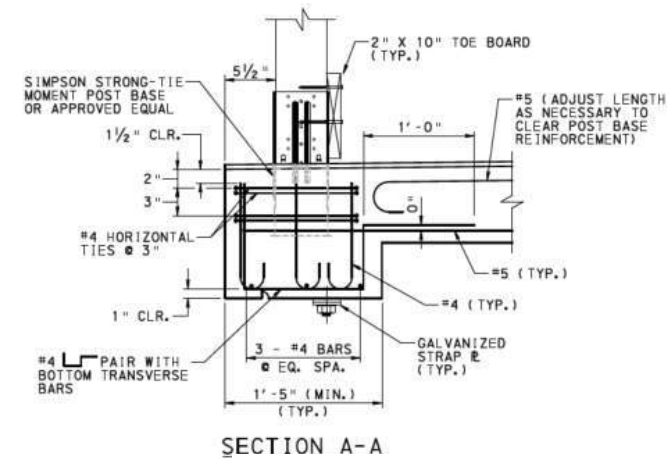
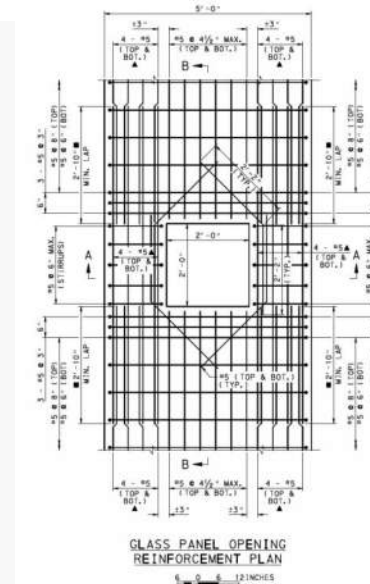
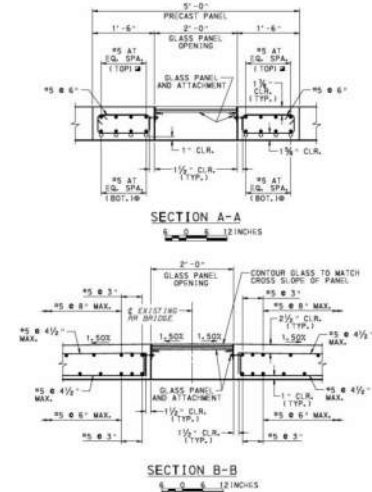
Deck Design

- Fabrication tolerances.
- 4 bearing points.
- Load was EV2 and EV3 with ped loads or construction.
- Couldn't be too heavy to set with a crane on the previous panel.

Manor Township wanted glass panels to stand on and see the Conestoga River below.

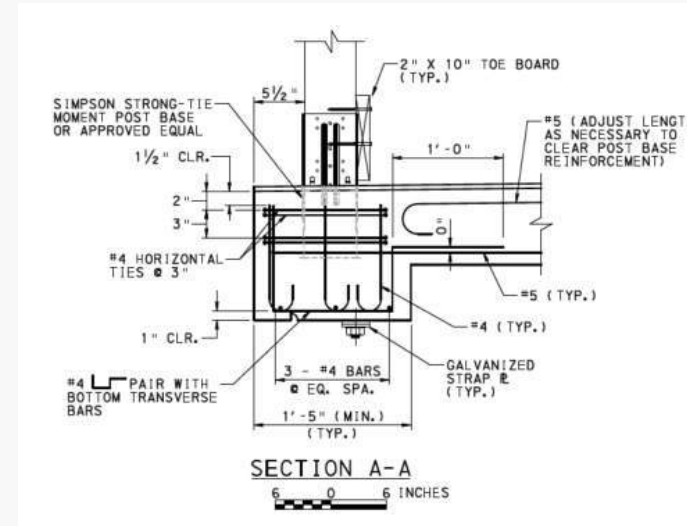
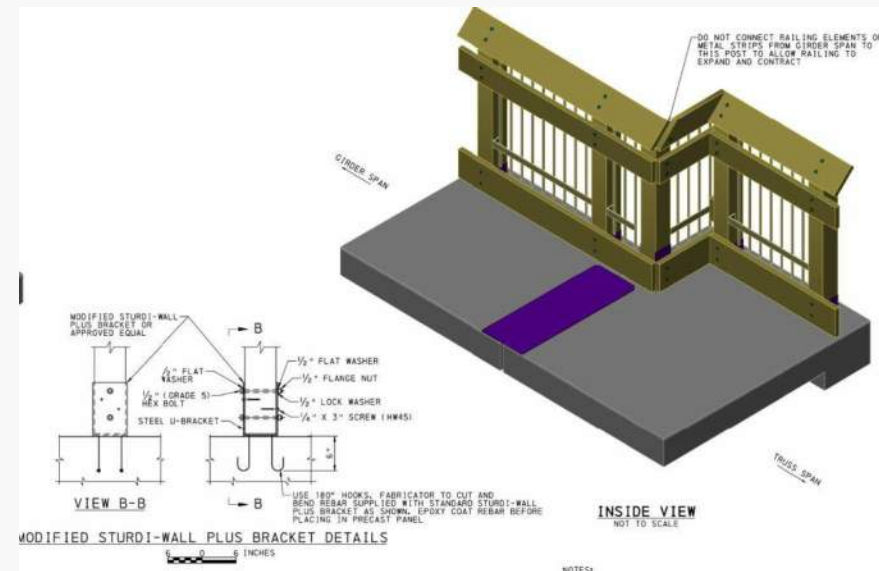
Railing Design

Manor Township wanted timber railing with black steel balusters.

100% custom design for impact forces and linear loading of any member in any direction.

Tall enough for bicyclists, but not so tall that couldn't see the Susquehanna over it.

Anchorage into deck required tight rebar tolerances and a Simpson Strong Tie post anchor.

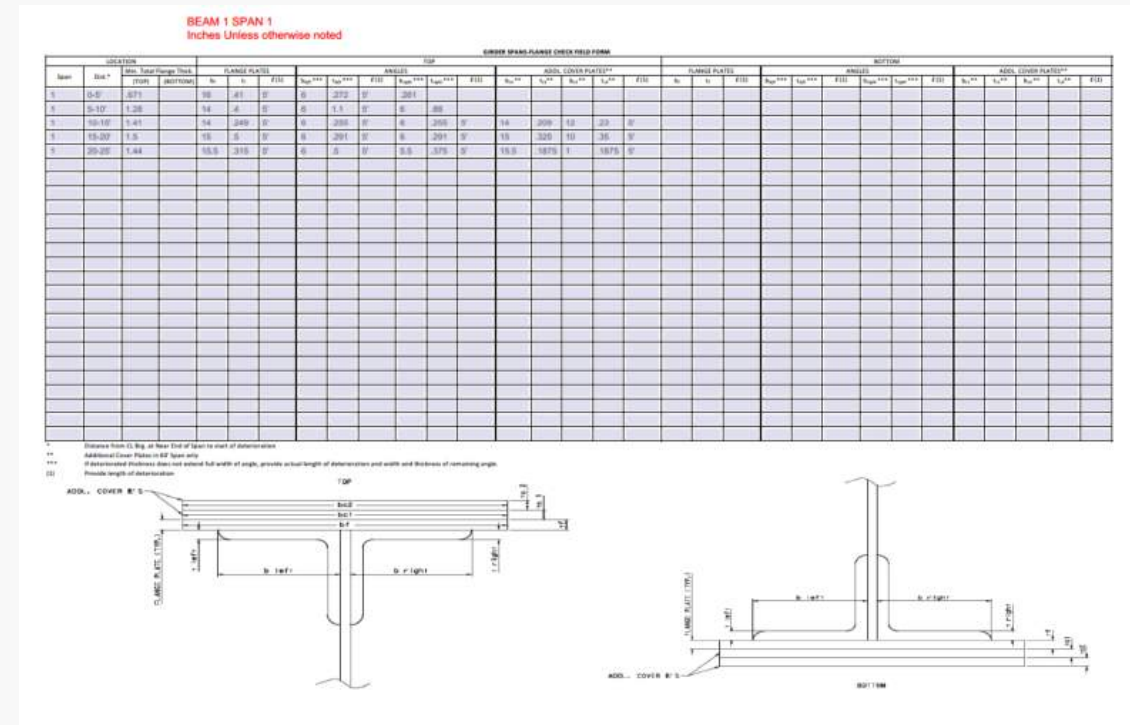
Railroad ties in place. We don't know, nor would we ever know the condition of the top flange until construction started.

Developed thickness spreadsheets that told the inspector the required top flange thickness along each span to meet the required loading.
