2022 D-9/ ASHE WORKSHOP

JOINT MGMT/ IIC COUNCIL QUALITY EFFORT

To identify focus areas where the potential for quality improvements may exist that would provide mutual benefit to both Design and Construction

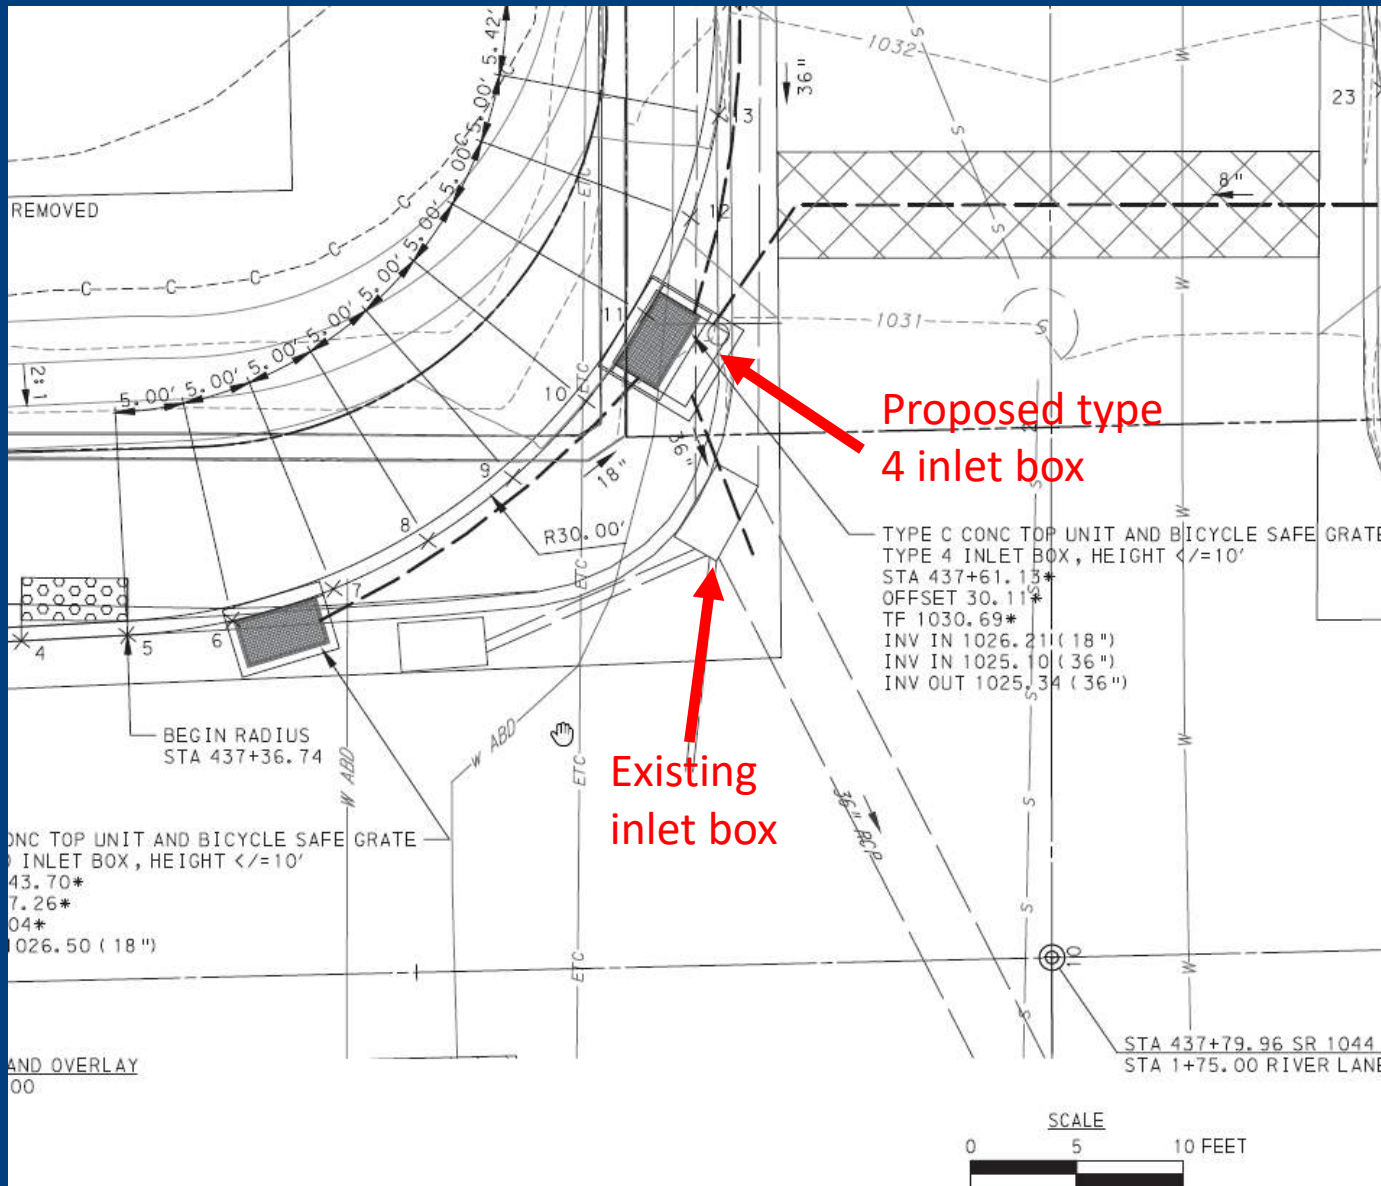
EXAMPLE #1

- Plan shows existing 36-inch pipe and 18-inch pipe coming into existing inlet box, with one 36-inch pipe going out
- New inlet box called out as Type 4, but with 36-inch pipe on such a skew needed a larger box
- Ordered larger box for 36-inch pipe on sharp skew instead of Type 4

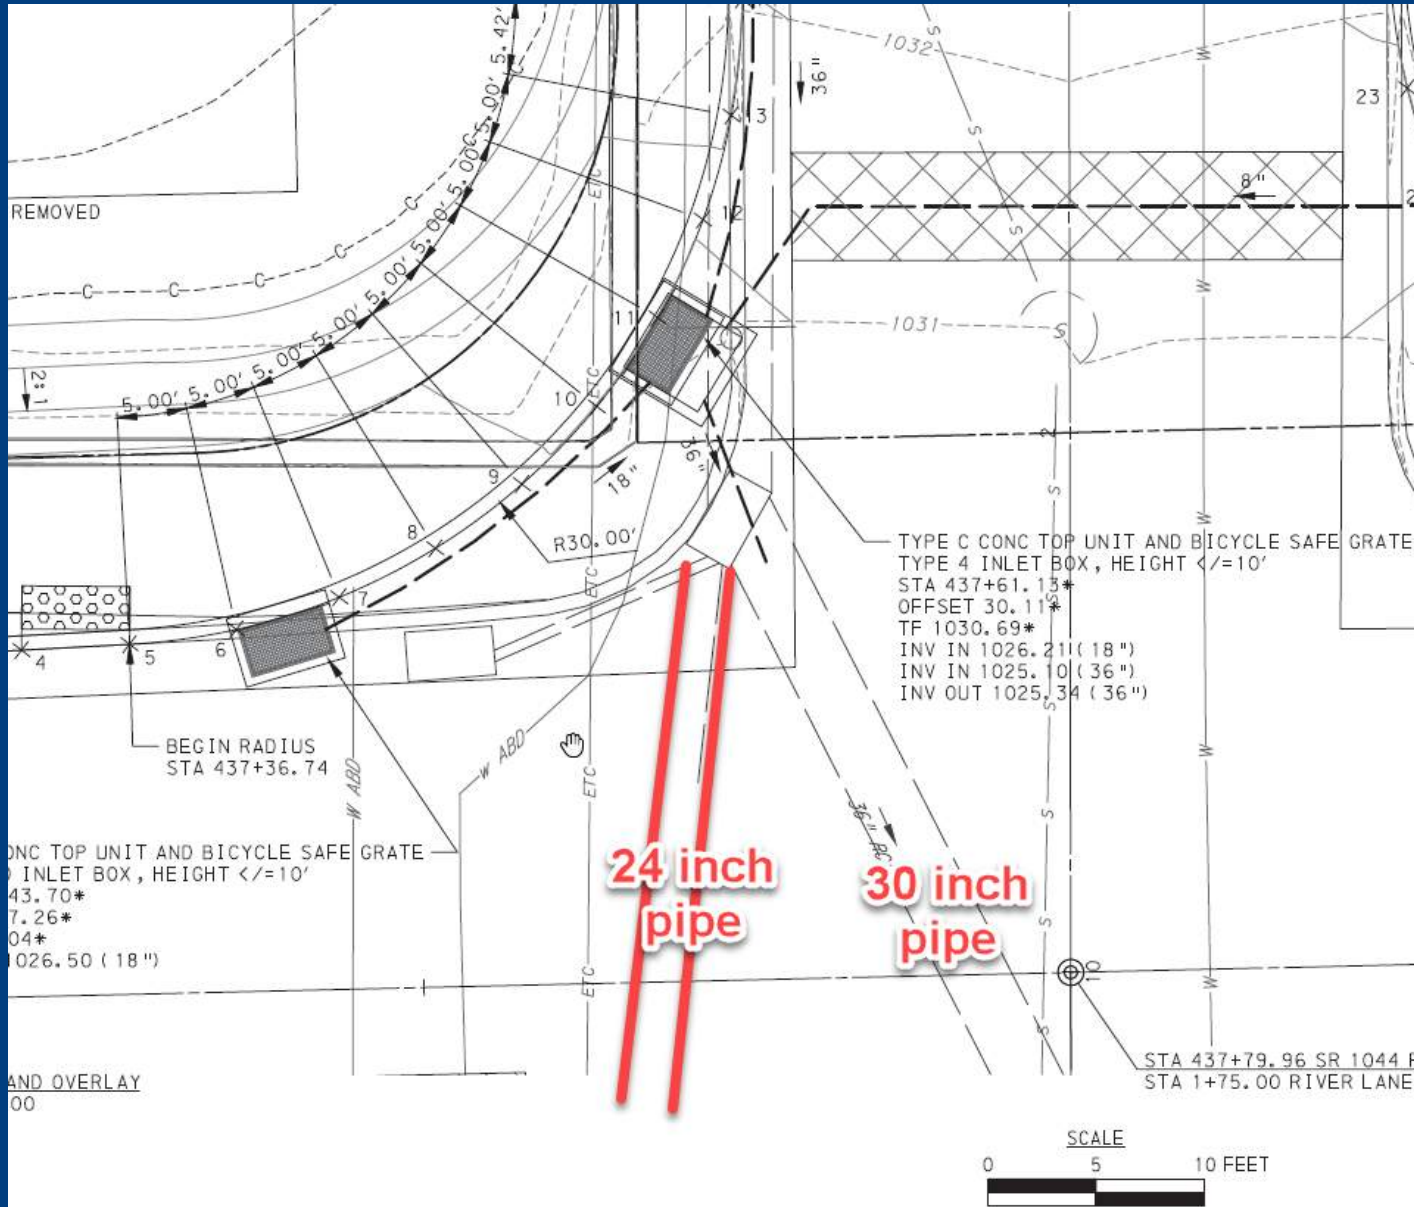
EXAMPLE #1 (cont.)

- When excavating at existing inlet box, found the actual condition to be different than shown
- Instead of one 36-inch pipe outlet, there were two pipes: one 24-inch and one 30-inch

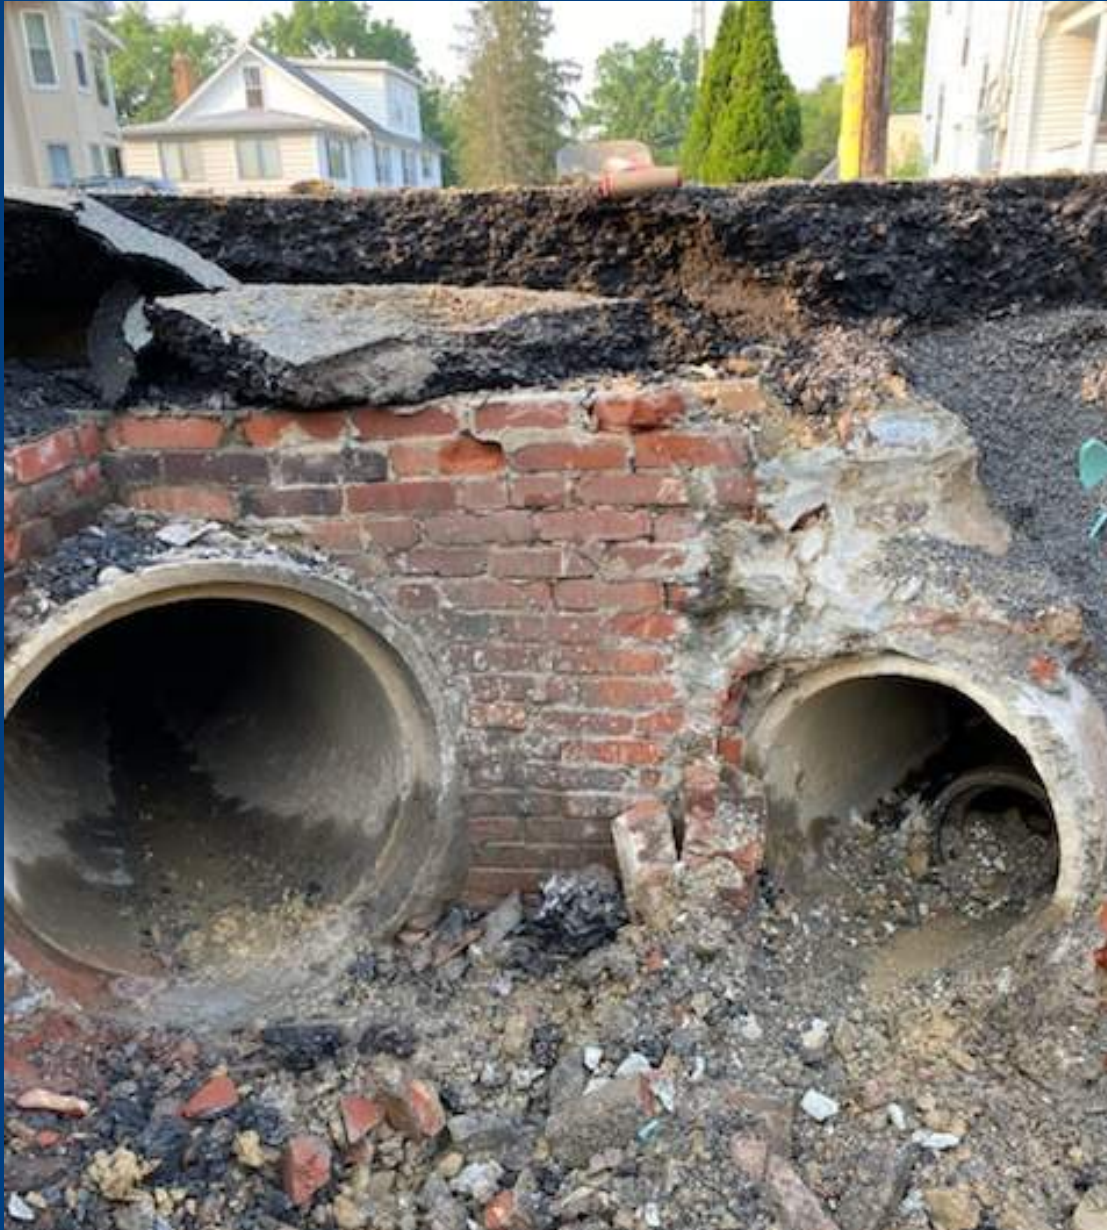
EXAMPLE #1 (cont.)

- Actual condition at existing inlet box
- Left outlet pipe 30-inch concrete (not 36")
- Right outlet pipe 24-inch concrete
- Both were needed and functional
- This changed the entire approach
- Field staff scrambling to make decisions on what to do with traffic control

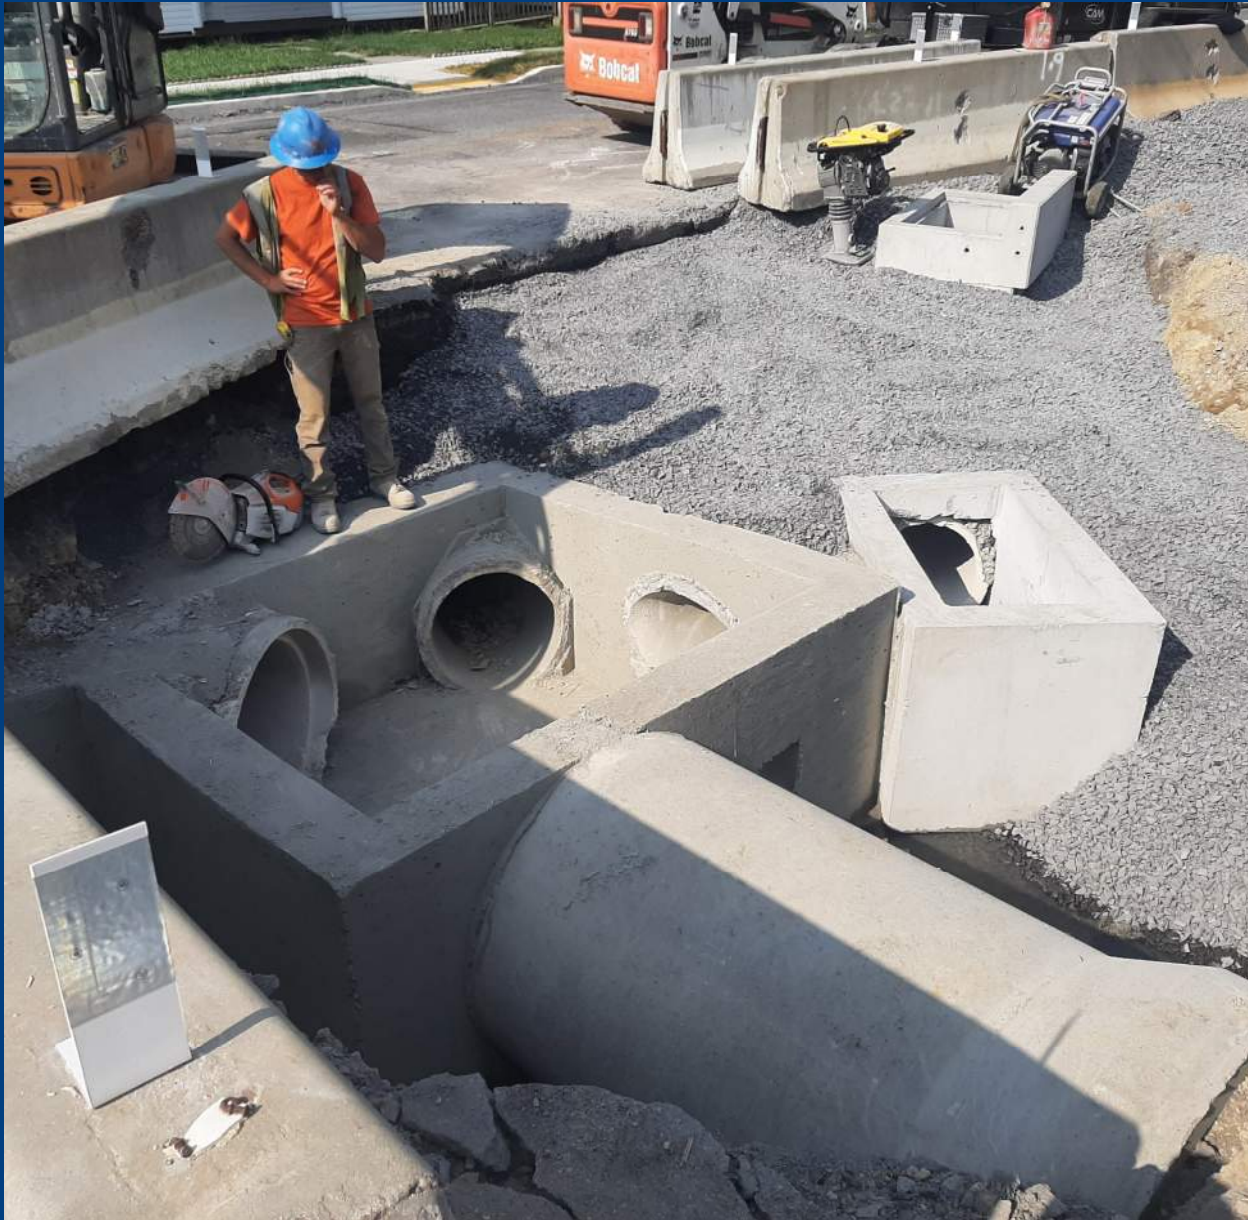
EXAMPLE #1 (cont.)

- Because both pipes needed to remain, a new large inlet box was cast in place at the junction of these two pipes
- Due to the time needed for cast-in-place box, temporary traffic control issues were encountered
- The larger precast box that had been previously ordered due to the 36-inch pipe on a skew was no longer needed

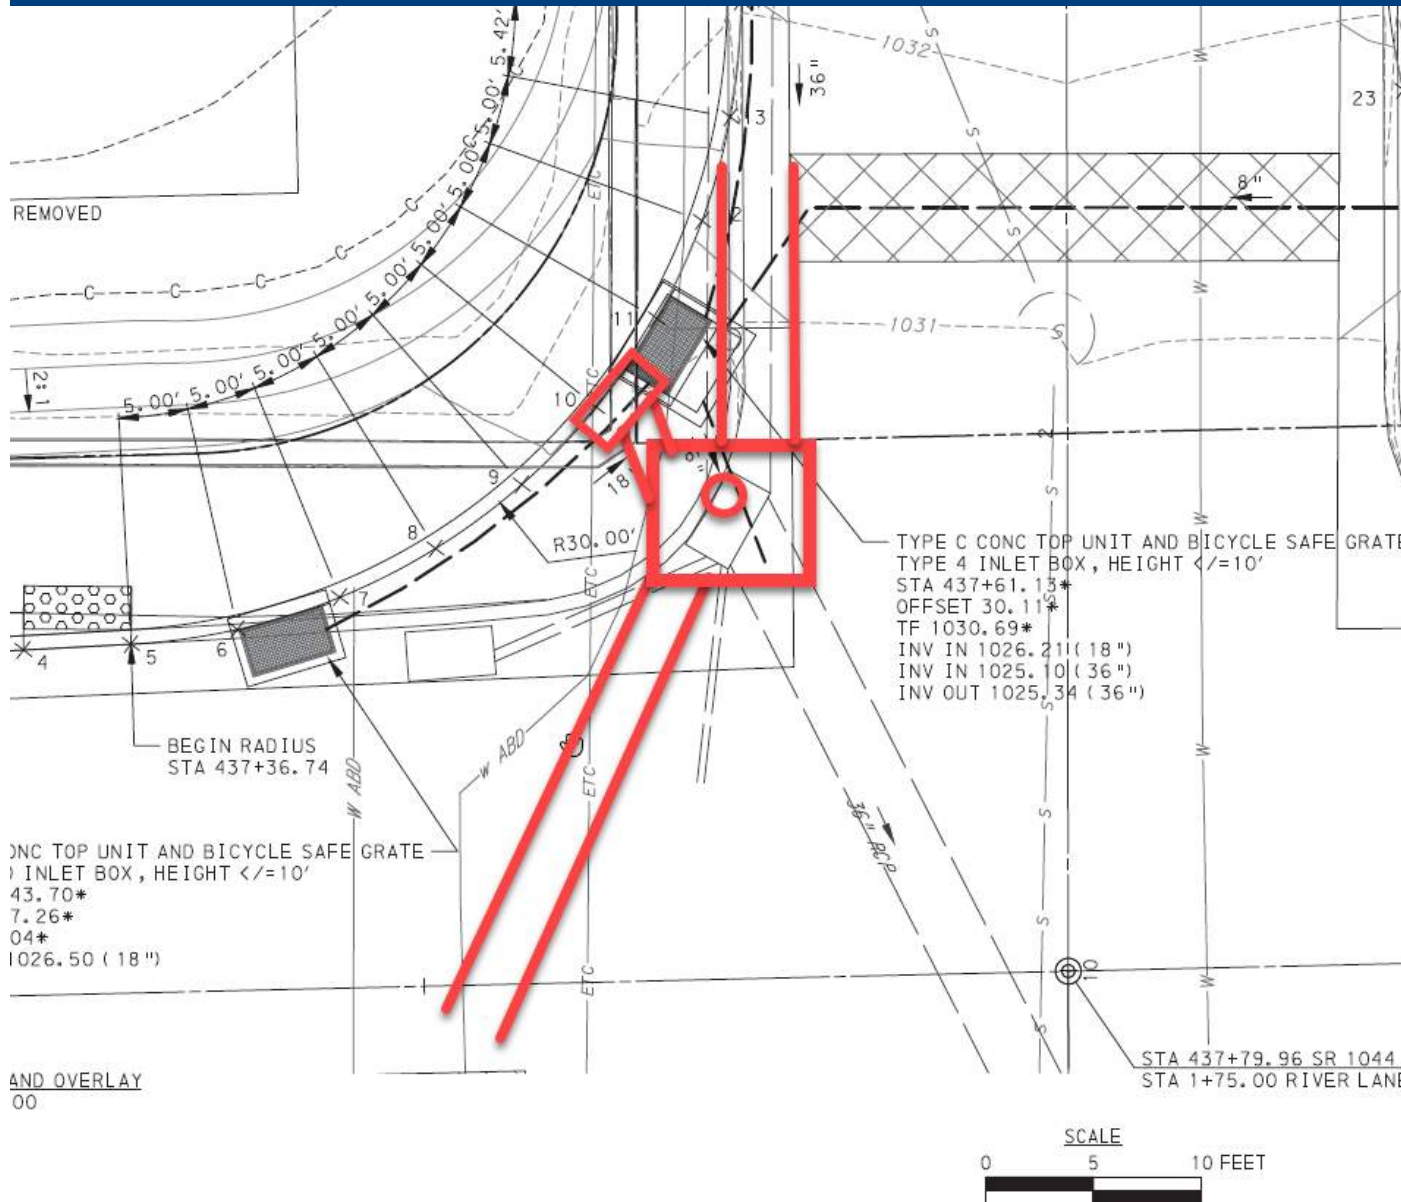
EXAMPLE #1 (cont.)

- Approximate as-built box location with manhole
- Time impact – approximately 7 days to cast in place new box and top w/ manhole
- Project impact - substandard traffic control during this time
- Cost impact - \$21,375 total

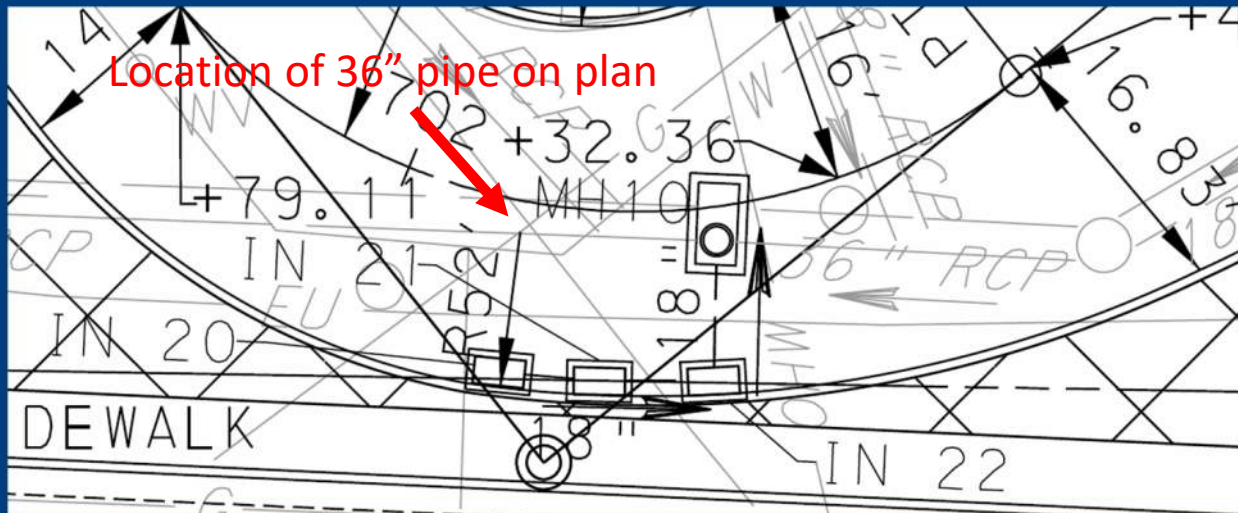
EXAMPLE #2

- New drainage was designed to be outlet to an existing 36" pipe
- Actual location of 36" pipe was in conflict with three new inlets that were to be installed
- Drainage was redesigned
- Redesign added cost and delay to project since the inlets were larger and now had to be cast in place
- Original inlets were precast and on site ~ these had to be purchased and given to maintenance

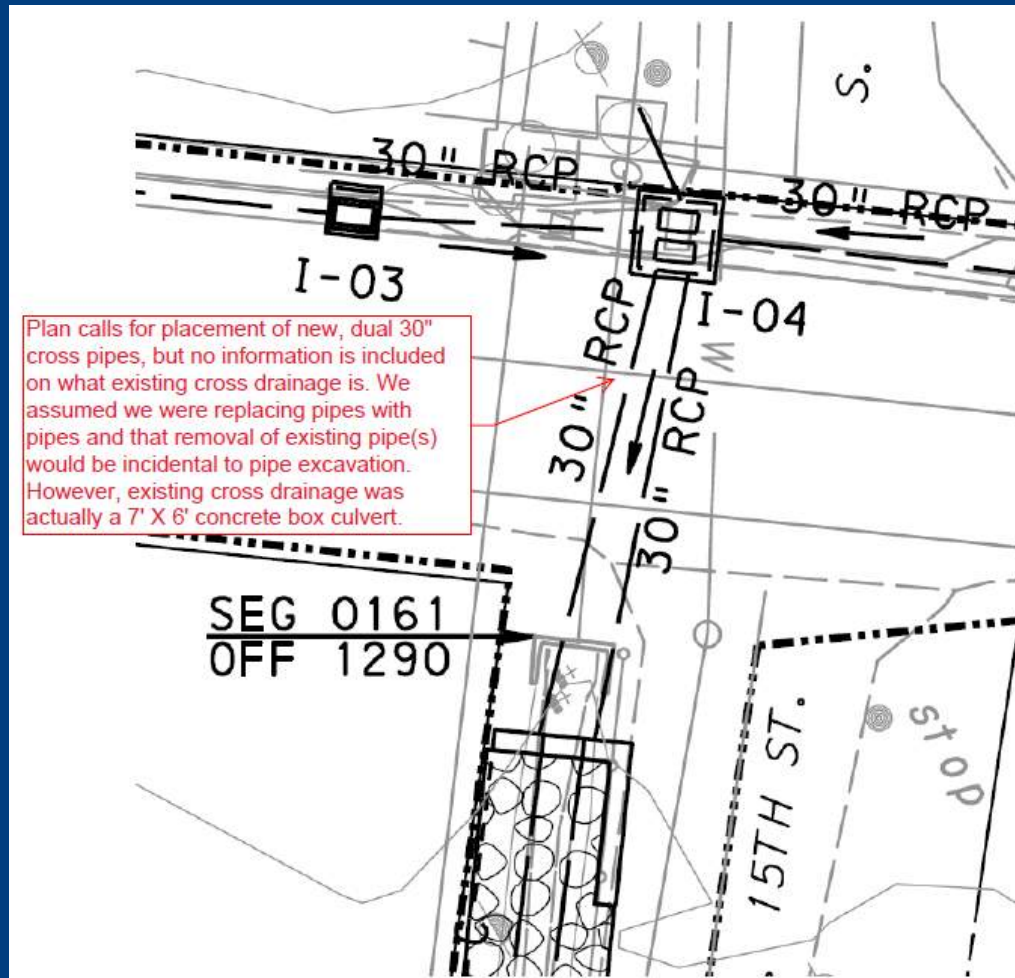
EXAMPLE #3

- Plans called to replace the existing cross drainage with two 30" pipes, but no call out indicating what existing cross drainage consisted of
- Existing cross drainage was found to be a 7' X 6' concrete box culvert
- Although removal of small existing pipes would be incidental to pipe excavation, structure demolition (i.e. ~ box demolition) is not incidental
- There was no item for structure demolition to remove the box
- Department had to add a demolition item with long-term traffic control to enable the work to be completed in a safe manner (Cost ~ \$27K , Delay ~ two weeks)

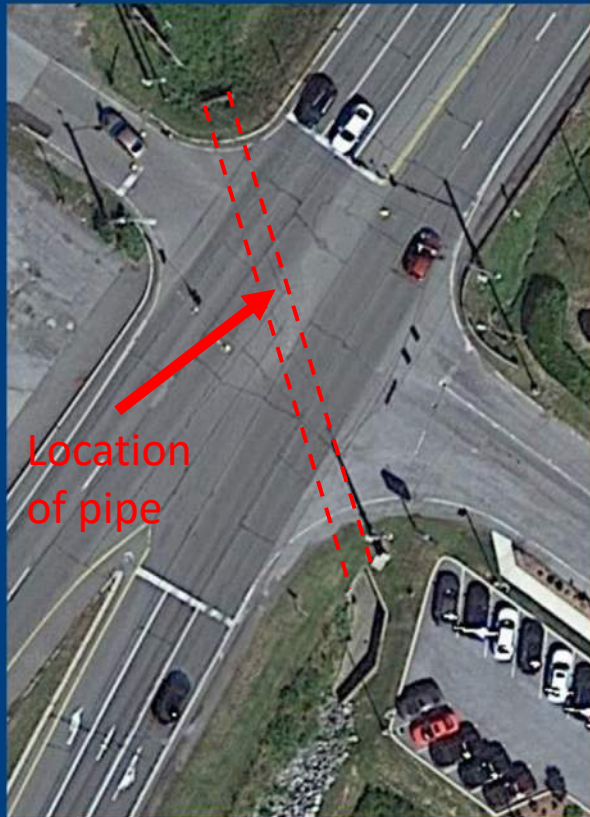
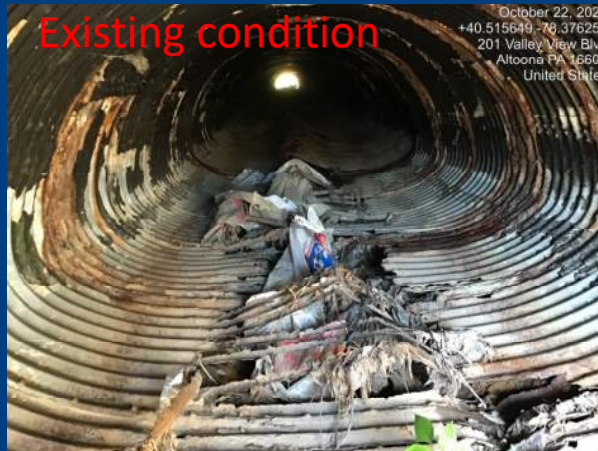
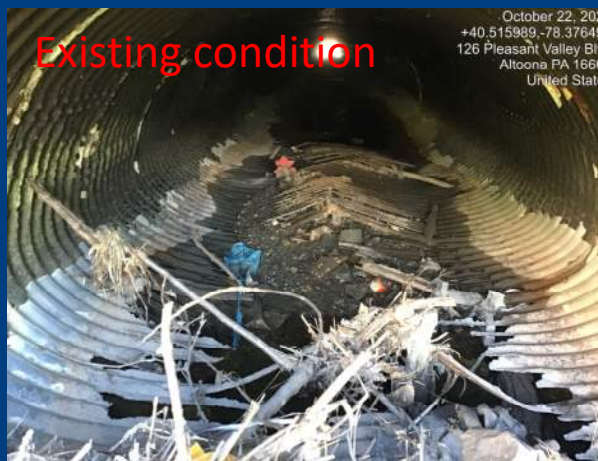
EXAMPLE #4

- During construction, the IIC was reviewing pipe cleaning locations and found a failing 46"x70" elliptical metal pipe
- This was a mill and overlay project and the paving was already complete, so replacement was not a desirable option
- The designer proposed to use a Geospray Pipe Liner to rehabilitate the pipe
- Cost to project: \$189,000

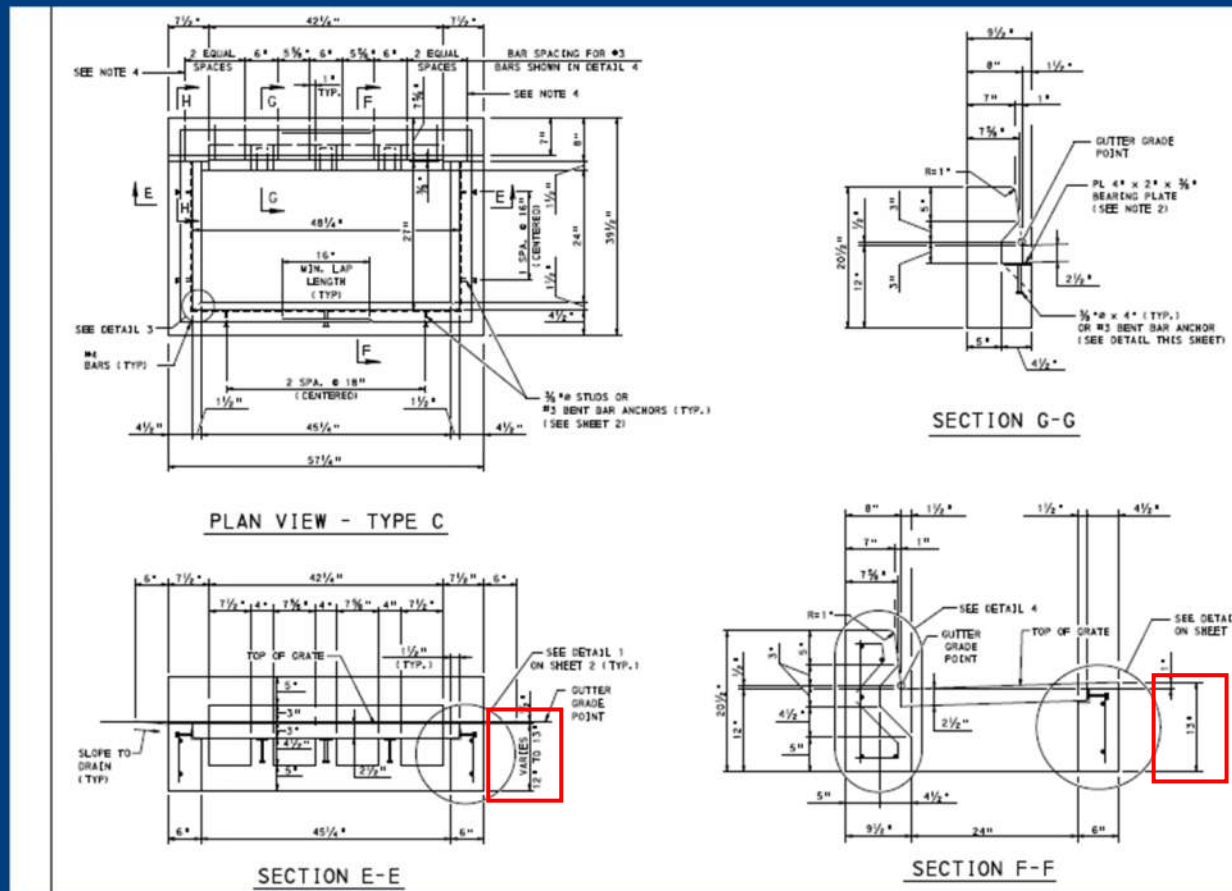
EXAMPLE #5

- New Type C Inlet Tops utilizing existing grates were planned. Old tops were 8" depth. Current RC-45M Type C inlet tops are 13" in depth.

- Special provision/ details required to provide alternate inlet tops or provide a grade adjustment of existing inlets item

- In this case, work order was processed for adjusting inlet grades to accept standard top at a cost of \$800 per inlet (luckily, contractor accepted Allied Contract pricing in lieu of force account)

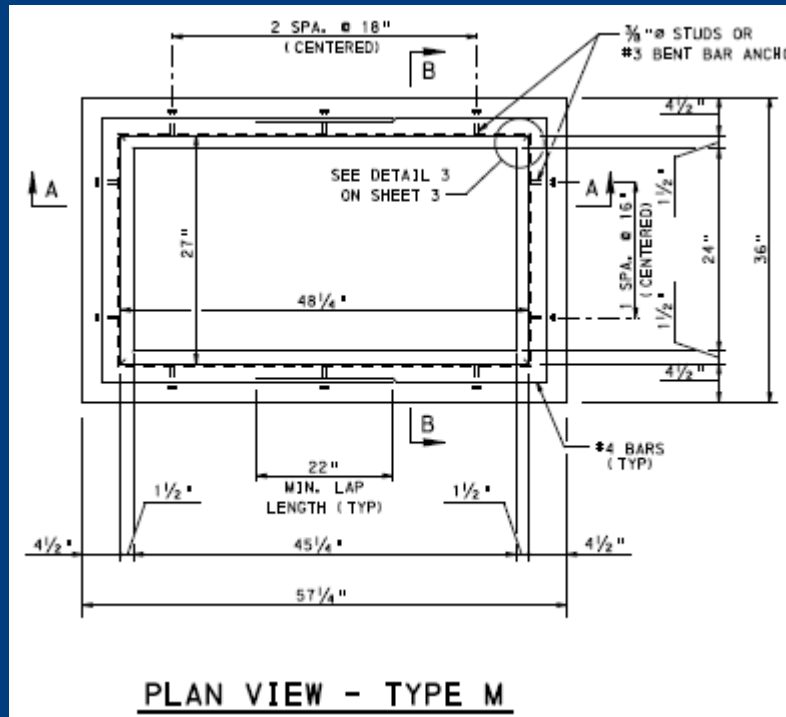
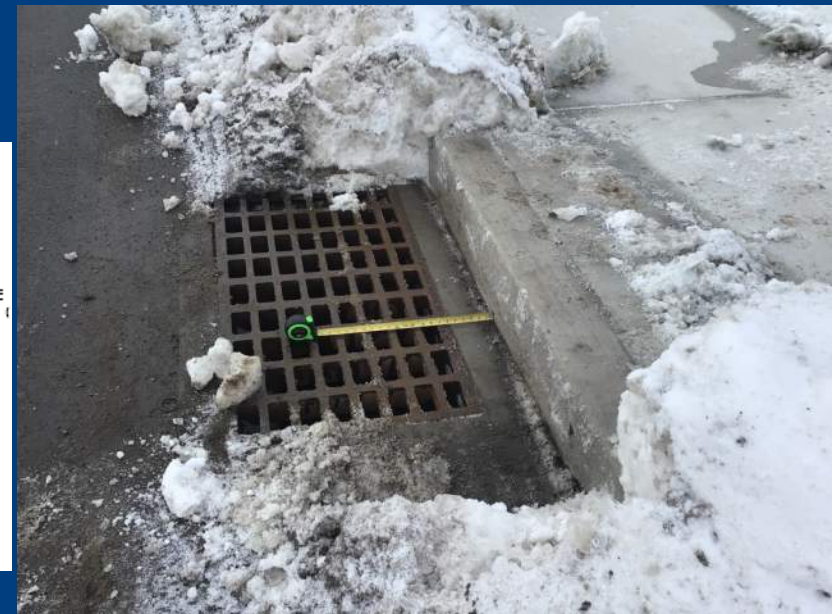
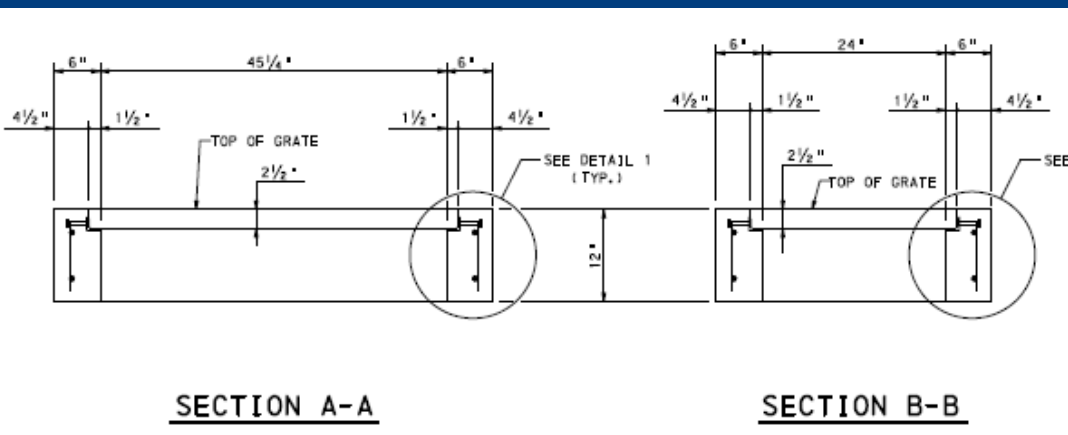
EXAMPLE #6

- Corridor improvements project calls for installation of precast Type M Inlet Tops on existing inlets in curbed section
- Due to 4" width of concrete around the perimeter prior to the inlet grate, water will bypass inlet between curb and grate

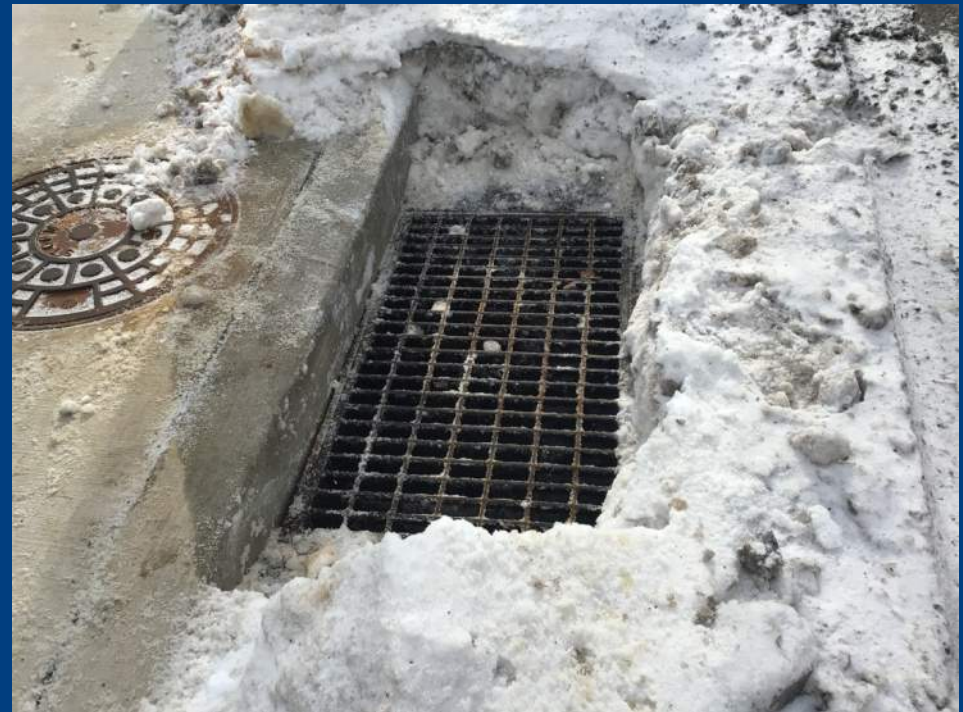
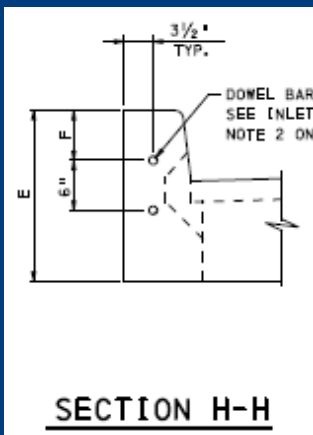
EXAMPLE #6 (cont.) ~ Desirable condition is Type C Top & Frame

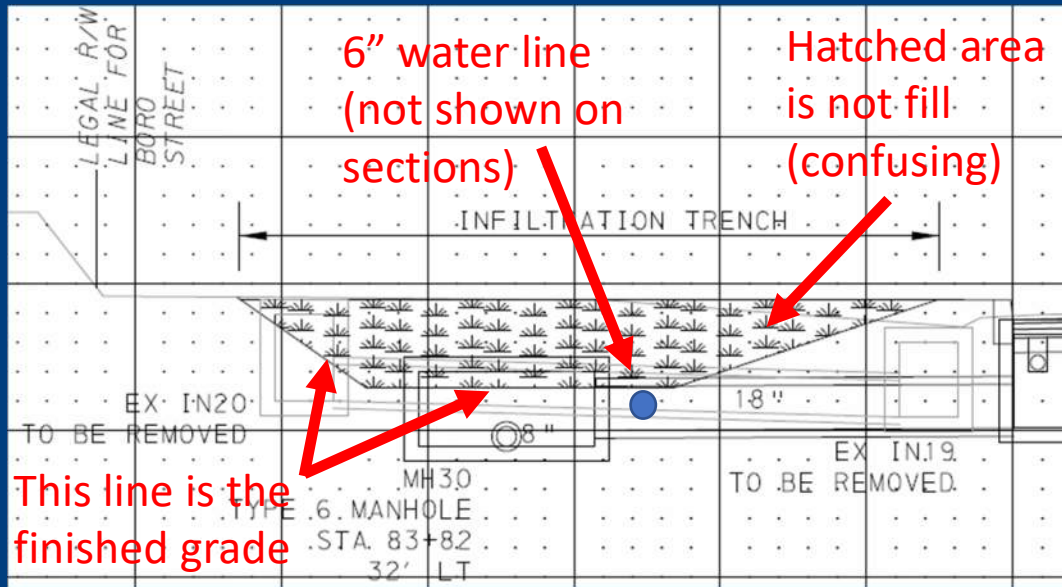
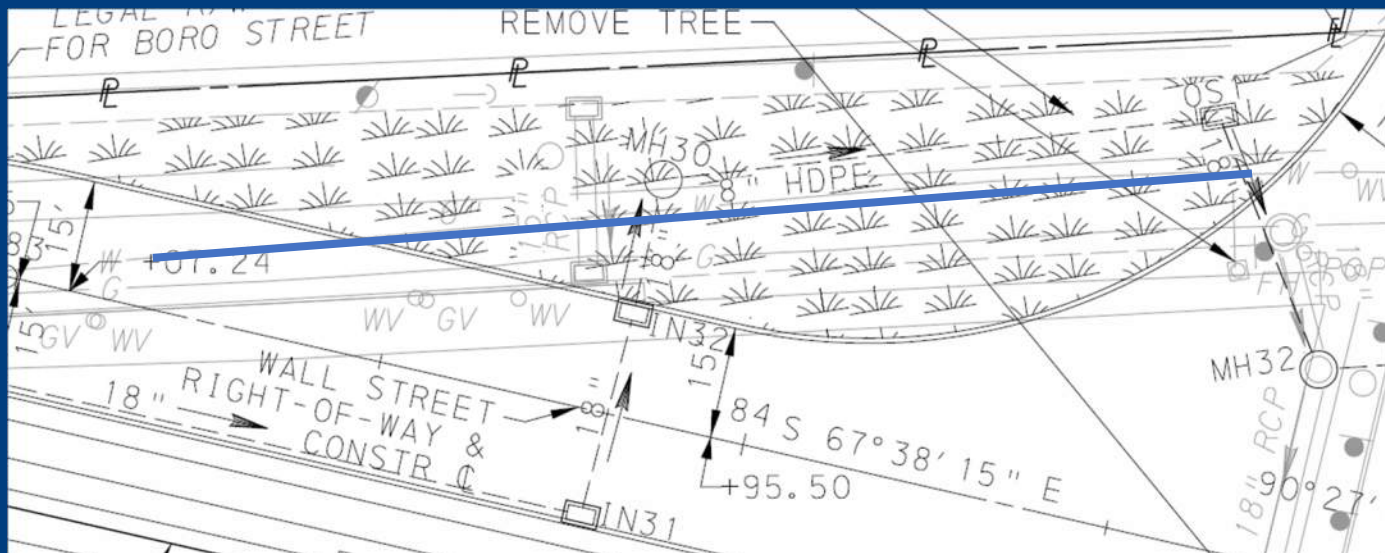
EXAMPLE #1

- An existing 6" waterline is shown on the plan view, but not shown on the cross sections
- This waterline ended up being near the bottom of a new infiltration trench whereby the active waterline would be exposed/undermined during trench construction
- The waterline was also in conflict with an 18" pipe to be installed

- END RESULT: Waterline was relocated adding delay and cost to the project

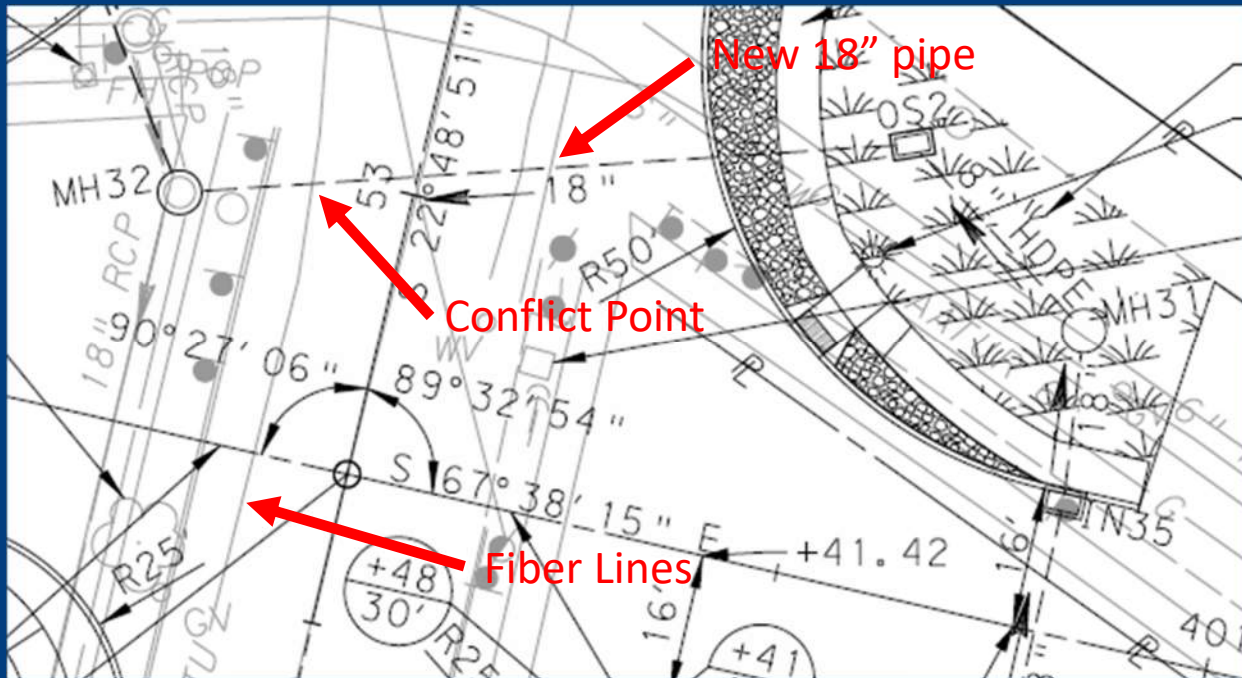
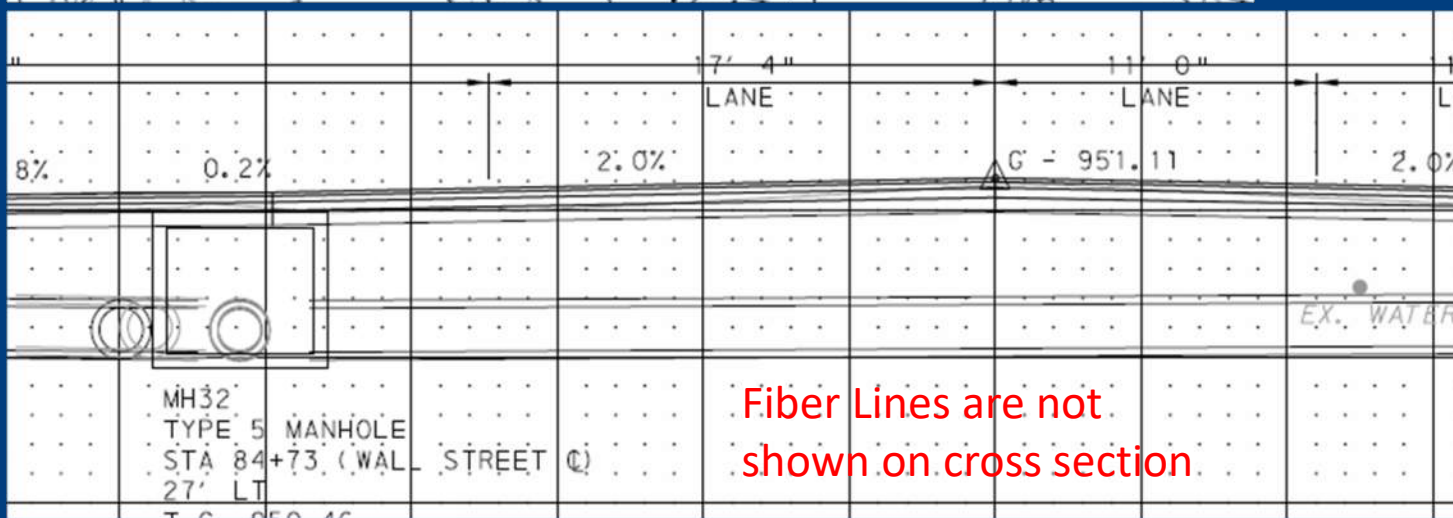
EXAMPLE #2

- Existing fiber optic lines are shown on the plan view, but not shown on the cross sections
- An as designed drainage pipe was to connect to existing drainage
- While excavating, it was found that existing fiber optic lines were in conflict with the pipe

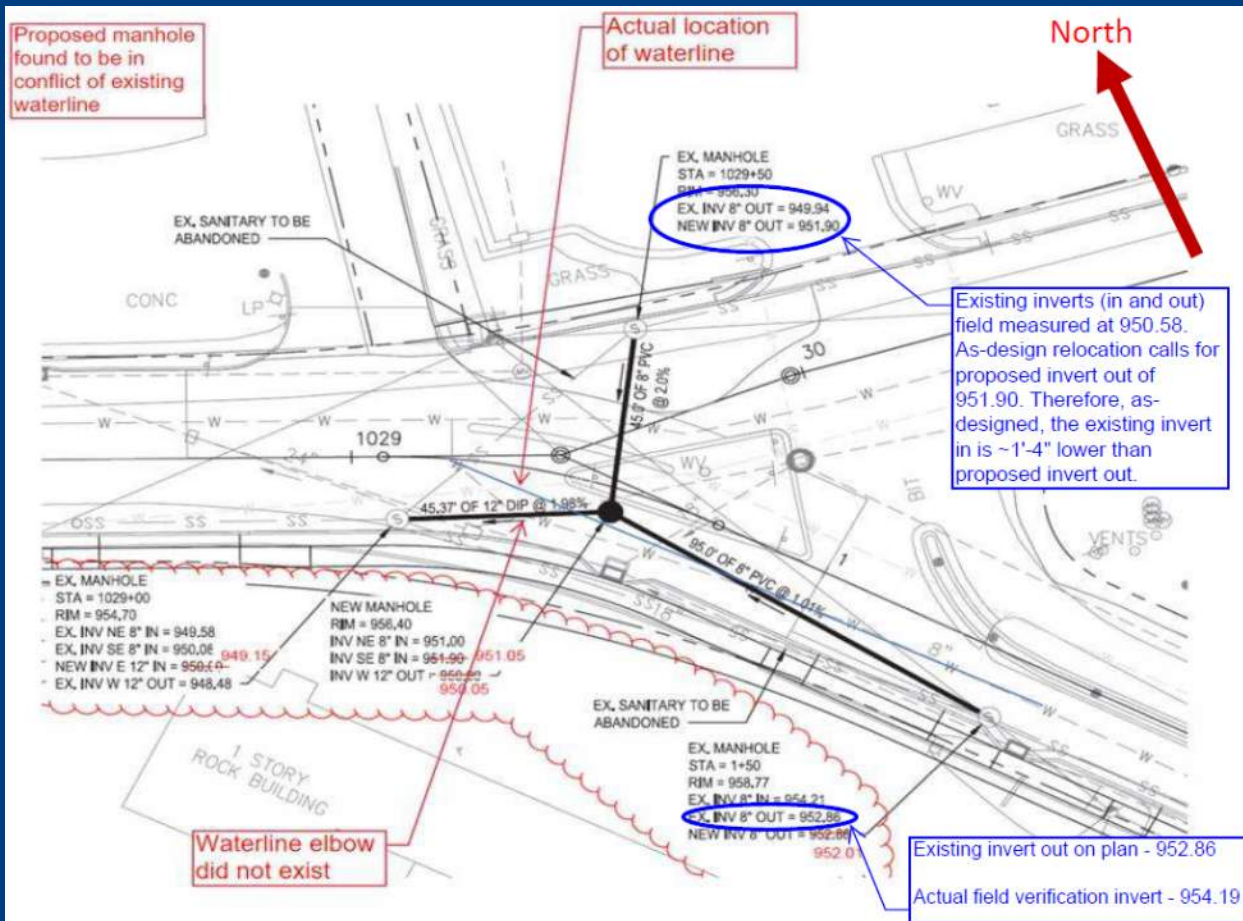
EXAMPLE #3

- \$4.2M safety improvement project includes incorporated sewer line relocation work
- Contractor plans to start sewer relocation shortly after NTP on 11/21/21 (before local bituminous plant closes for season) to be set to go with intersection work in the spring
- Ten days before NTP issued, utility meeting held with sewer and water authorities
- As part of meeting and to confirm aspects of the work, manhole covers were opened and it immediately became apparent several existing inverts as shown on the plans were off significantly (see in blue)

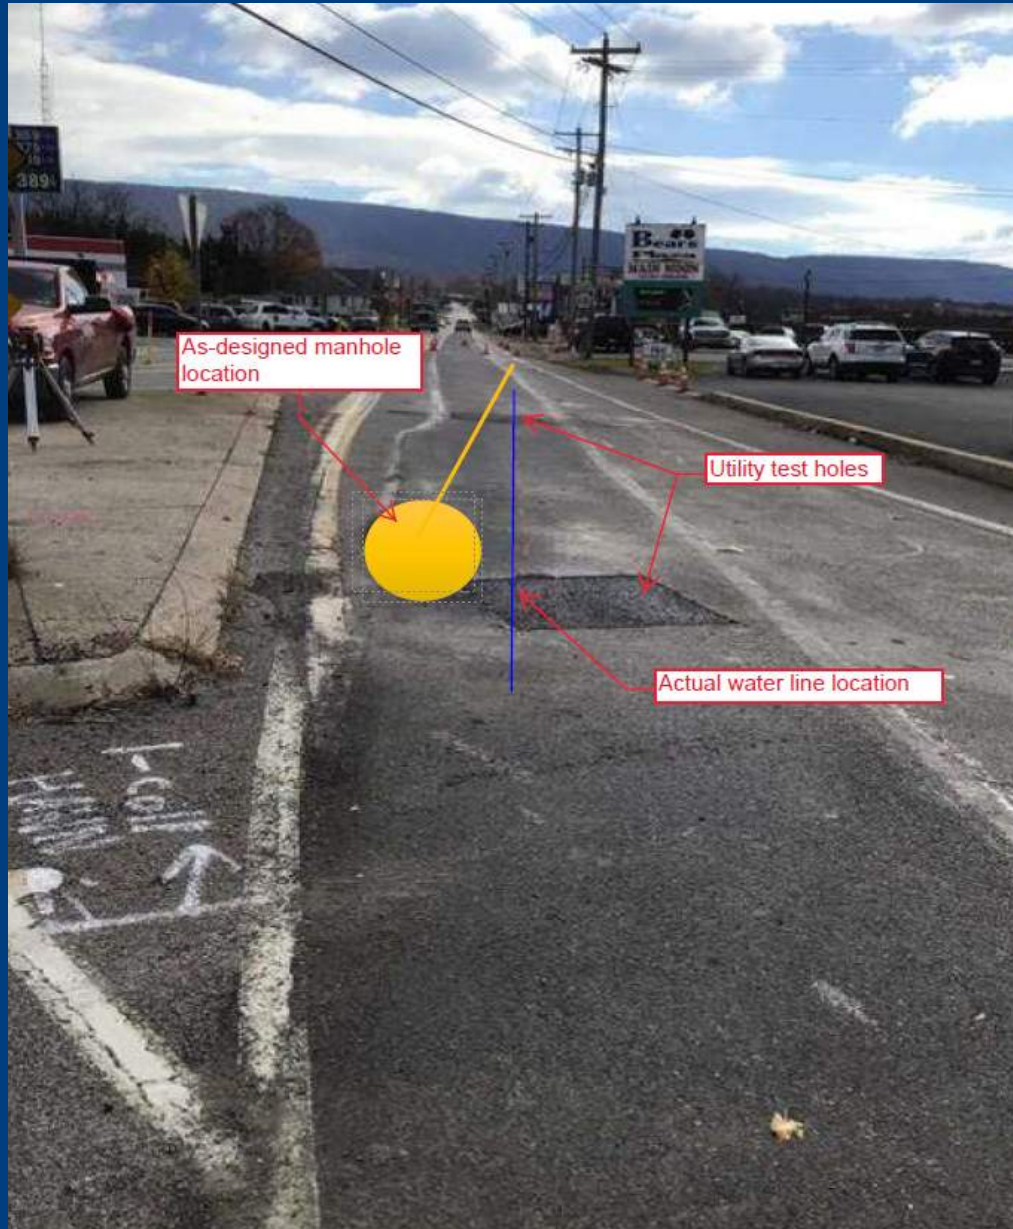
EXAMPLE #3 (cont.)

- In addition, municipality noted that the location of the existing water line as shown may not be correct due to relocation work completed the prior season
- Test holes were taken and verified the water line was incorrectly shown and, as a result, would be in conflict with the new proposed sewer manhole
- Complete re-design of sewer relocation would be required

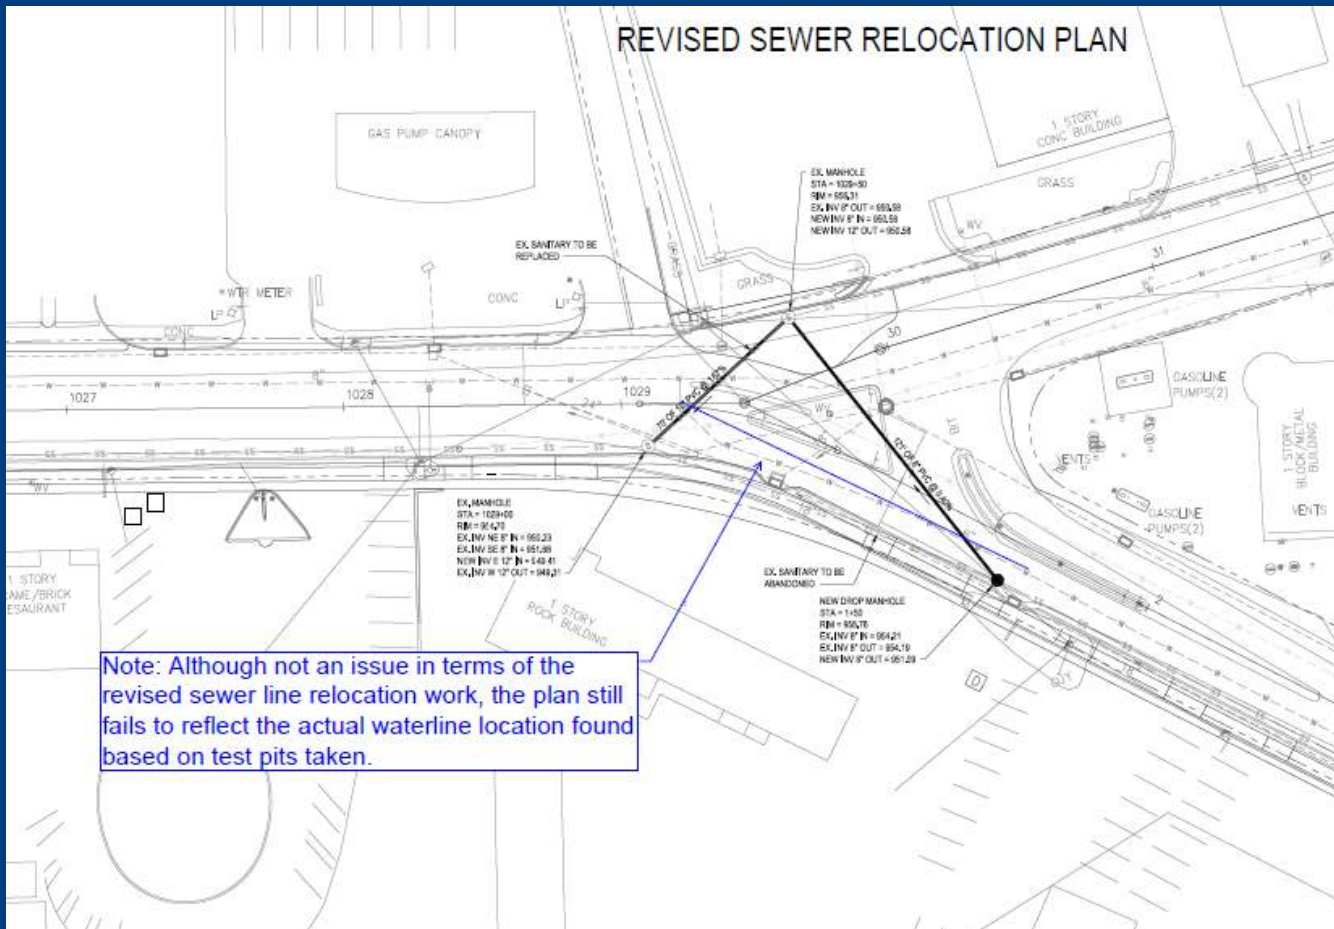
EXAMPLE #3 (cont.)

- Sewer relocation redesign took two months
- Contractor has placed Department on written notice of utility delay status, as they will now be unable to start work until the spring
- Overall additional costs are not yet determined, but may include additional costs of relocation work, acceleration to meet original completion milestones, standby/material storage costs, etc.
