2022 D-9/ ASHE WORKSHOP

JOINT MGMT/ IIC COUNCIL QUALITY EFFORT

To identify focus areas where the potential for quality improvements may exist that would provide mutual benefit to both Design and Construction

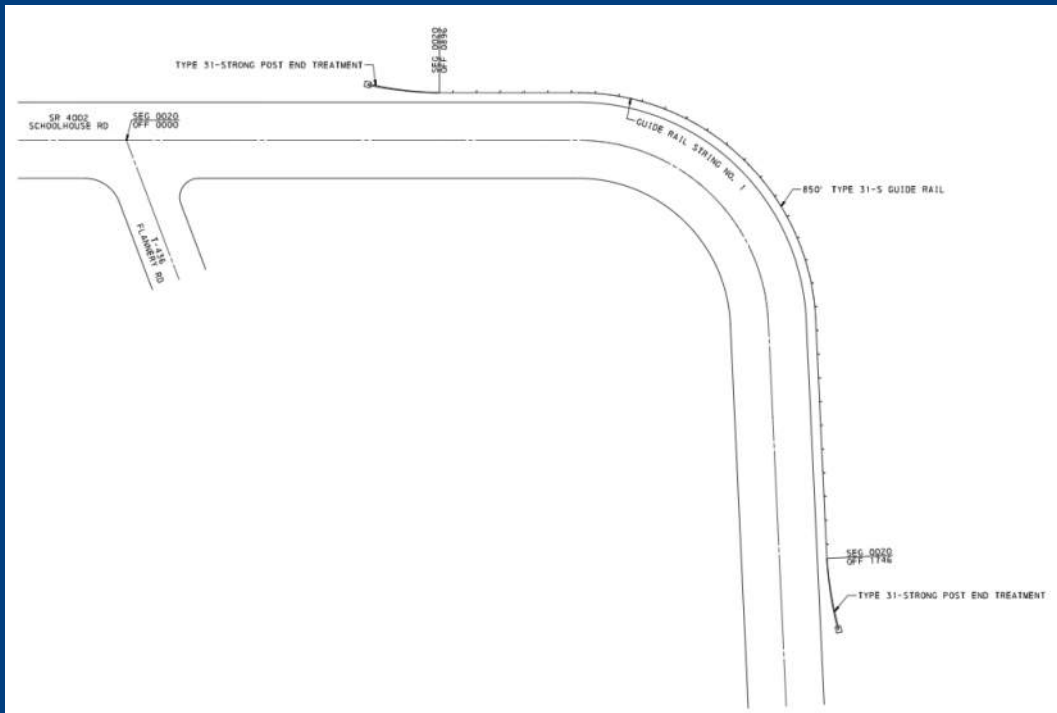
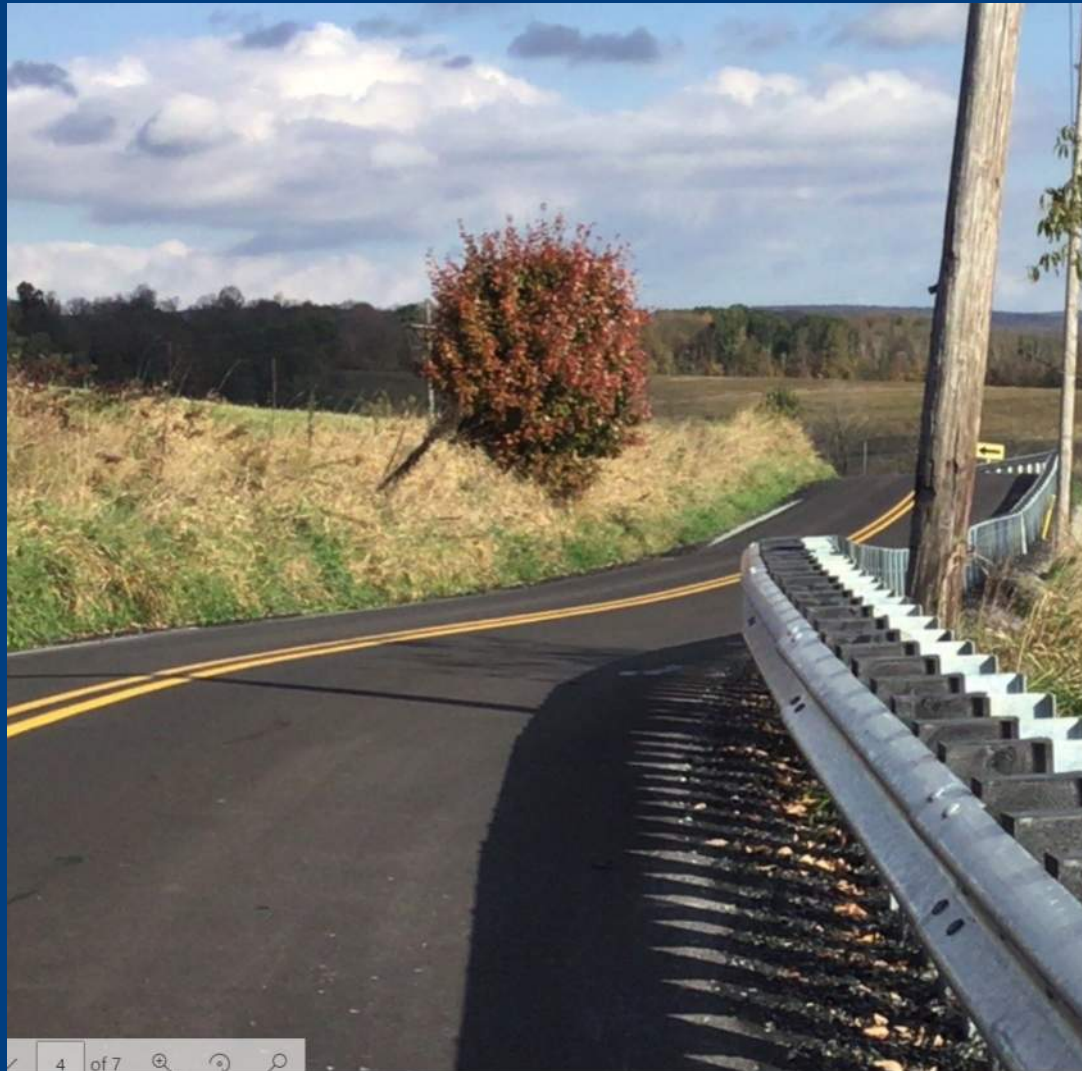
EXAMPLE #4

- New Type 31-S guiderail depicted around curve
- No utilities depicted on plan
- In reality, several overhead utility poles were located along the run
- Along with requiring string realignment (to <2' from shoulder edge in some areas), added Type 31-SC and 31-SCC for proper deflection

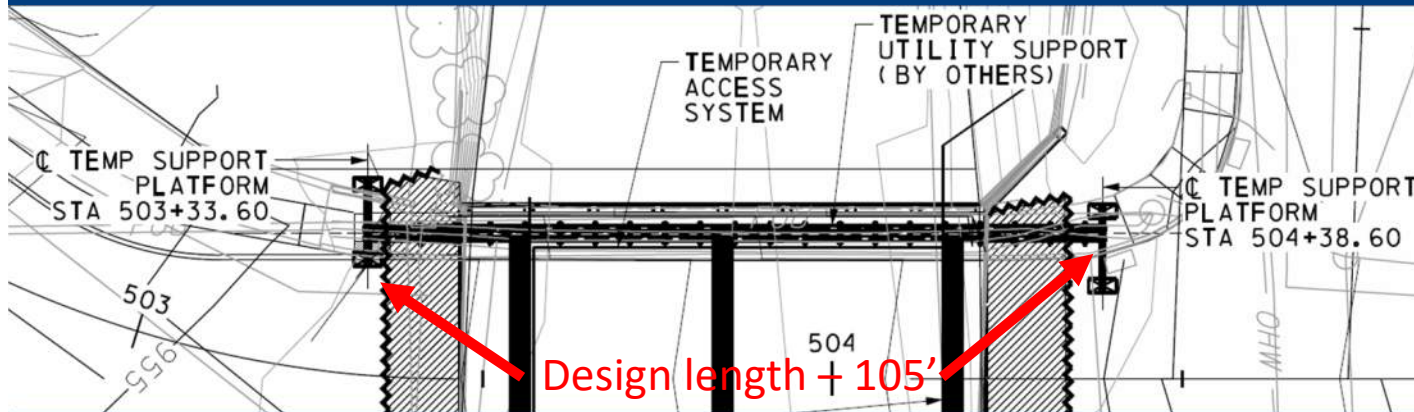
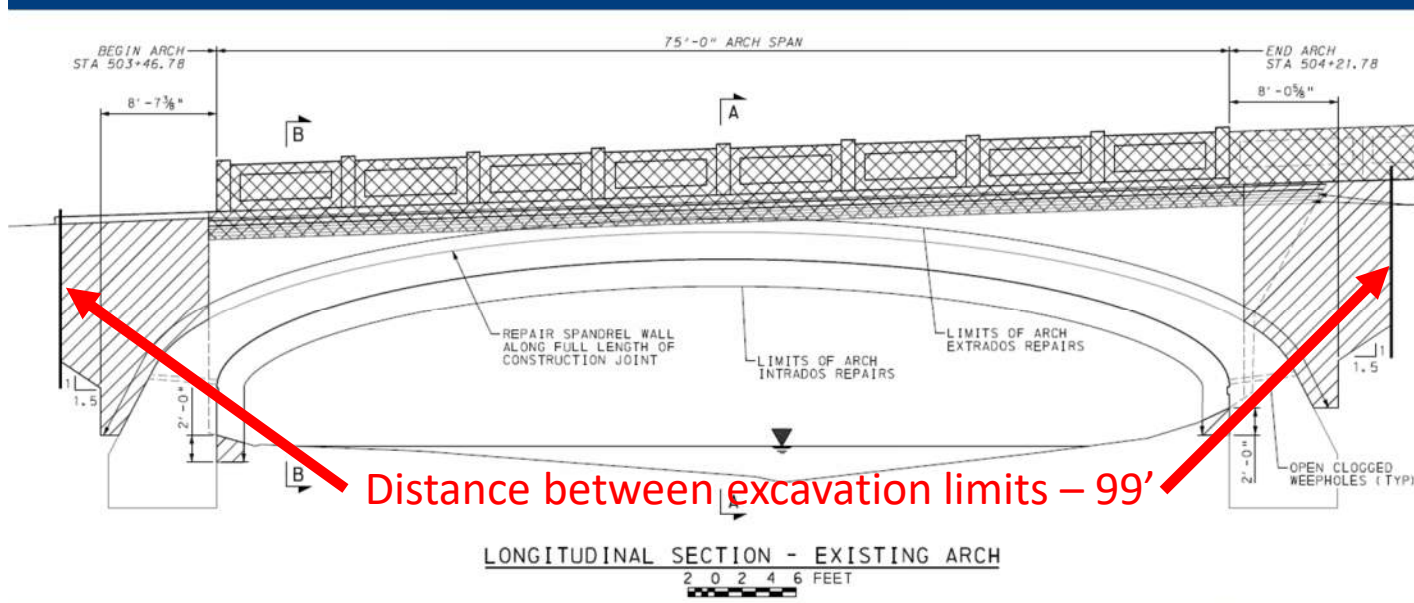
EXAMPLE #5

- Temporary support beam for Verizon line was designed at 105'
- Distance between excavation limits was 99'
- Taking the width of the shoring and holes into consideration, leaves 1.5' of space behind the shoring to set the footing for the support platform

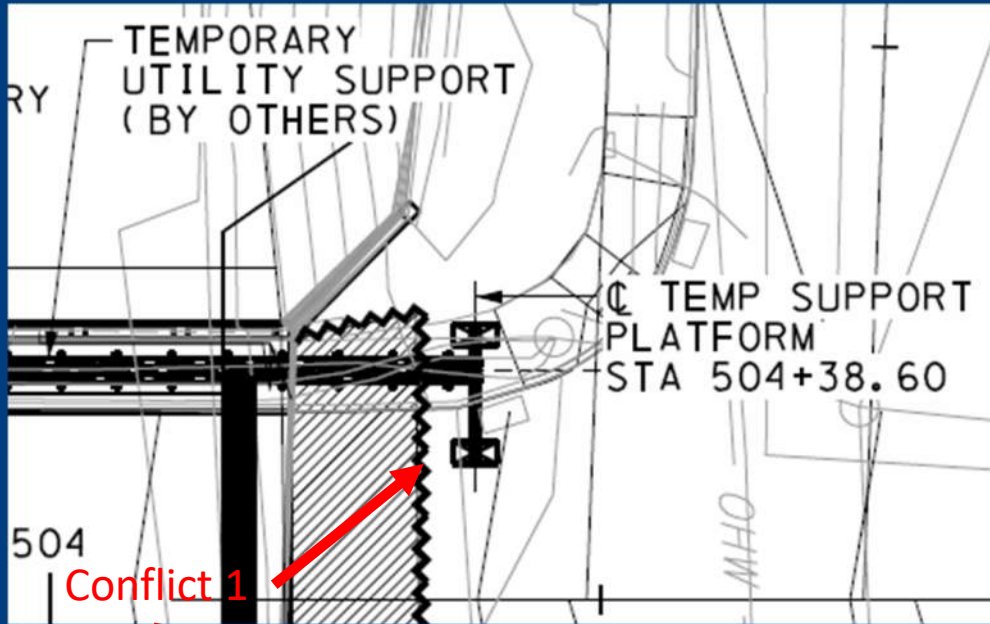
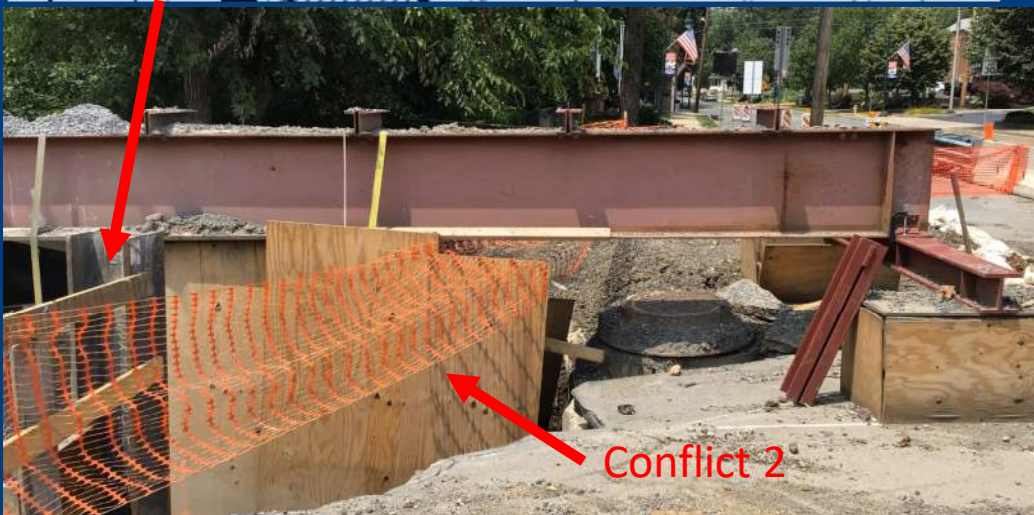
EXAMPLE #5 (cont.)

- Footing support platforms were 4' long
- Conflict 1: The footing support platform would be on top of the shoring
- Conflict 2: The footing support platform would be in the same location as the access point for the Verizon Conduit
- END RESULT: Verizon needed to order a longer beam. That combined with constructability complications and the temporary support operation added a month delay to the project.

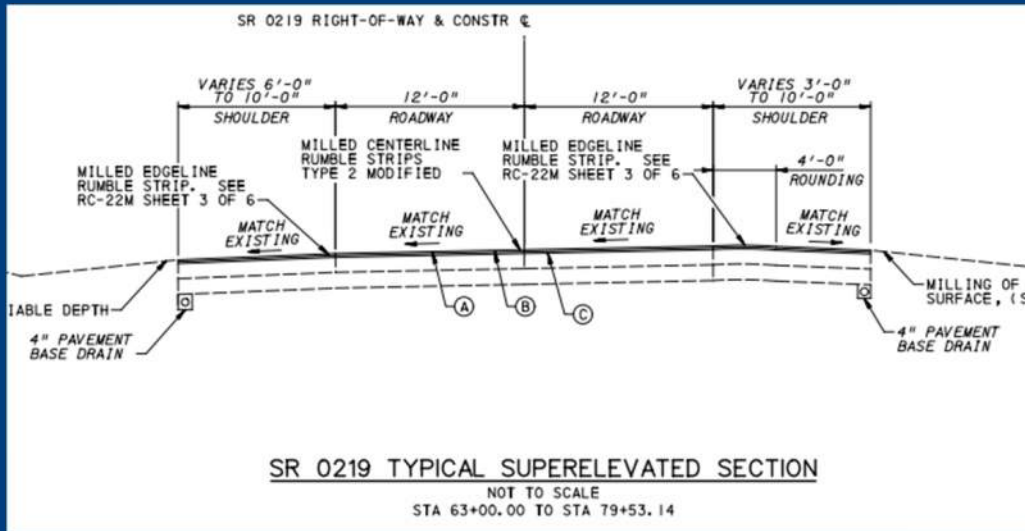
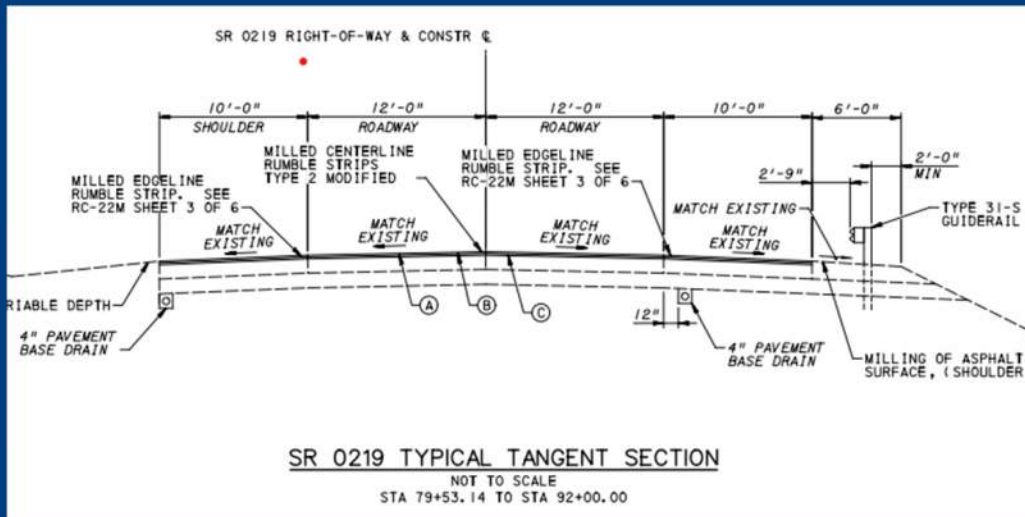
EXAMPLE #1

- Typical Cross Section shows shoulder widths vary 3' to 10' from Sta 63+00 to 79+53.14

- Typical Cross Section shows shoulder widths are 10' from Sta. 79+53.14 to 92+00

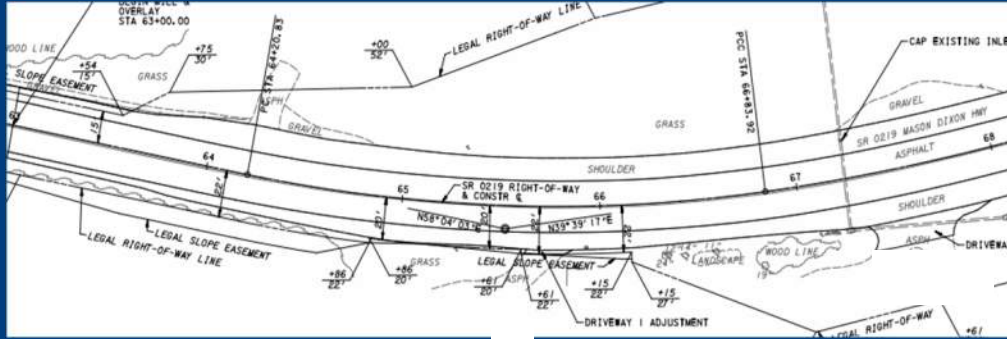
EXAMPLE #1 (cont.)

- Plan Sheets Show 10' (scaled) shoulders starting about Sta 64+00 Left and 67+25 Right
- Design calculations assumed two 5' shoulders from Sta 63+00 to 92+00 causing significant quantity overruns
- Actual Wearing Course, Leveling Course, Tack, and Milling quantities were roughly double the plan quantities

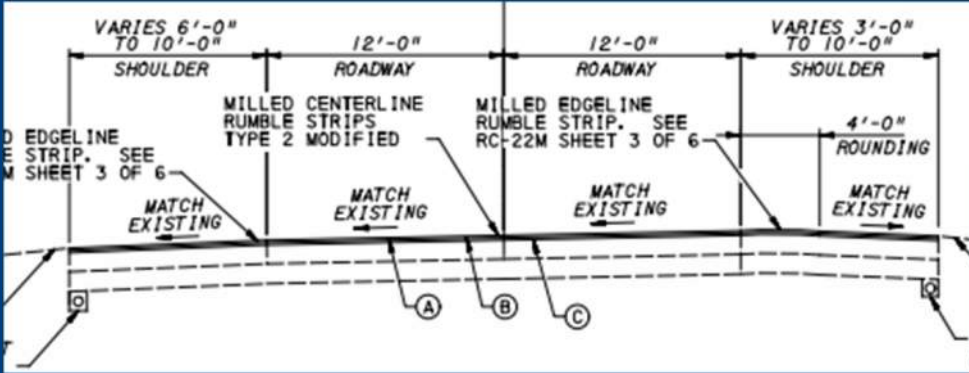
EXAMPLE #2

- Milling called out as 2 1/2" depth on Cross Section but tabbed as 1 1/2" depth

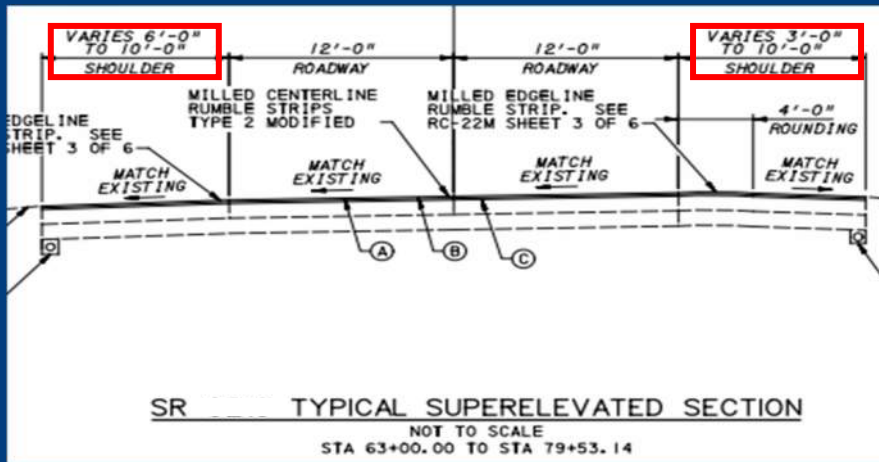
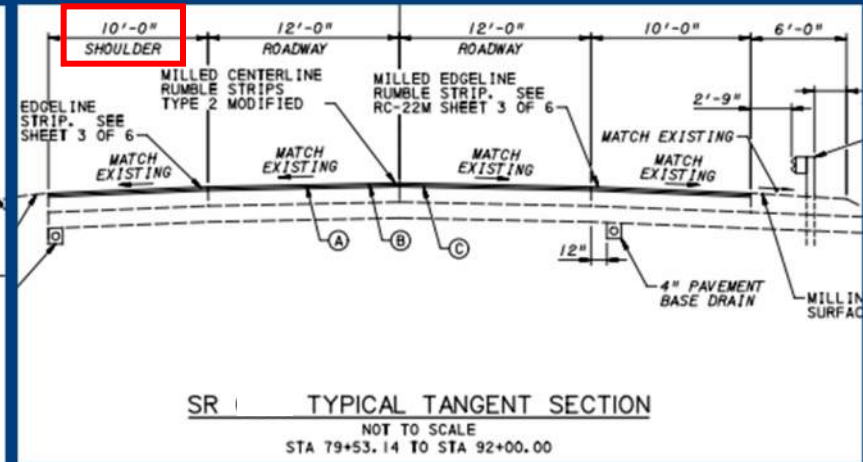
EXAMPLE #2 (cont.)

- Designers assumed 5' average shoulder widths, but Cross Sections show shoulder widths as 10' or varying from 3' to 10'

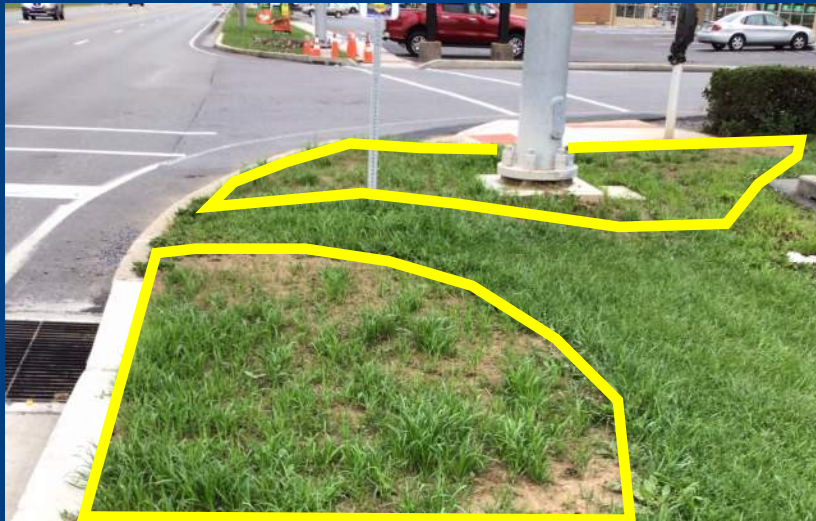
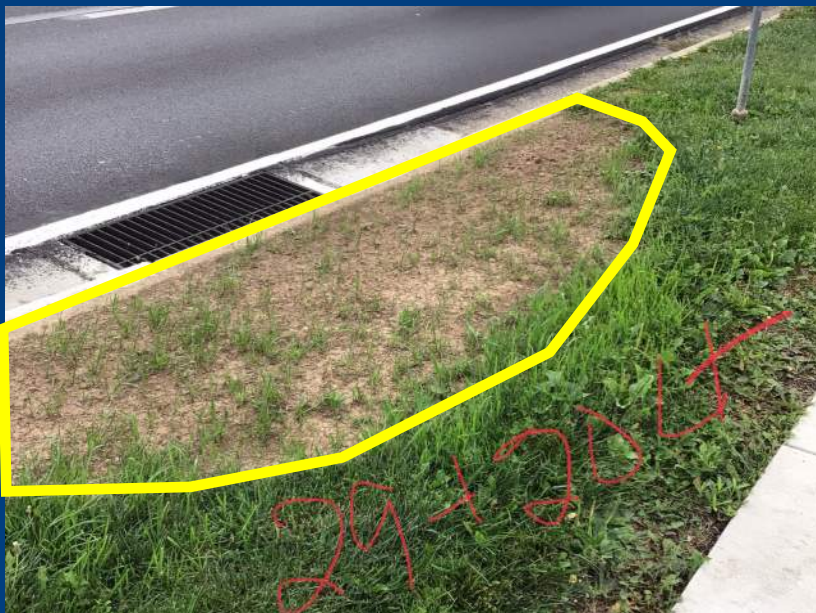
- When specifying formula B seeding on a project, topsoil is almost always required
- This project called for 570 LB of B seed, but there was no topsoil item
- Many of the areas that required seeding were adjacent to curb replacement, inlet top replacement, driveway adjustments and signal pole foundations
- These areas were all lawn areas and required topsoil for proper growth
- Cost to add: \$69,000
- Also verify quantity of seed needed. Out of the 570 LB of B seed, less than 100 was needed.
- Overestimating quantity can lead to contractor renegotiation of prices, costing the project just as much money for less

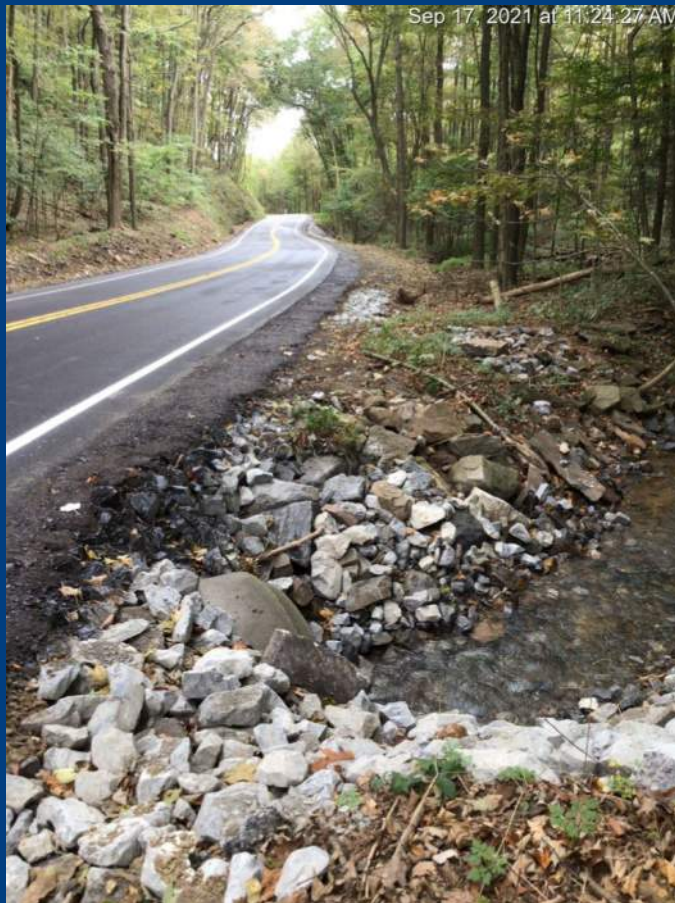
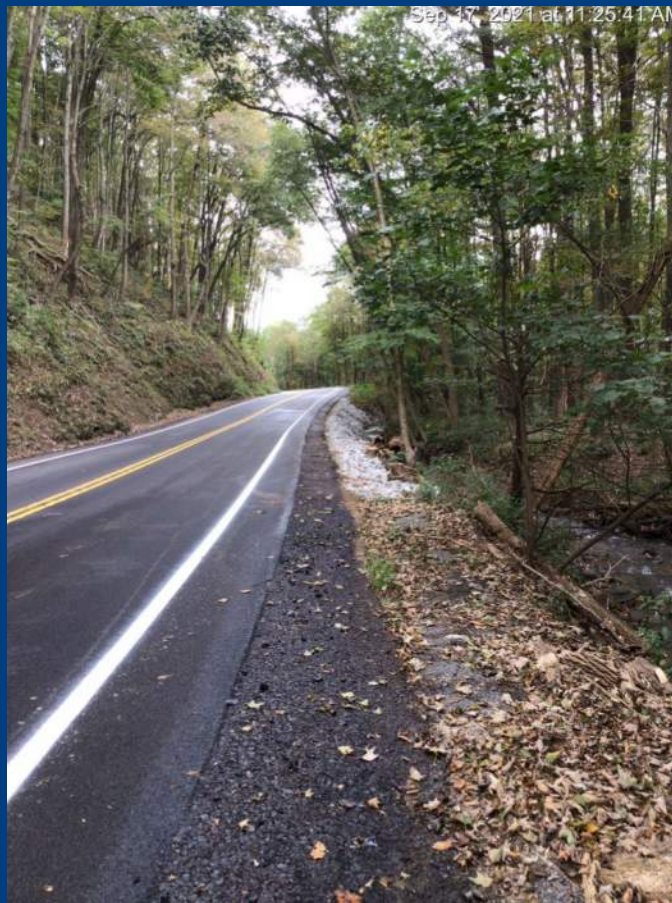
EXAMPLE #2

- In these areas, item called for tree trimming of unlimited height to the existing right-of-way line
- Doing so would have left numerous trees as just ~20' high stumps off the right of way
- Decision made instead to cut up to 20' in height and blend cuts to avoid killing trees

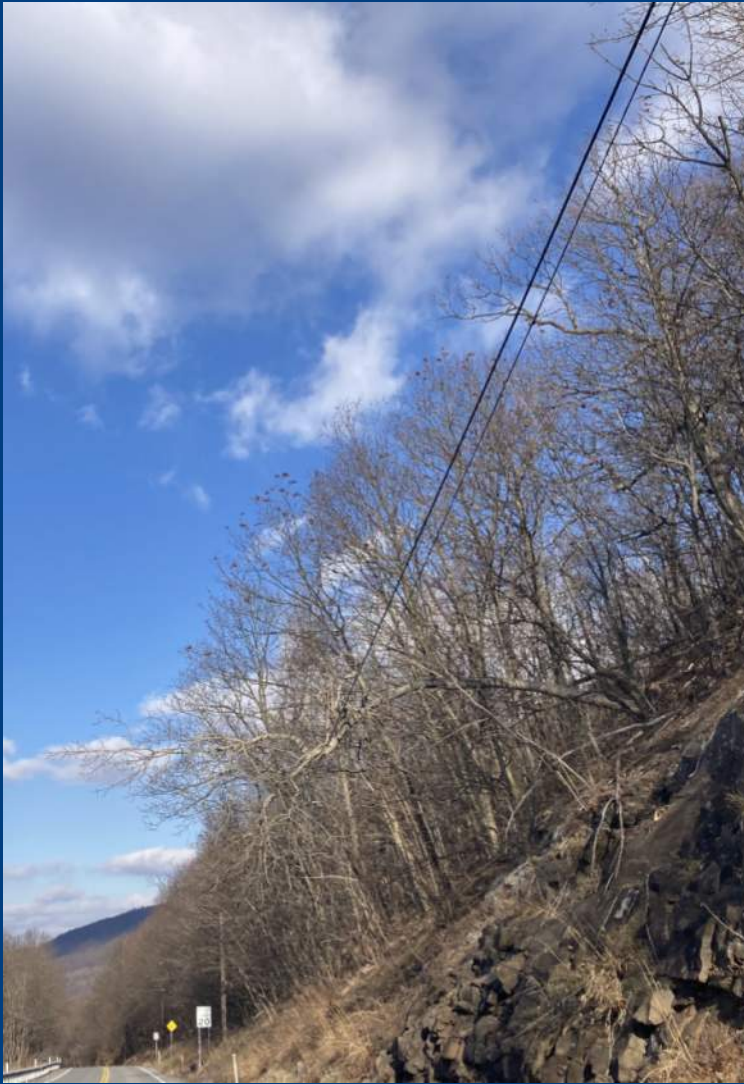
EXAMPLE #3

- 3.6 mile long safety improvement project with resurfacing, guiderail, drainage, signing, signal, and bridge rehabs
- Contract includes item for tree trimming, but no tree removal
- Throughout corridor, there are numerous dead or dying trees leaning towards the roadway (majority within existing ROW)
- After NTP, coordinated with Maintenance and Environmental Units and identified 81 trees for removal due to safety concerns as well as an additional 1075 LF of tree trimming
- Work will need to be performed via force account, with a preliminary estimate of roughly \$100K

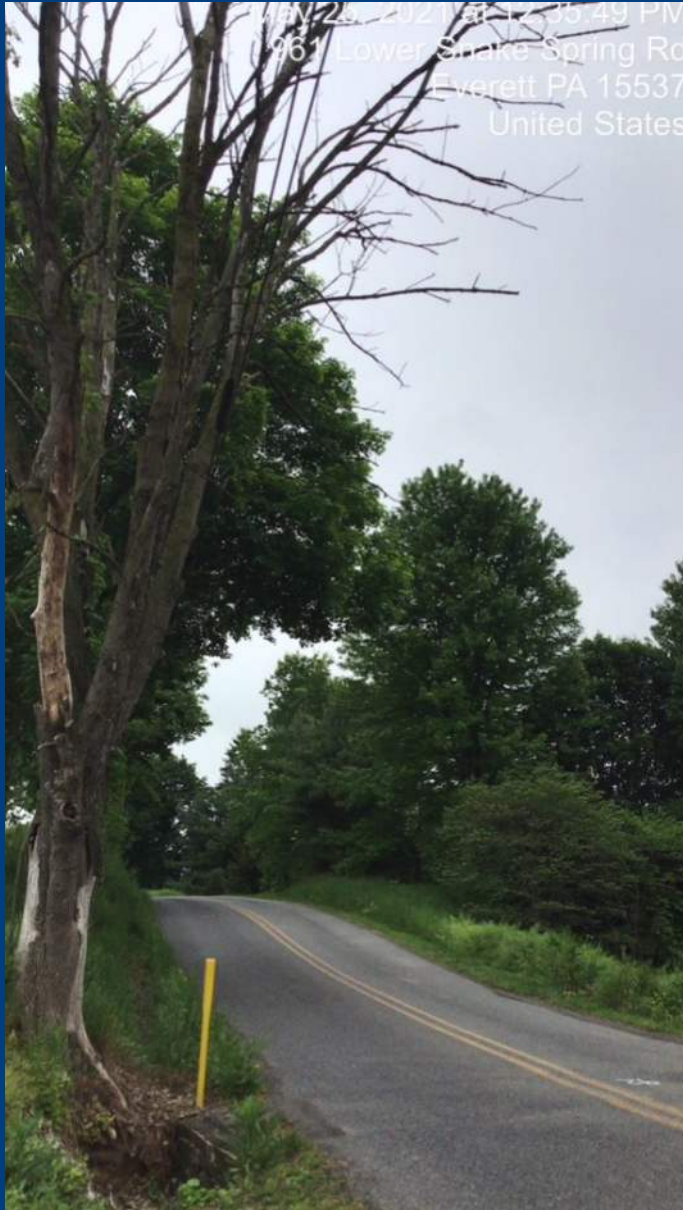
EXAMPLE #4

- Dead tree just off right-of-way
- Throughout corridor, there were about 15 trees of similar condition and location
- Due to maintenance funding concerns, decision was made to leave as is
- In some cases, may be advisable to account for these costs and either take ROW or include as knock-out block to see if right-of-entry can be obtained

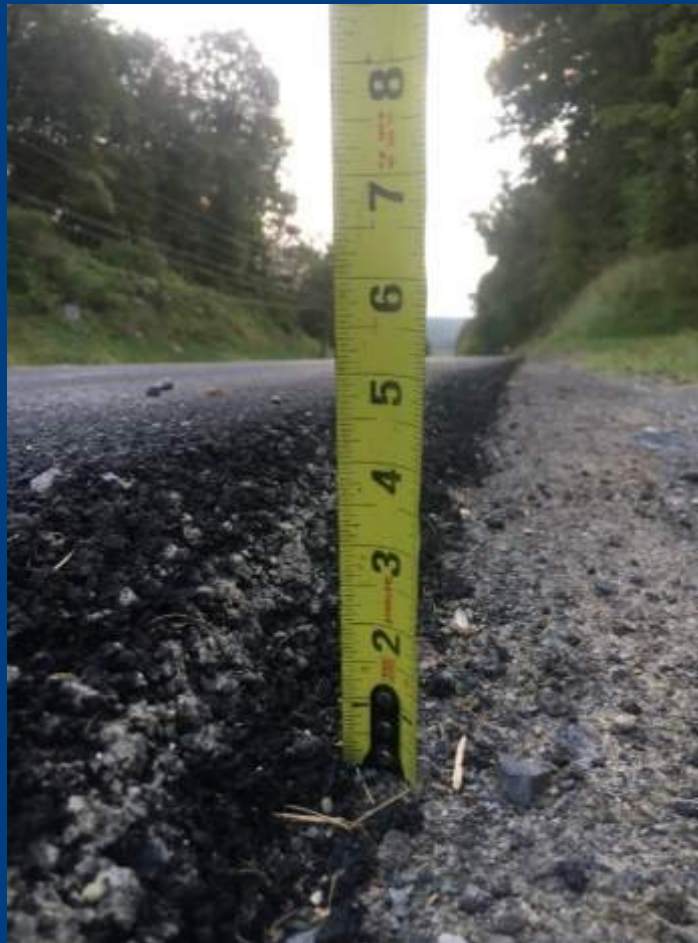
EXAMPLE #1 (cont.)

- Photo below represents some of the actual field conditions encountered
- When computing shoulder back-up, whether mill/fill or overlay, there are rarely cases where the existing road does not already have shoulder drop-offs that need accounted for

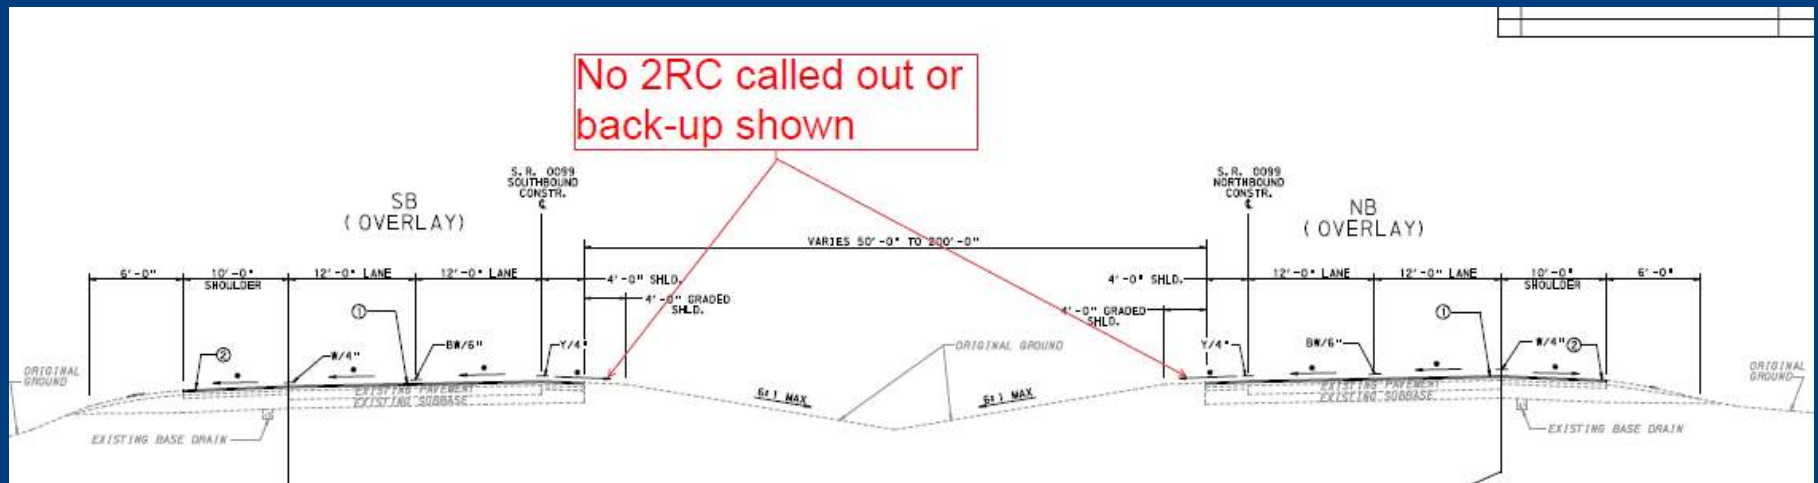
EXAMPLE #2

- Project scope was for 1" thin lift overlay of four-lane
- No shoulder back-up was shown in median areas or included in back-up quantity computations
- Additional quantity of 2RC back-up added via work order at a cost of \$131K

Only location
2RC was called
out or tabbed
(guiderail areas)

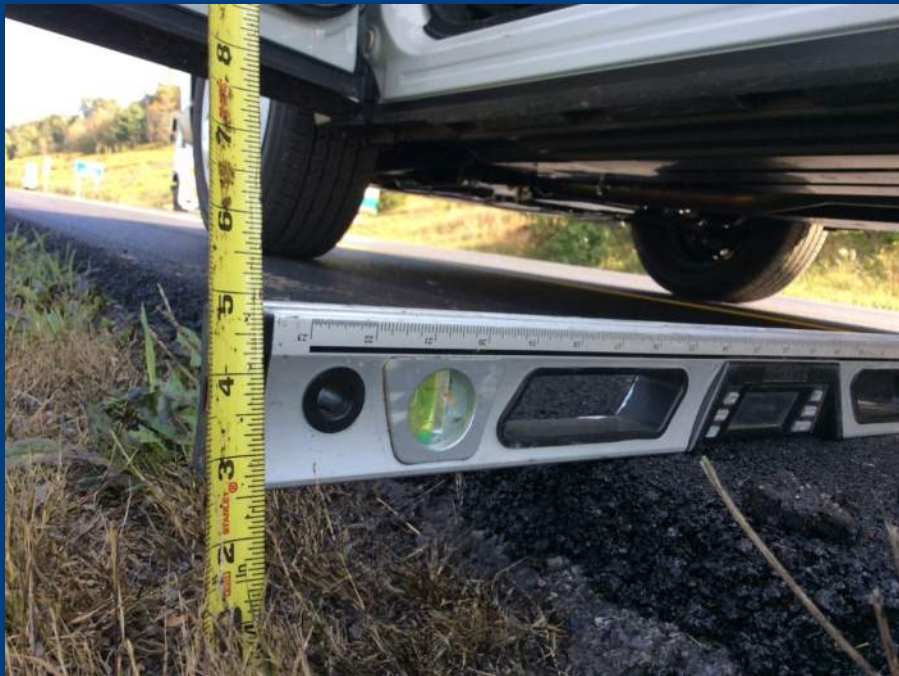
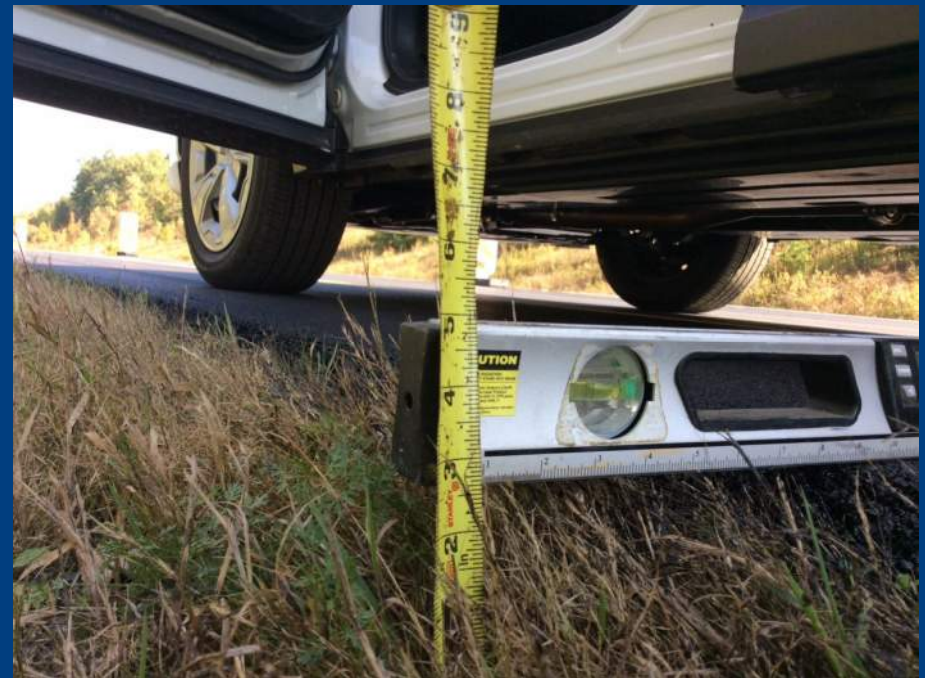
- Photo below represents final edge drop off in median before back-up placed
- Note that drop off is $>1''$ thin lift depth due to drop-off condition being pre-existing ($\sim 1.5''$)

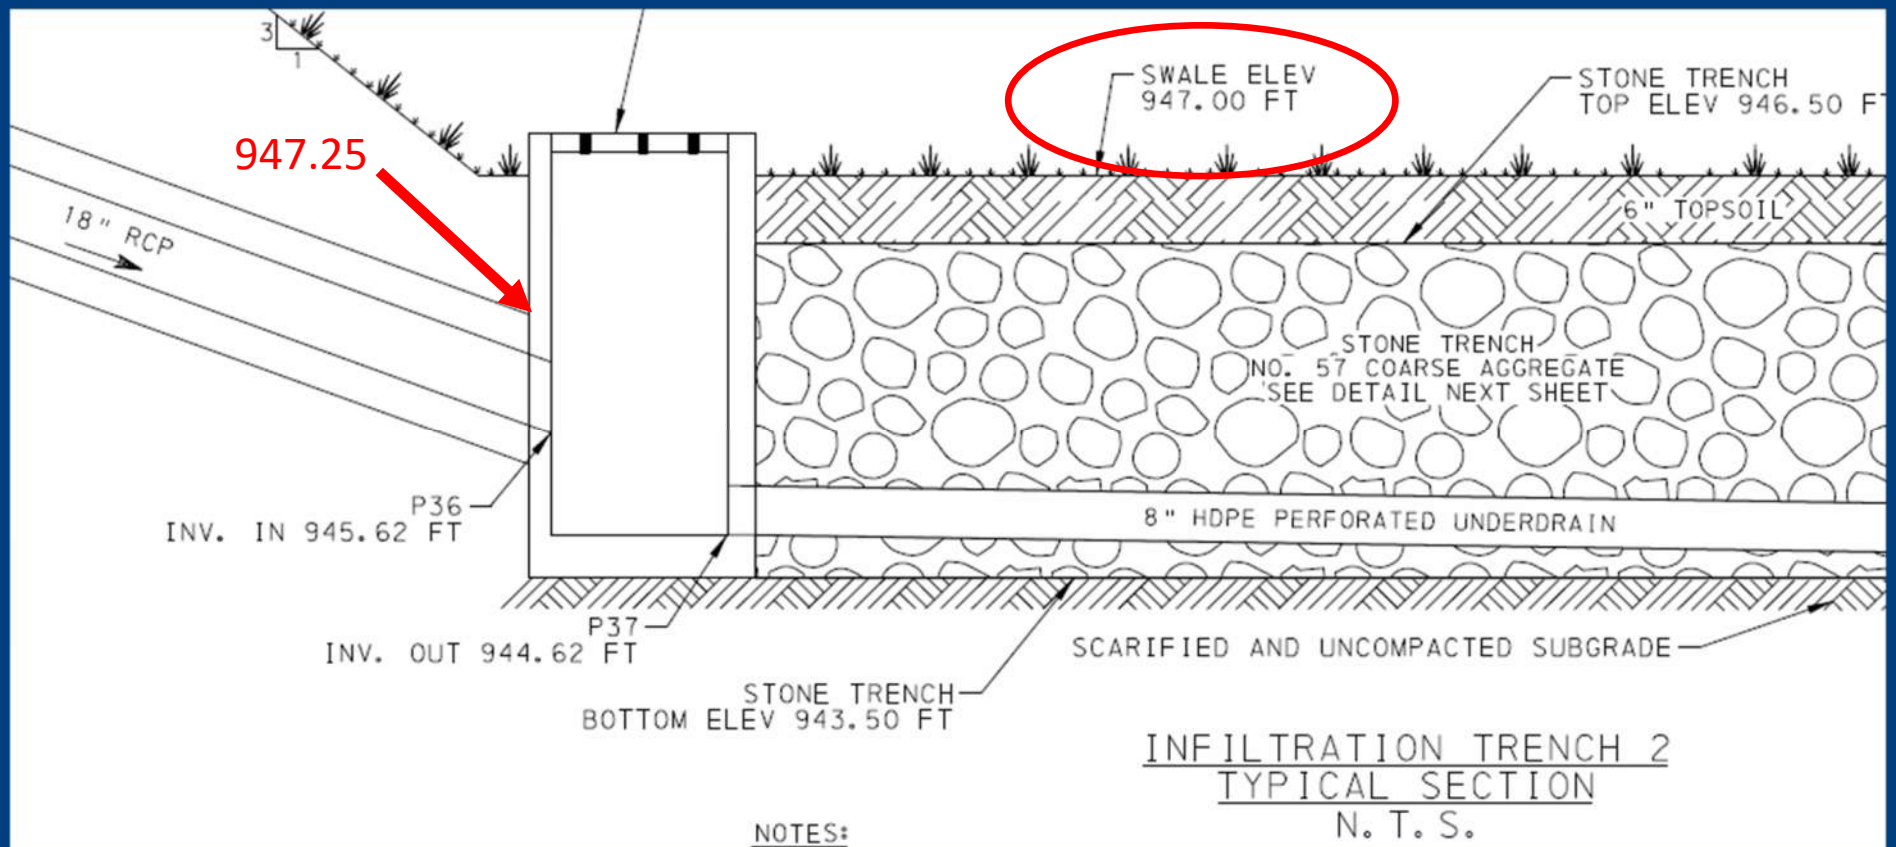
- The top of this 18" pipe entering the manhole is 947.25 as designed (based on invert)
- The top of swale elevation is 947.00 as designed
- Therefore, top of pipe would be 3" above finished grade if constructed as designed
- This one issue affected multiple drainage locations and required drainage to be redesigned
- If the detail was drawn to scale, this issue would have been realized during drafting

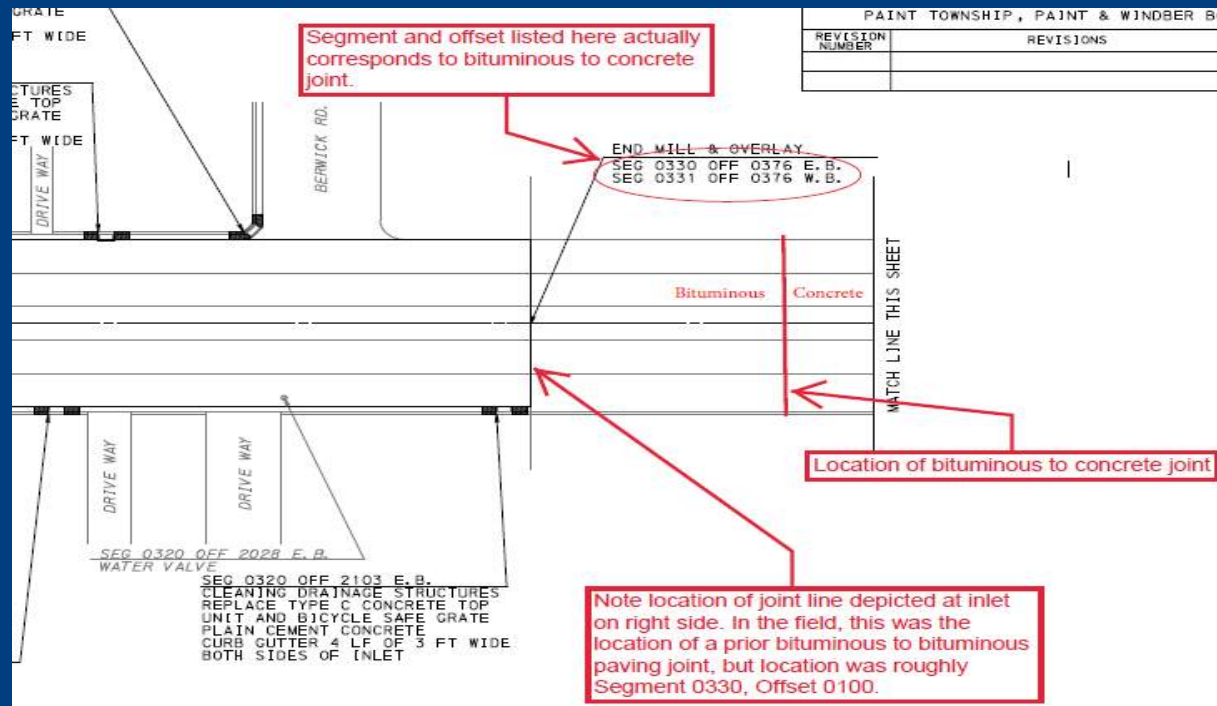
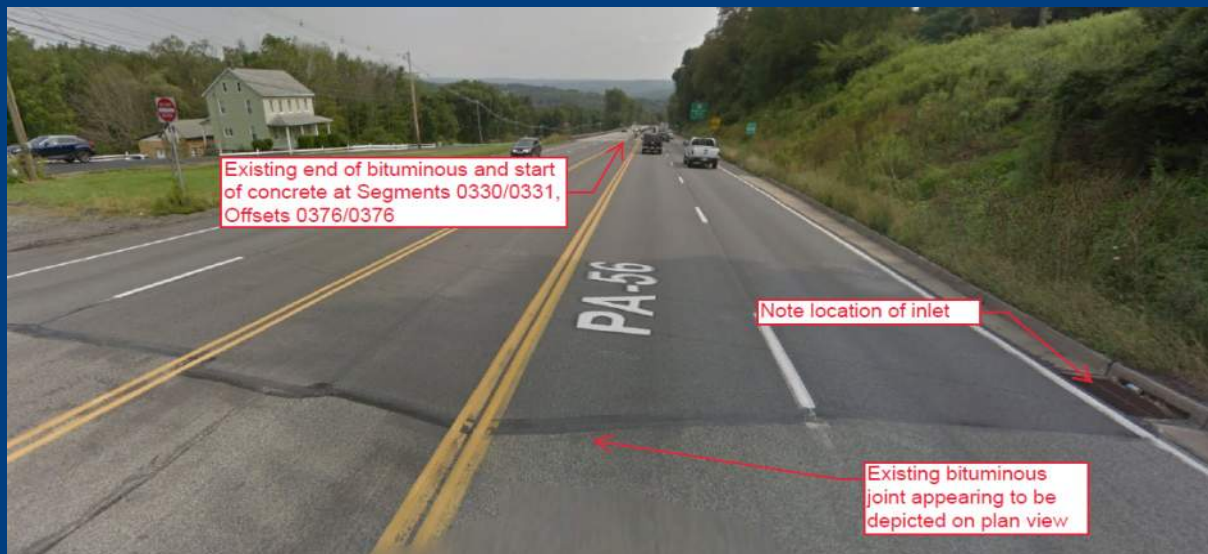
EXAMPLE #3

- Not to scale plan view appears to show end of mill and overlay corresponding to prior bituminous paving joint
- Intent, however, was to pave to concrete joint
- Contractor laid out to bituminous joint and left roughly 276' of old bituminous
- Not discovered until final inspection
- Although segment and offset were correct, contractor argued the plan was misleading due to location of joint at inlet and presence of prior bituminous joint
- Based on potential exposure for claim, required work order to pave remaining 276' costing \$59K (including remob)

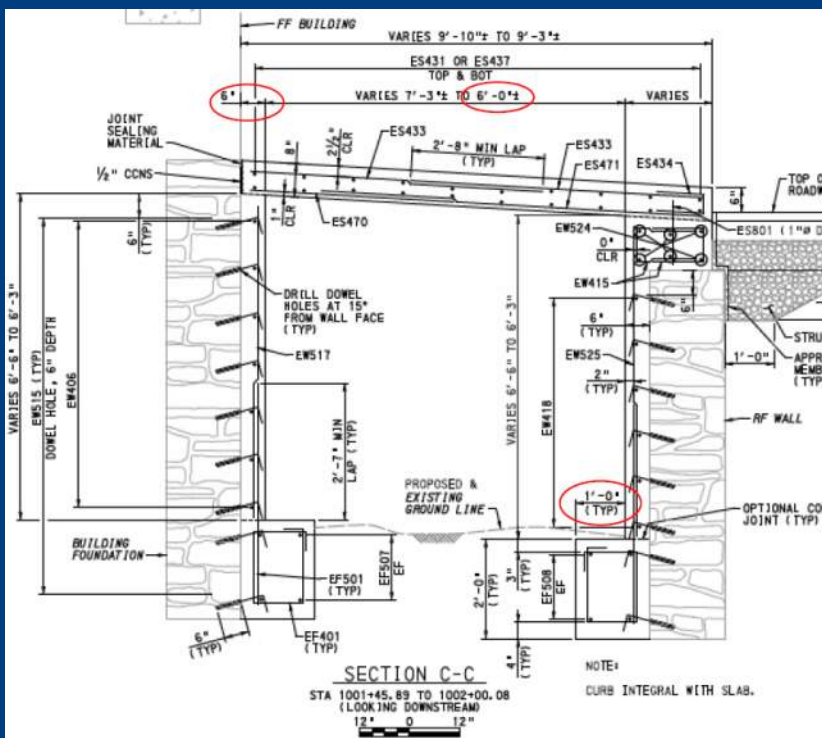
- Temporary Channel Diversion detail on E&S Plan appears to show adequate work area, showing a minimum diversion width of 2' (but no minimum height)
- 6'-0" minimum clearance after encasements shown on Section C-C of the structure plan
- Sandbags are shown set once down the middle of the stream and just switching the bags at upstream and downstream ends between each phase/ side of work
- Underpinning 1'-6" (1' beyond 6" encasement) on each side, so clearance between underpinning is 4' minimum
- Bags would need stacked vertically in order for contractor to have 1' work area on each side of diversion ($4' - 2' / 2 = 1'$)

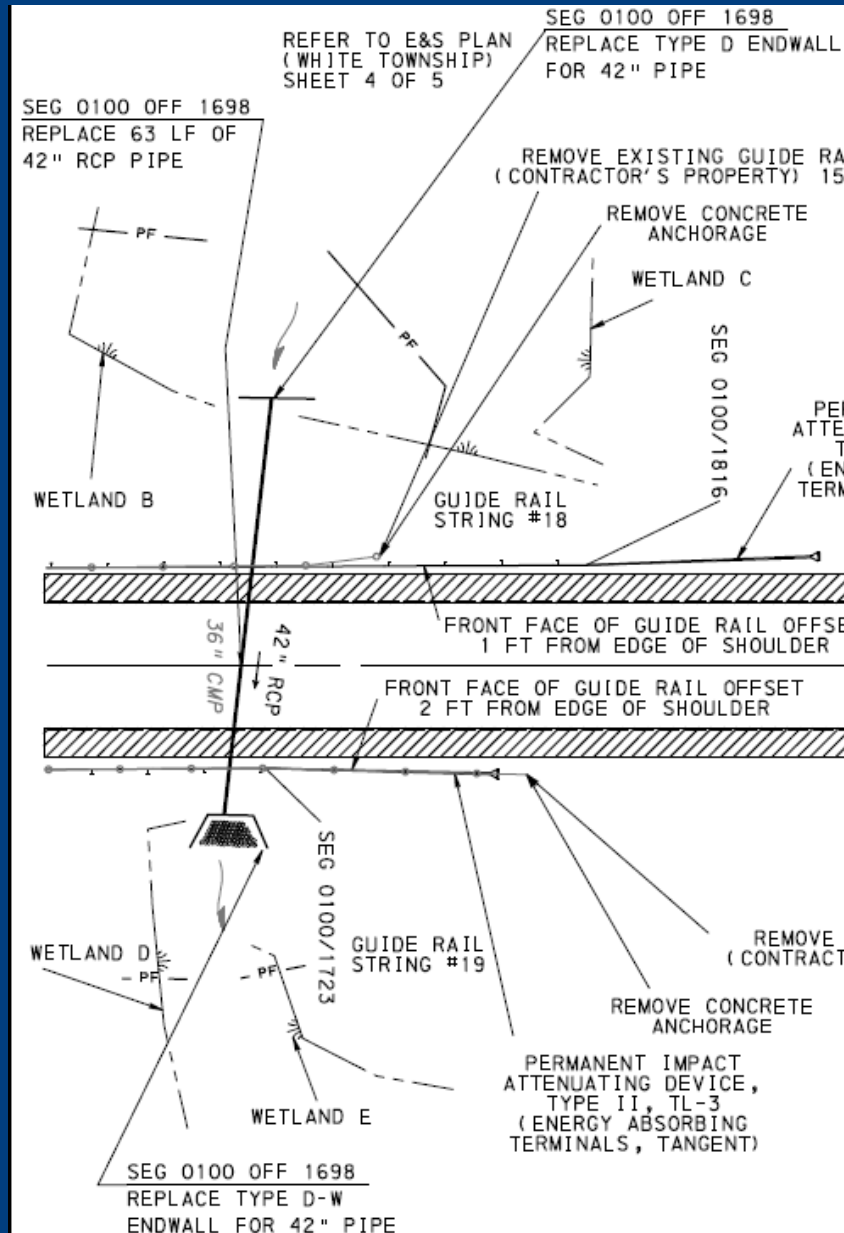
EXAMPLE #5

- Replacing existing 36" cross pipe with a new 63' long, 42" cross pipe
- Notice the distance from the guiderail to the ends of pipe on this drawing (which is to scale)

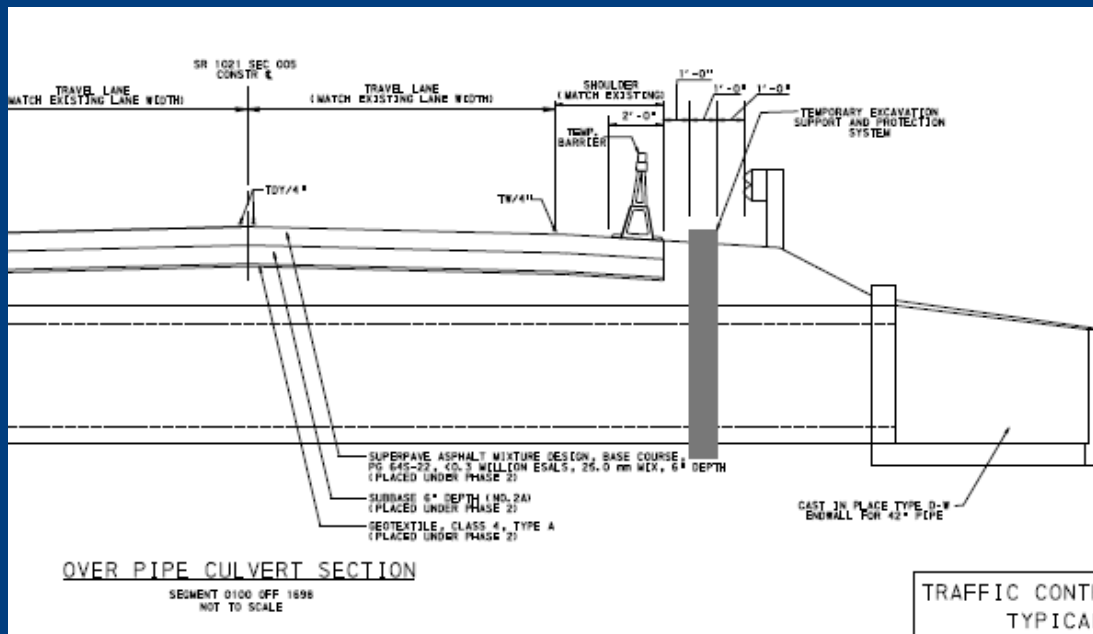
- Detail shown on TCP, NTS detail calls for shoring on downstream end of pipe
- Contractor field measures over 19'-6" from back of proposed temporary barrier to back side of headwall and cut depth of roughly 10'-6"
- Therefore, slope can be laid back at 1.5 to 1 and no shoring is required
- Item Description - "This work is the design and construction of a temporary excavation support and protection system or appropriately designed open cut excavation" (so we pay full price on item anyway)

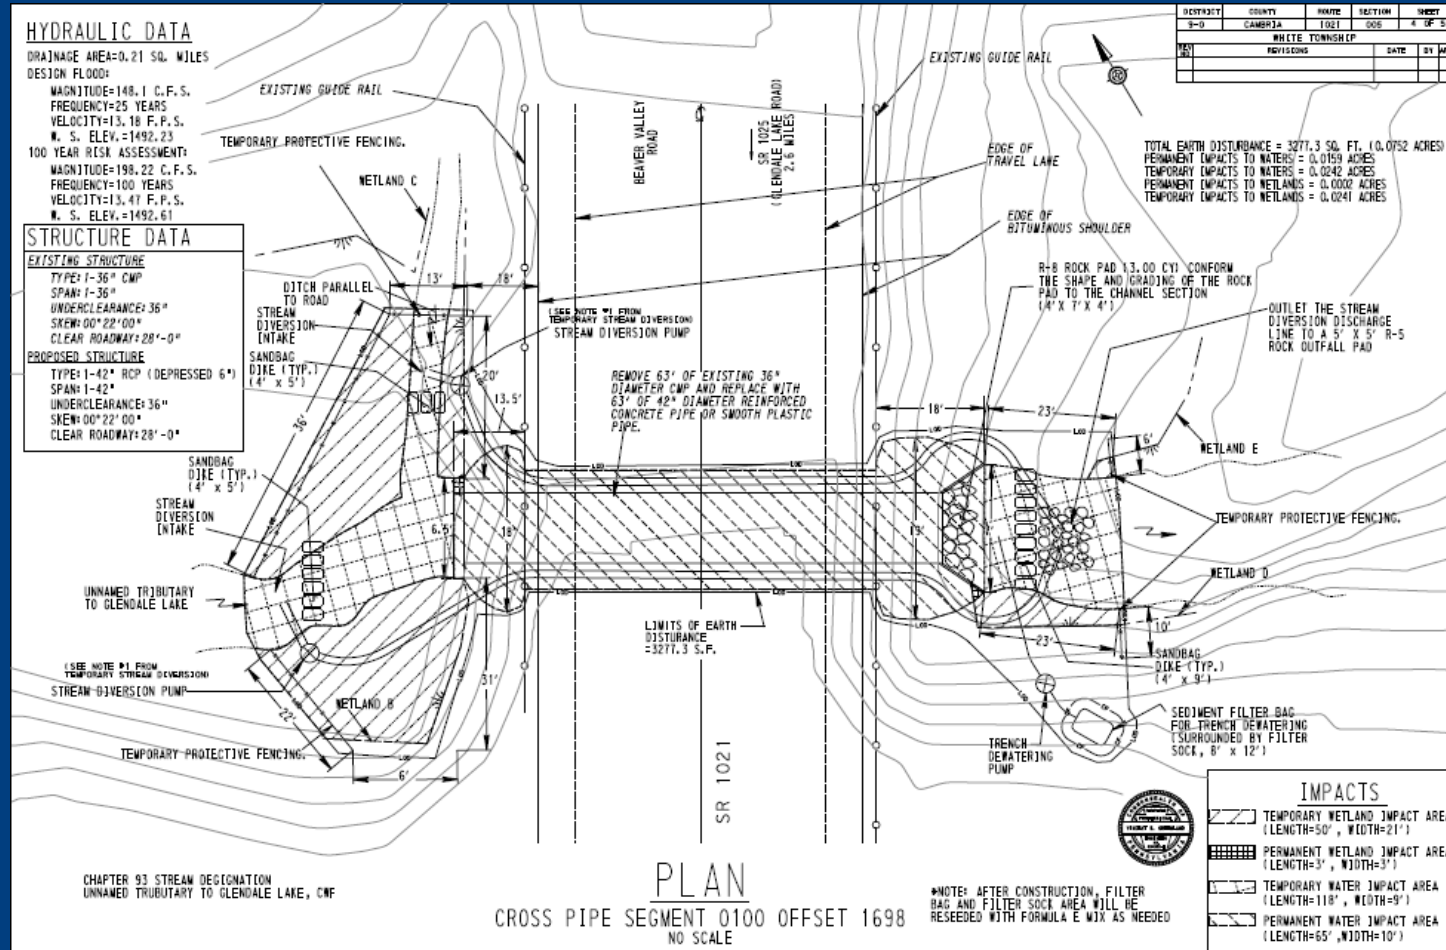
EXAMPLE #5 (cont.)

- Detail shown on E&S Plan ~ understand NTS, but looks completely different than 'to scale' plan
