# USING ABC TECHNIQUES UNDER PHASED CONSTRUCTION

Thomas Anthony, P.E., CBSI  
Structures and Bridge Inspection Department Manager  
The Markosky Engineering Group, Inc.

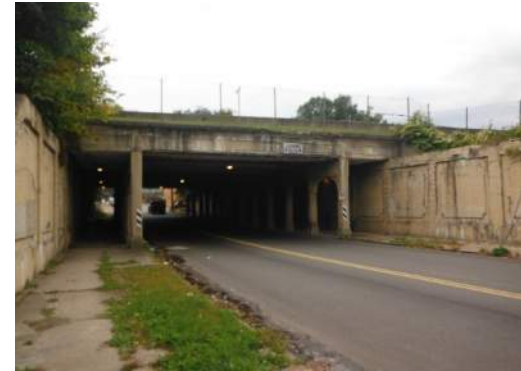
*Original structure elevation*

- East Busway
  - Center span built-up riveted steel plate girder
  - End spans rolled steel beams
  - Superstructure fully encased in concrete
  - Beam spacing approximately 2'-6"
  - Overlaid with several feet of embankment for roadway

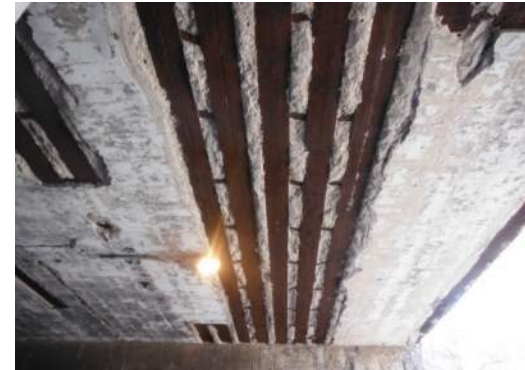
*Original Superstructure*

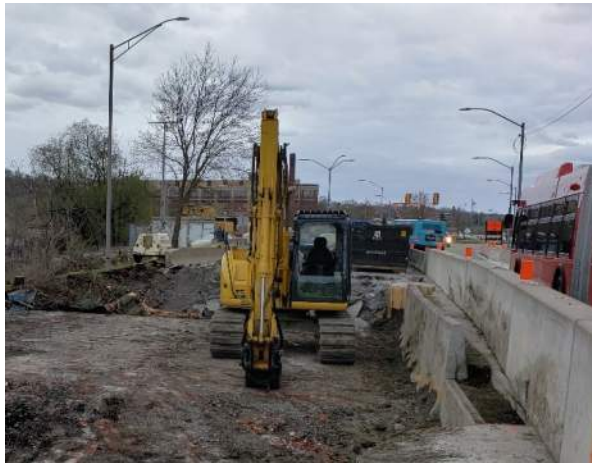
*Excavation of Pavement  
and Subbase*

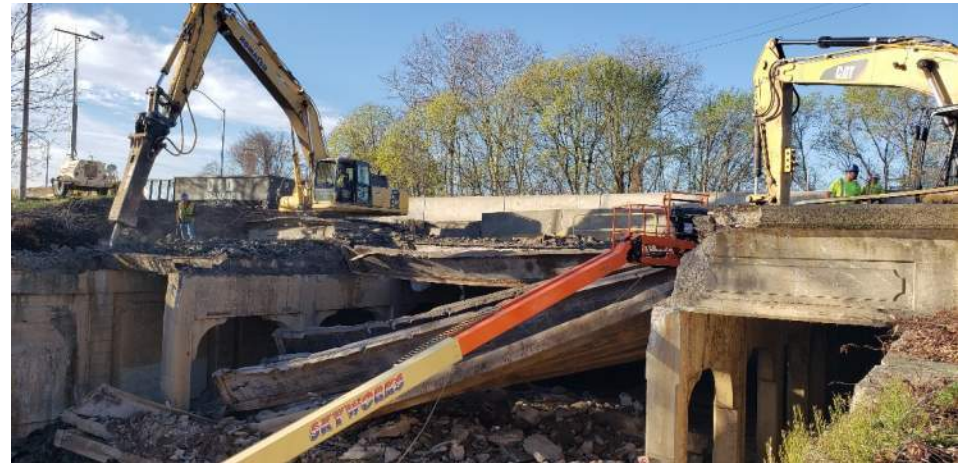
*Demolition of First Phase*

- During excavation it was discovered that the existing 3 span bridge did not consist of a constant depth beam
- Center span consisted of built up girder sections
- End spans were rolled beam sections with the beam seats at the same elevation as the deeper girder, resulting in more fill above the end spans
  - Required modifications to the temporary shoring

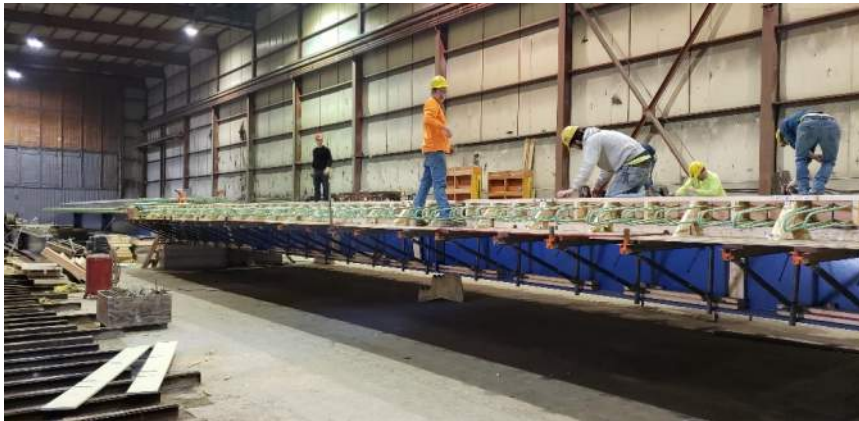
*Module Casting Operations*

- Construction of Modules - PennStress
  - All modules were cast at the same time

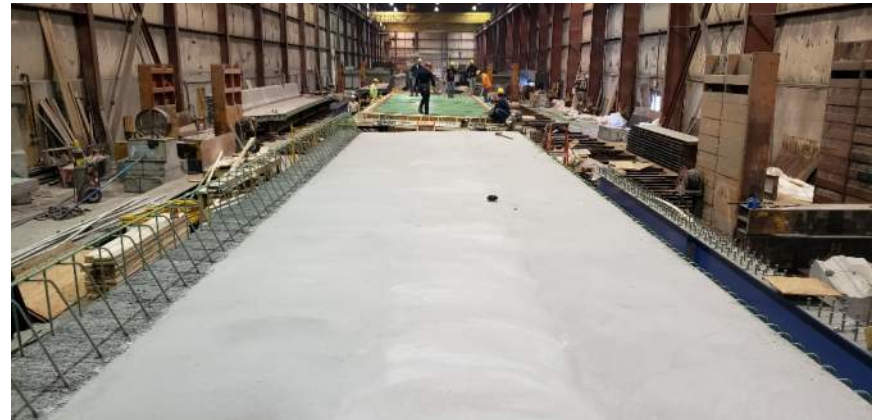
*Module in Casting Plant*

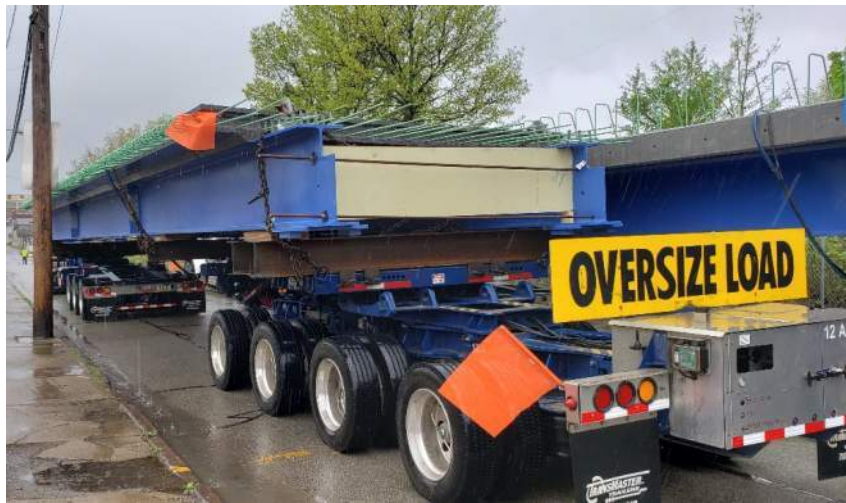
*Module Delivery*

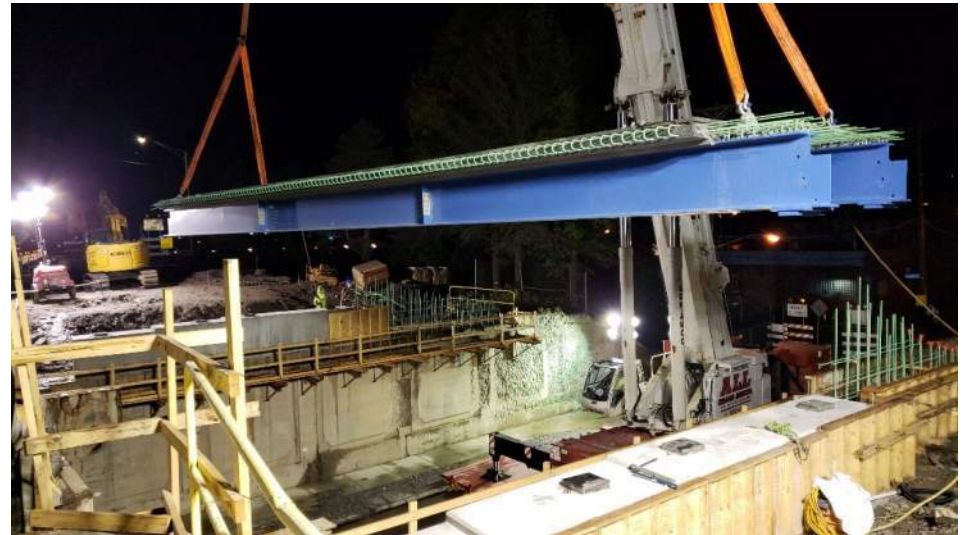
*Erection of First Module, Note the Bearings on the New Beam Seats*

- **First Phase of Module Erection, April 27, 2019**
  - Following construction of the new beam seats
    - Contractor erected the modules using a single crane pick with the crane placed on North Braddock Avenue
    - Weekend closure on city street
    - Work was conducted at night to facilitate a short-term closure of the busway

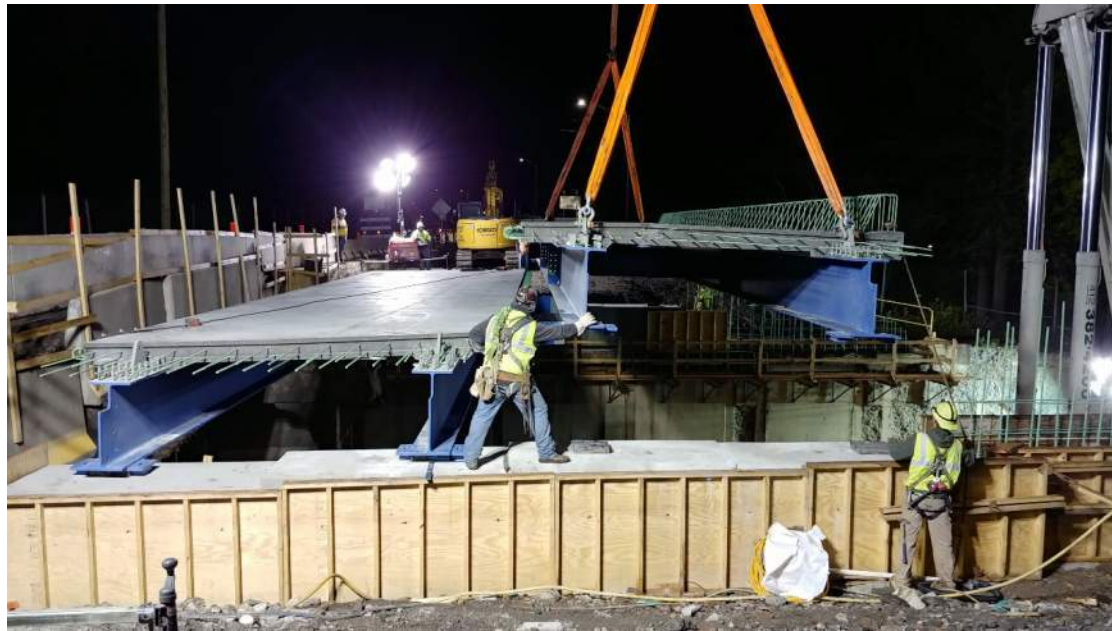
*Setting of Second Module*

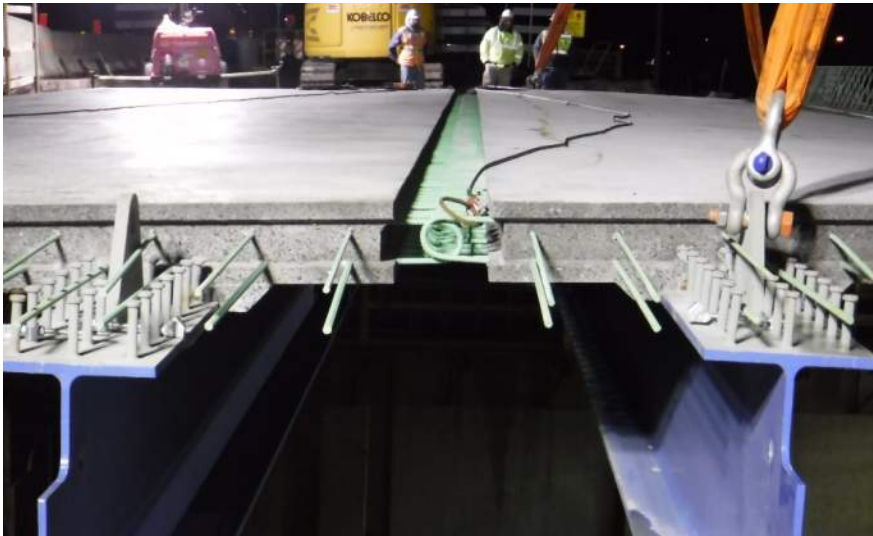
*Typical Joint Between Modules*

- Ultra High-Performance Concrete (UHPC) used in the joint between the modules
- End pours and diaphragms were constructed with accelerated concrete mixes

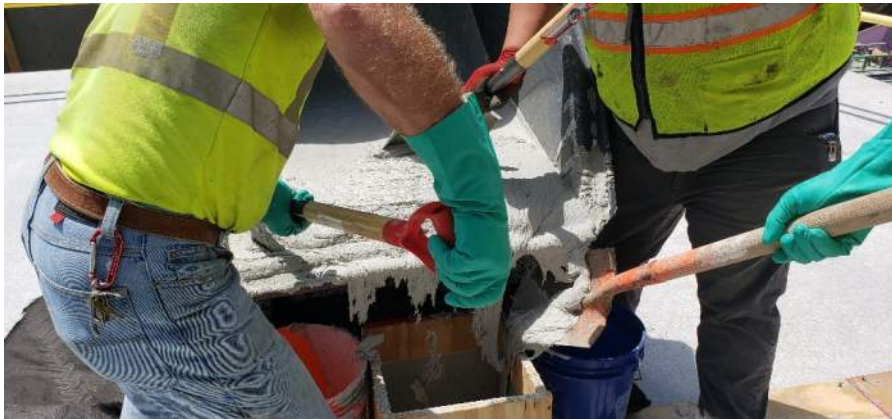
*UHPC Material Placement*

- Minor UHPC material pocketing occurred during the placement of the first joint
- Sounding of the concrete was performed and recommendations were obtained from the supplier.
- Second placement of the material achieved more consistent results

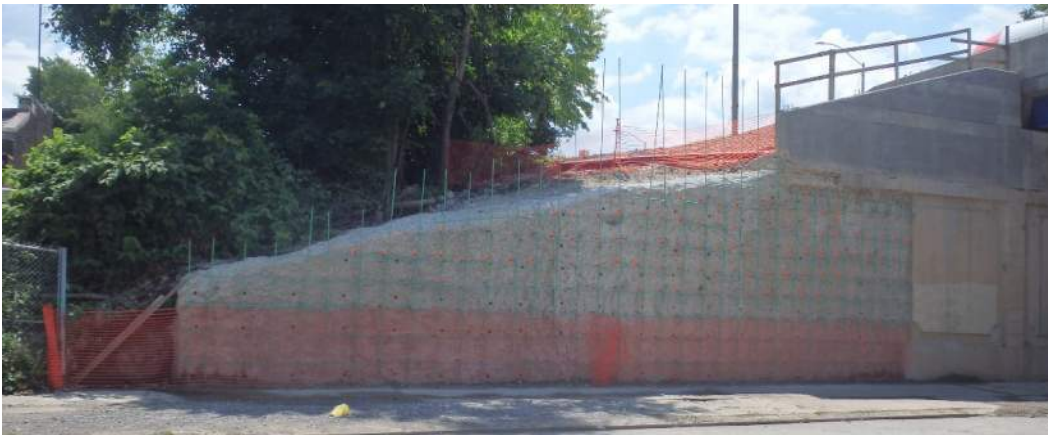
*Existing Wingwall Jacketing*

- Rehabilitation of existing abutments and restoration of sidewalks
- Depth of concrete deterioration was found to be greater than estimated
- More extensive jacketing detail was developed

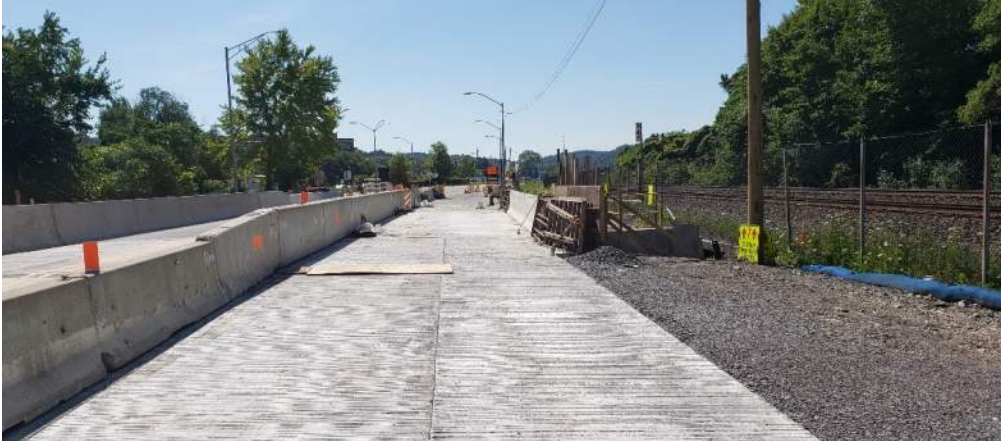
*Second Phase Traffic Control Pattern, Note Traffic is Bi-Directional to the Left of the Barrier*

- Completion of end diaphragms occurred on May 15, 2019
- Traffic shifted to the new portion of the bridge on June 3, 2019
- Traffic pattern was bi-directional with a speed reduction, but allowed full operation of the busway with minimal delays

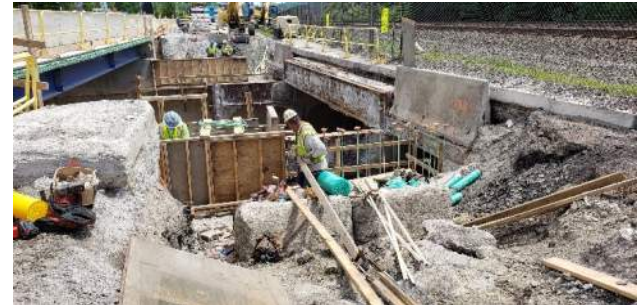
*Construction of Second Phase Beam Seat Structure Girder on the Right*

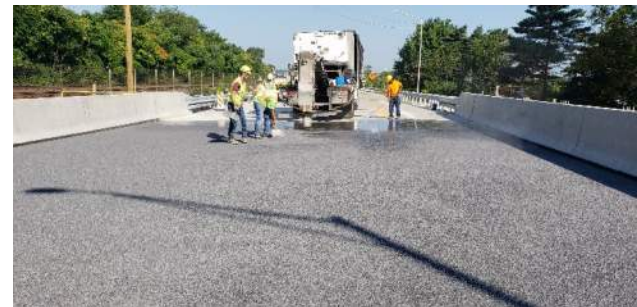
*Application of Epoxy Overlay*

- Previous projects using modular construction specified a smooth finish to the decks in accordance with PennDOT standard specifications
- Epoxy overlay applied to the full width of the completed deck
  - Problem - poor slip resistance of first two modules with traffic
- Shot blasting on first two modules prior to switching traffic
- Re-blast the modules prior to epoxy overlay

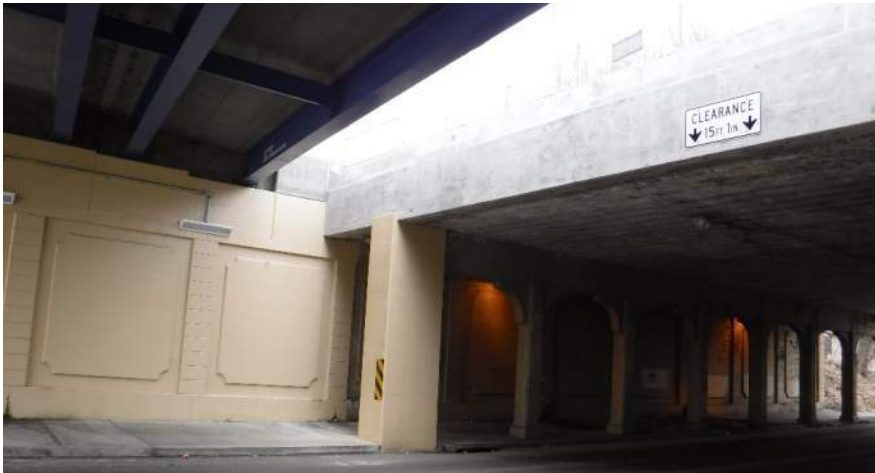
*Encasement of Remaining  
Beam and Pier Column –  
Note the Railroad Ballast  
Toe Wall*

- Lack of existing structure plans presented several issues, including the discrepancy in the superstructure depth
- Two other issues which resulted from this lack of information were the limits of the existing pier removal and encasement details for the railroad portion of the steel superstructure to remain

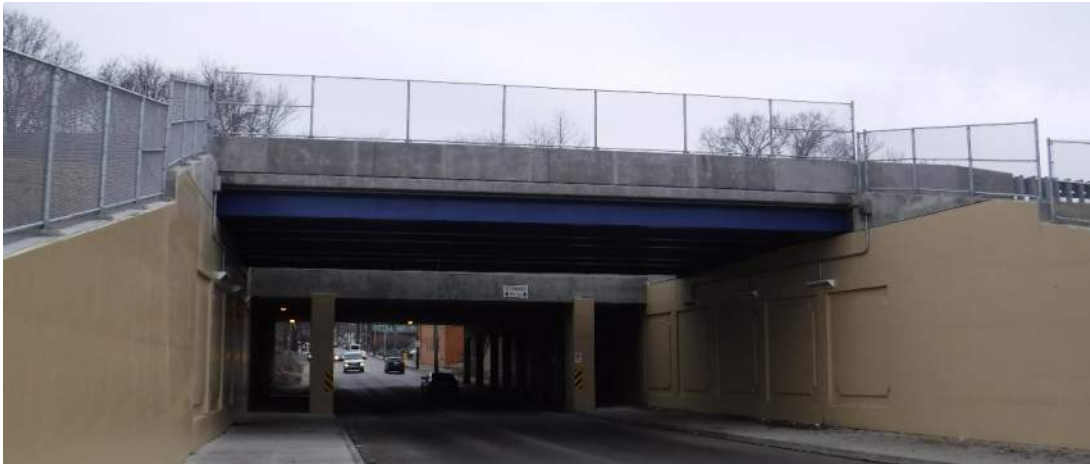
*Completed Structure*
