# ASHE / PennDOT District 9

## Bridge Topics

April 17, 2018

# MSE Wall Panel Distress

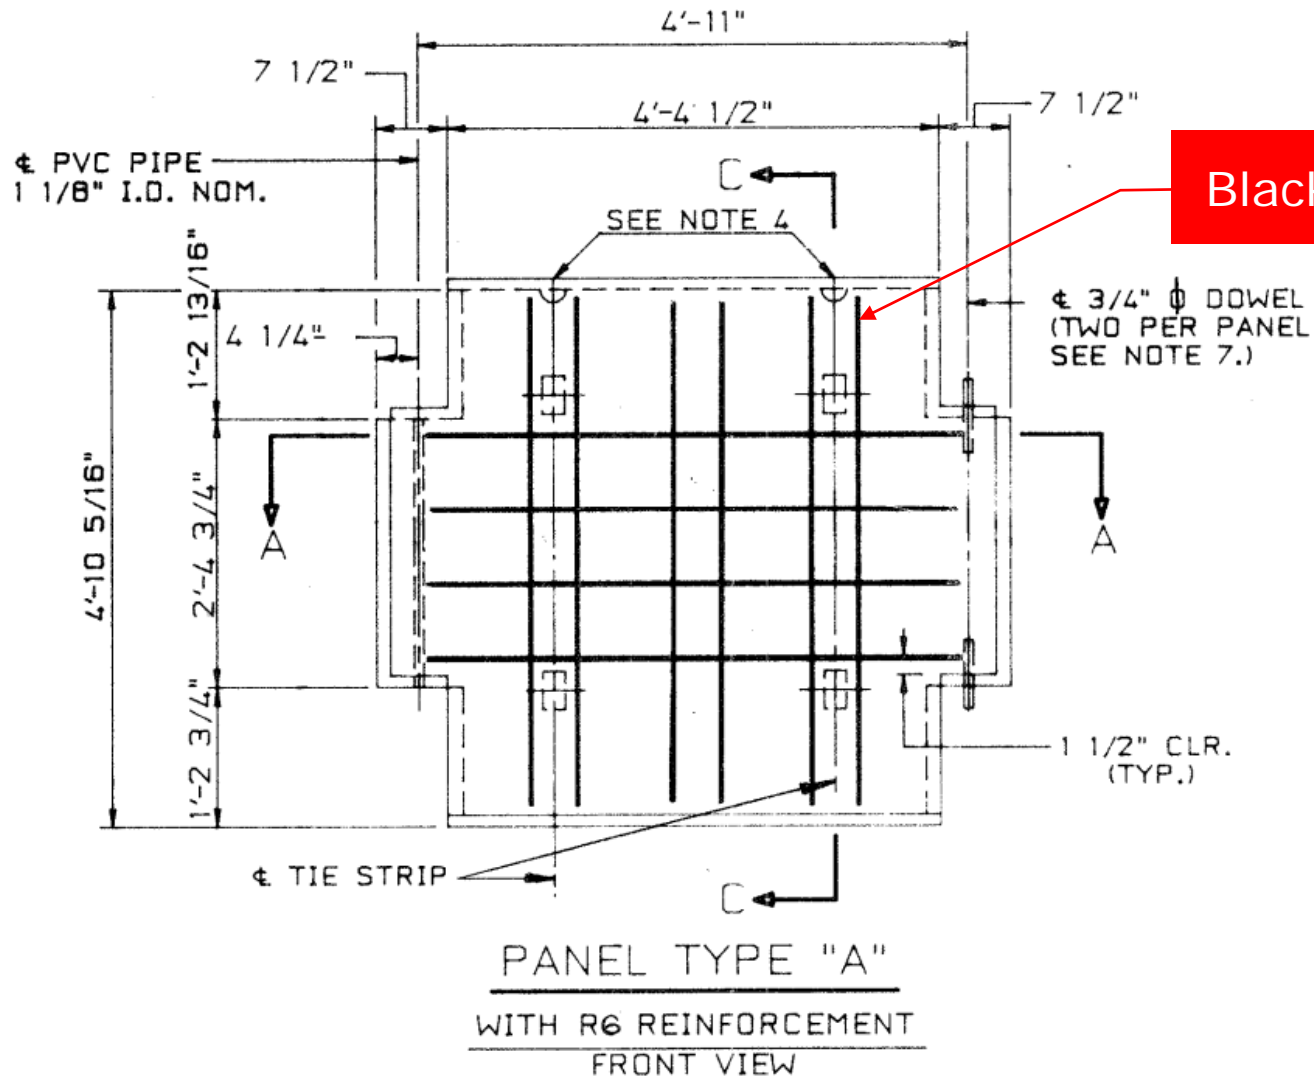
- Contract let 5/18/2017
- 128 total number of panels with visible cracks
- 21 panels visibly “bulging” and identified in contract for removal and replacement
- \$10,000 per panel replacement cost
