# ASHE Altoona/ PennDOT 9-0 Workshop

## Construction Update

**Brad J. Brumbaugh, P.E.**  
**Assistant District Executive - Construction**

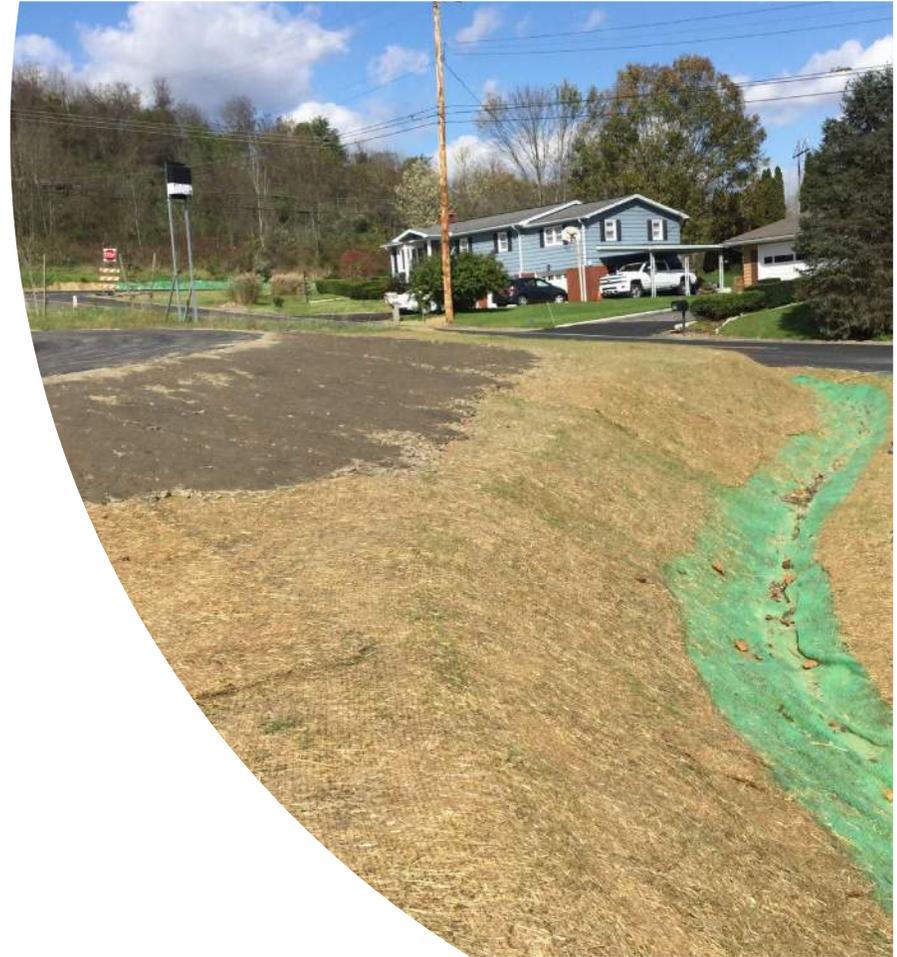
# Topsoil Best Management Practices

- TILL subsoil to required depth: 2 inches for furnished, 6 inches for placing stockpiled
- REMOVE all debris larger than 2 inches
- KEEP IT DRY by covering if stockpiling either stockpiled or furnished topsoil on site
- Make sure it is DRY if bringing in furnished topsoil
- COMPACT as required for proper lift thickness (lightweight/static)

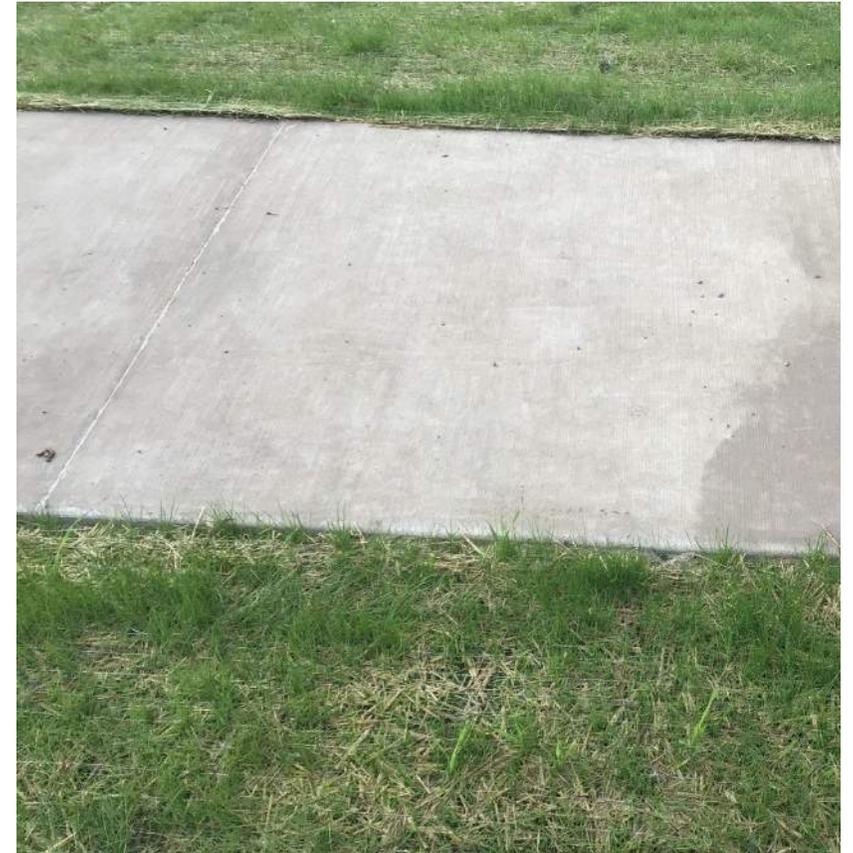
# Seeding Best Management Practices

- NEVER use HAY MULCH for topsoil areas (good practice to use straw or wood cellulose for all permanent seeding - not hay)
- TILL *if ANY area to be seeded is hard panned or crusted* ~ need to till to a depth of 2 inches if it is. On slopes this can be accomplished by tracked equipment travelling up and down the slope.

- TILL if the seeded area is topsoil, 3:1 or flatter till to a depth of 2 inches - *topsoil must be compacted during placement and then tilled prior to seeding*

- TILL previously temporarily seeded or mulched topsoil areas before applying permanent seed
- REMOVE DEBRIS that is > 2 inches (anywhere that must be mowed and includes all topsoil areas)

- MOW and WATER if needed or required
- VERIFY GROWTH at 90 days for 70% coverage. Department to direct re-seeding if needed. Re-seeding is only paid for if Department directed out of date seeding (and area was prepared properly) or if a slope fails

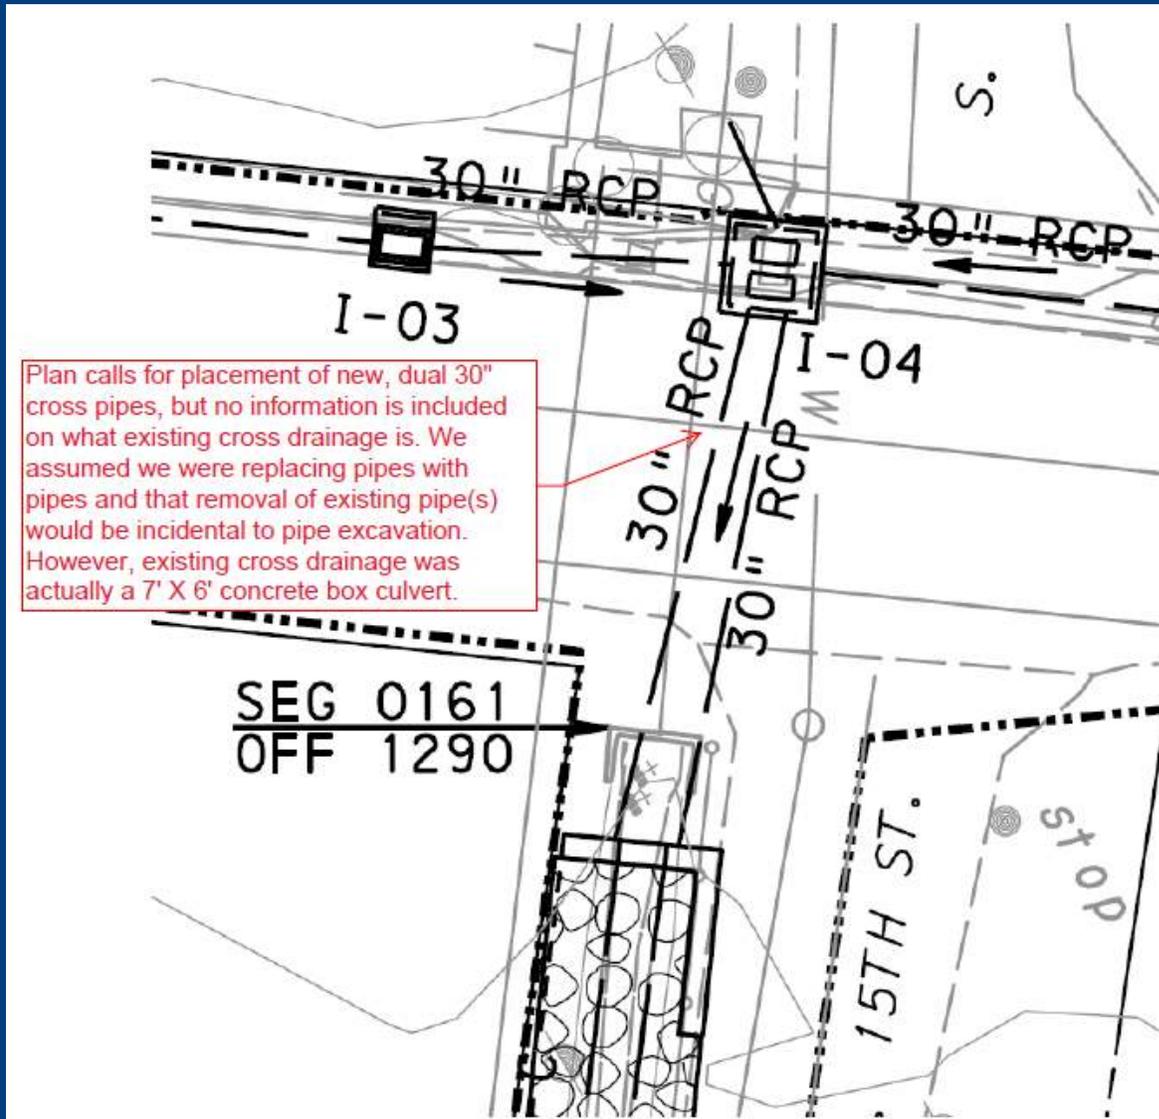
## EXAMPLE #3

- Plans called to replace the existing cross drainage with two 30" pipes, but no call out indicating what existing cross drainage consisted of
- Existing cross drainage was found to be a 7' X 6' concrete box culvert
- Although removal of small existing pipes would be incidental to pipe excavation, structure demolition (i.e. ~ box demolition) is not incidental
- There was no item for structure demolition to remove the box
- Department had to add a demolition item with long-term traffic control to enable the work to be completed in a safe manner (Cost ~ \$27K , Delay ~ two weeks)

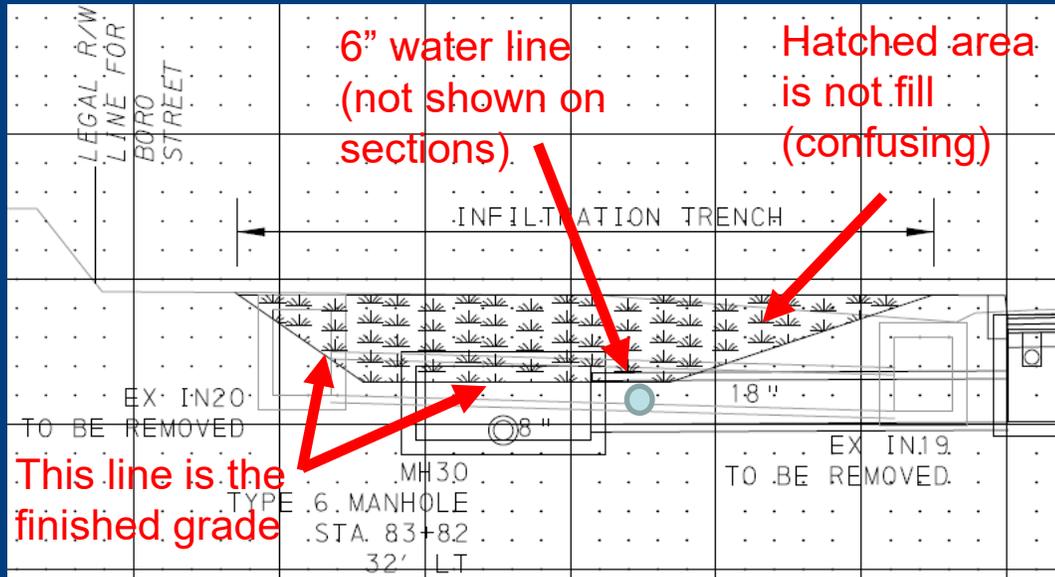
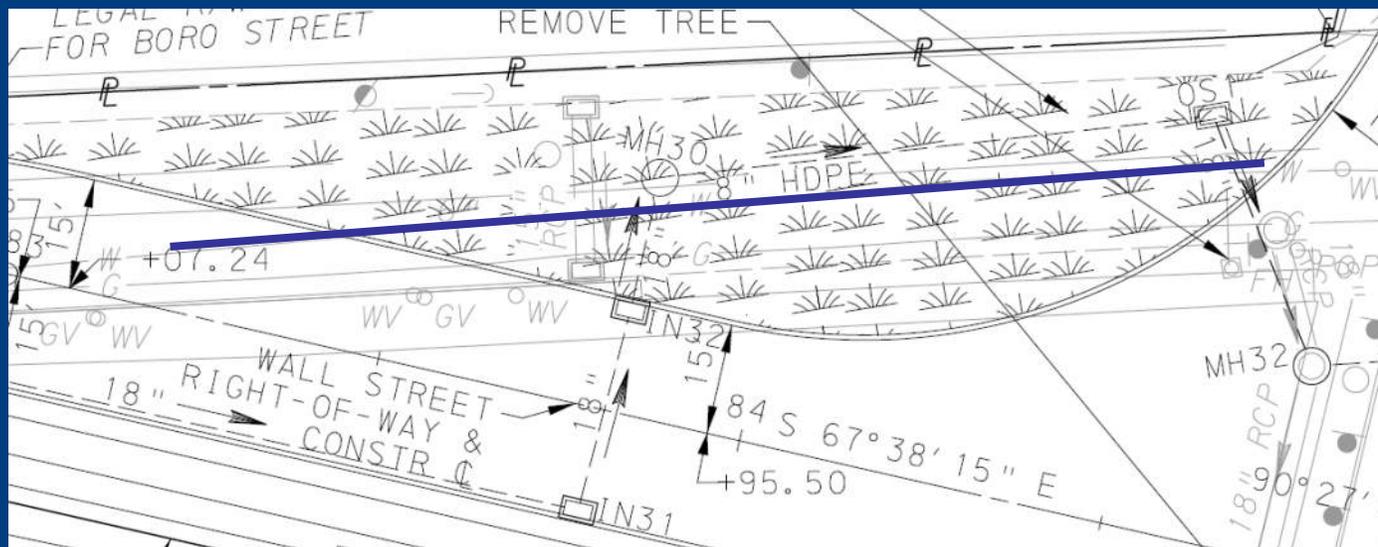
## EXAMPLE #1

- An existing 6" waterline is shown on the plan view, but not shown on the cross sections
- This waterline ended up being near the bottom of a new infiltration trench whereby the active waterline would be exposed/undermined during trench construction
- The waterline was also in conflict with an 18" pipe to be installed

- END RESULT: Waterline was relocated adding delay and cost to the project

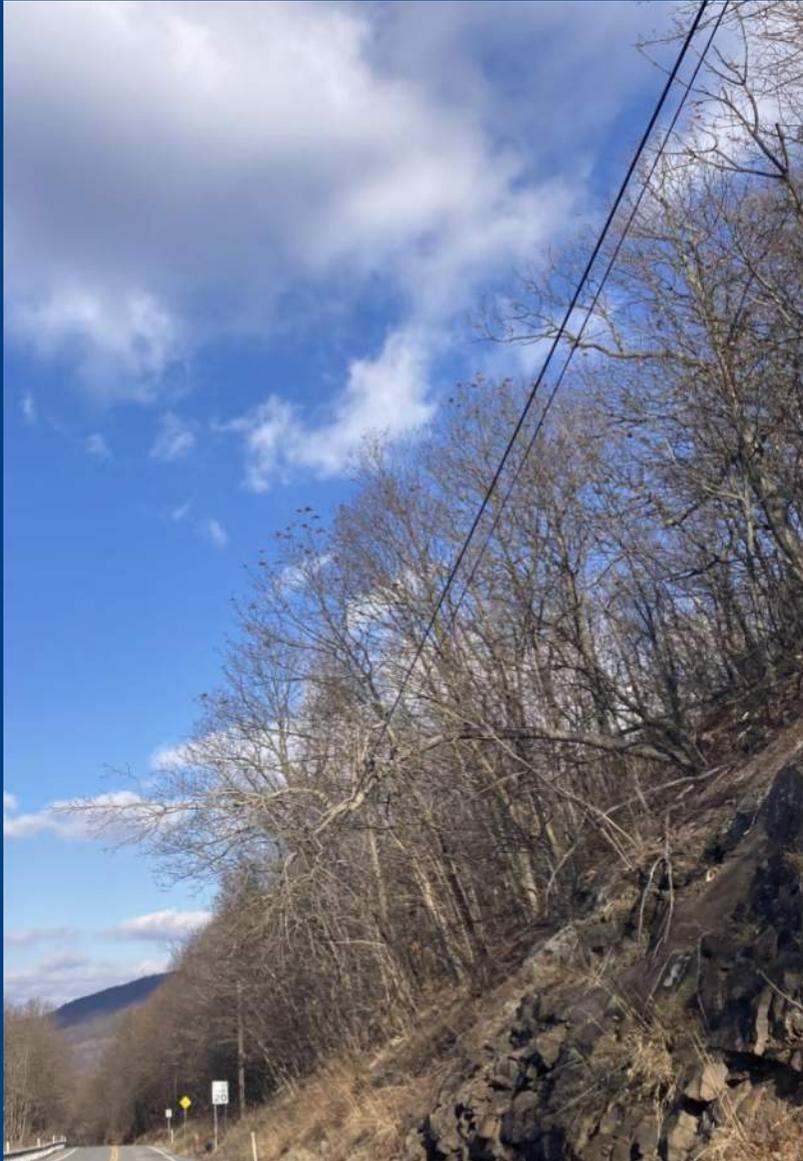
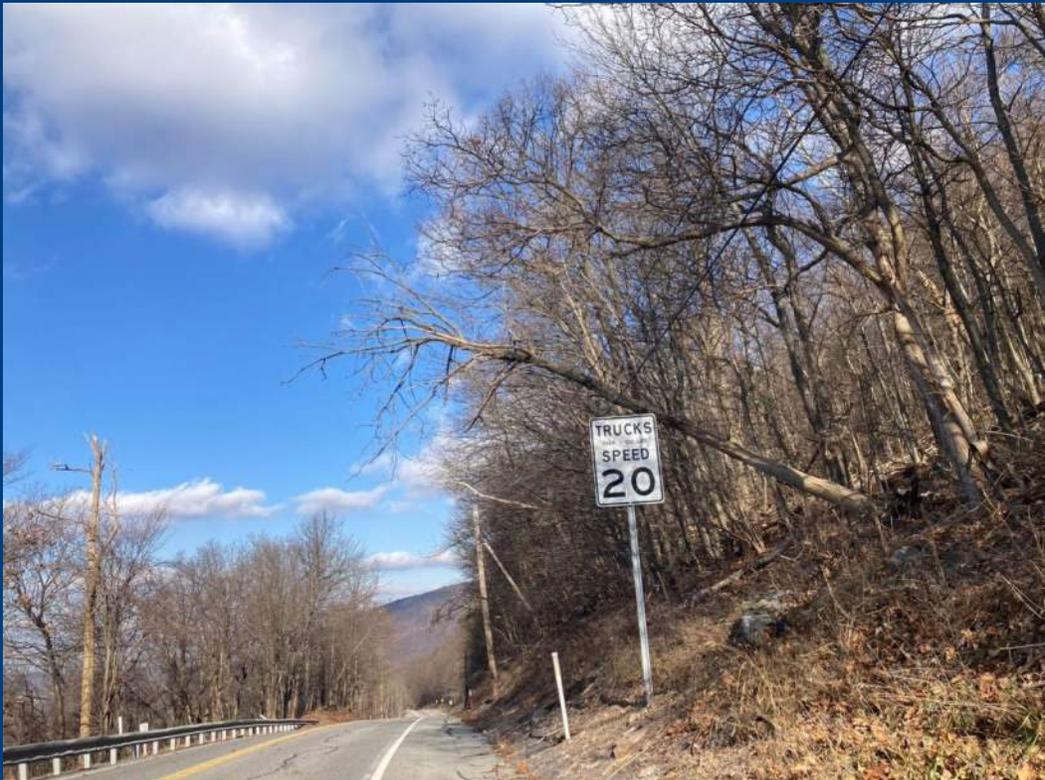
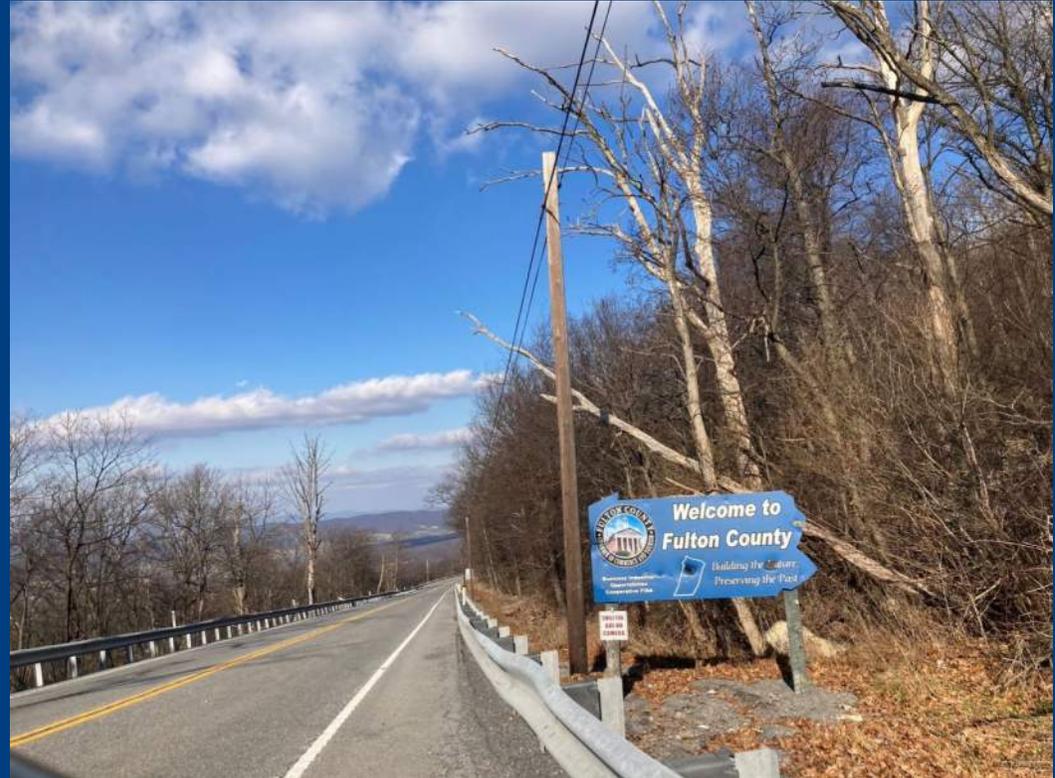
## EXAMPLE #4

- 3.6 mile long safety improvement project with resurfacing, guiderail, drainage, signing, signal, and bridge rehabs
- Contract includes item for tree trimming, but no tree removal
- Throughout corridor, there are numerous dead or dying trees leaning towards the roadway (majority within existing ROW)
- After NTP, coordinated with Maintenance and Environmental Units and identified 81 trees for removal due to safety concerns as well as an additional 1075 LF of tree trimming
- Work will need to be performed via force account, with a preliminary estimate of roughly \$100K

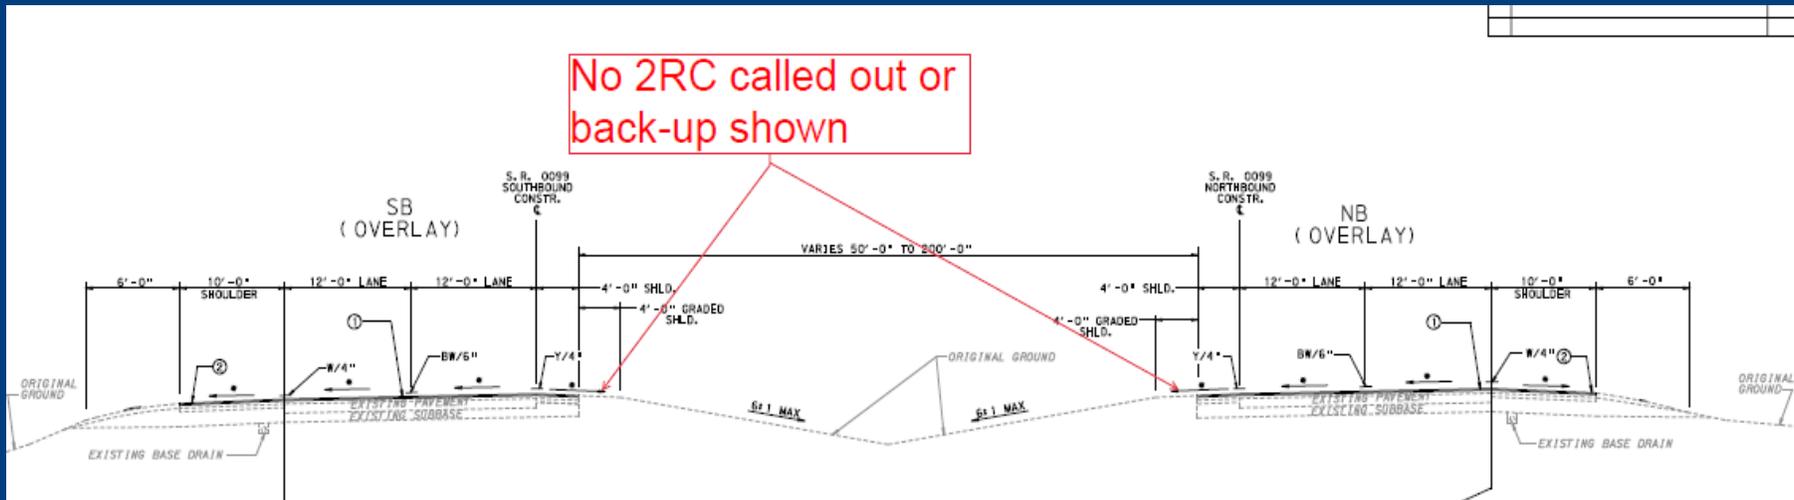
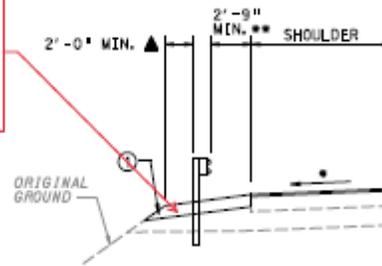
TYPICAL ROADWAY GUIDERAIL SECTION

- Project scope was for 1" thin lift overlay of four-lane
- No shoulder back-up was shown in median areas or included in back-up quantity computations
- Additional quantity of 2RC back-up added via work order at a cost of \$131K

Only location  
2RC was called  
out or tabbed  
(guiderail areas)

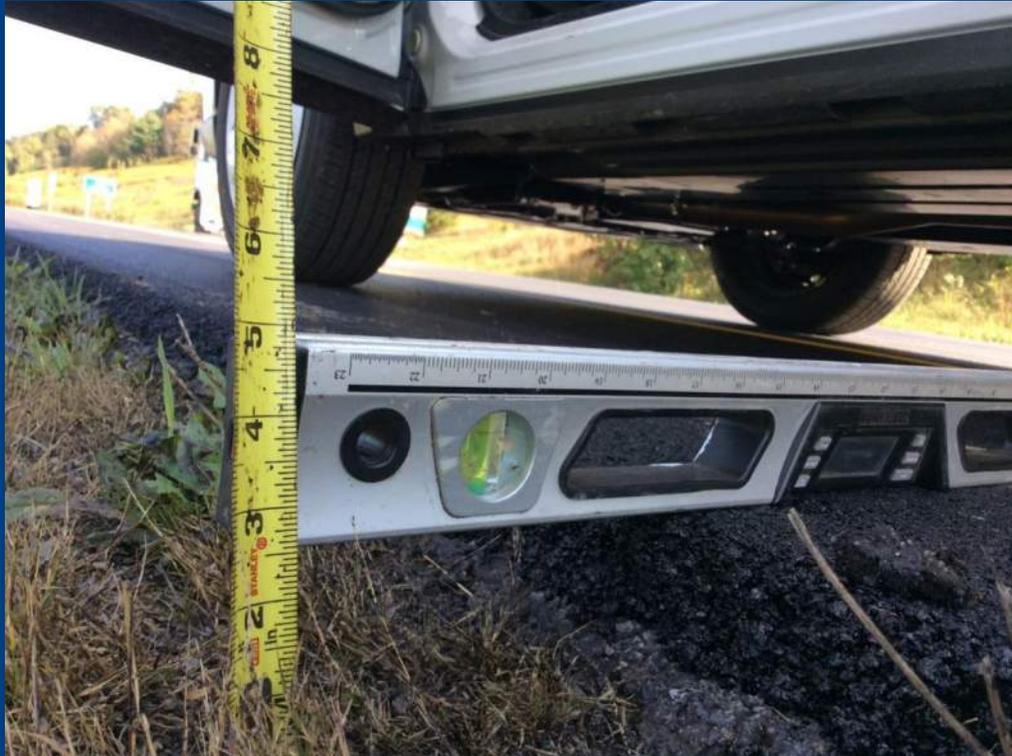
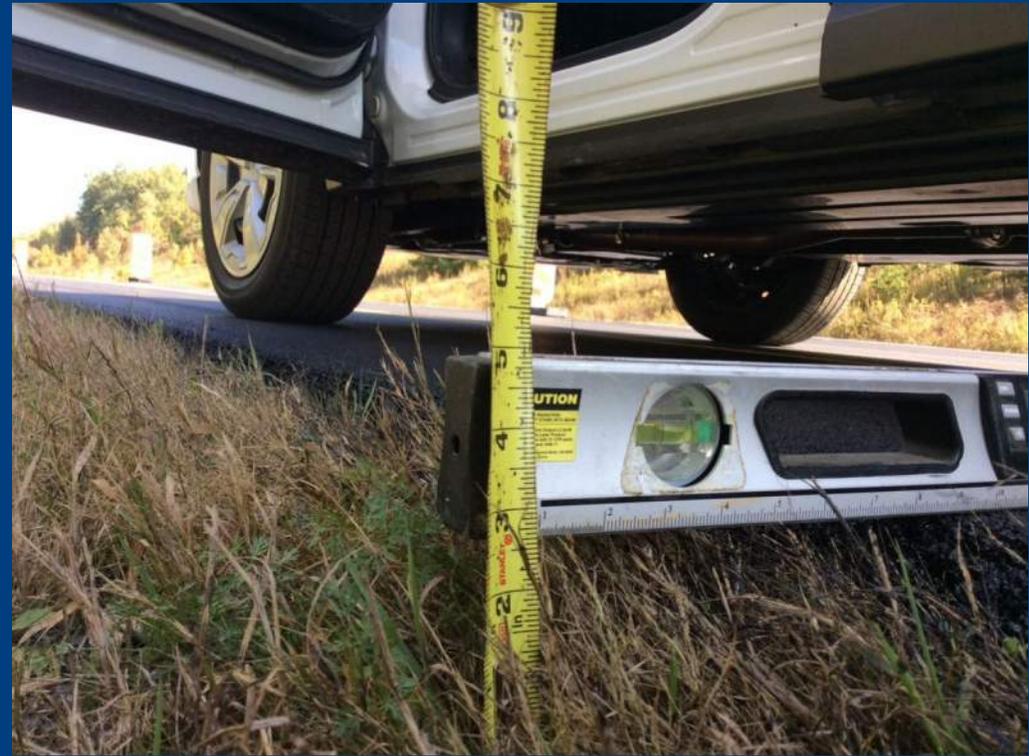
## EXAMPLE #2 (cont.)

- Photo below represents final edge drop off in median before back-up placed
- Note that drop off is  $>1$ " thin lift depth due to drop-off condition being pre-existing ( $\sim 1.5$ " )

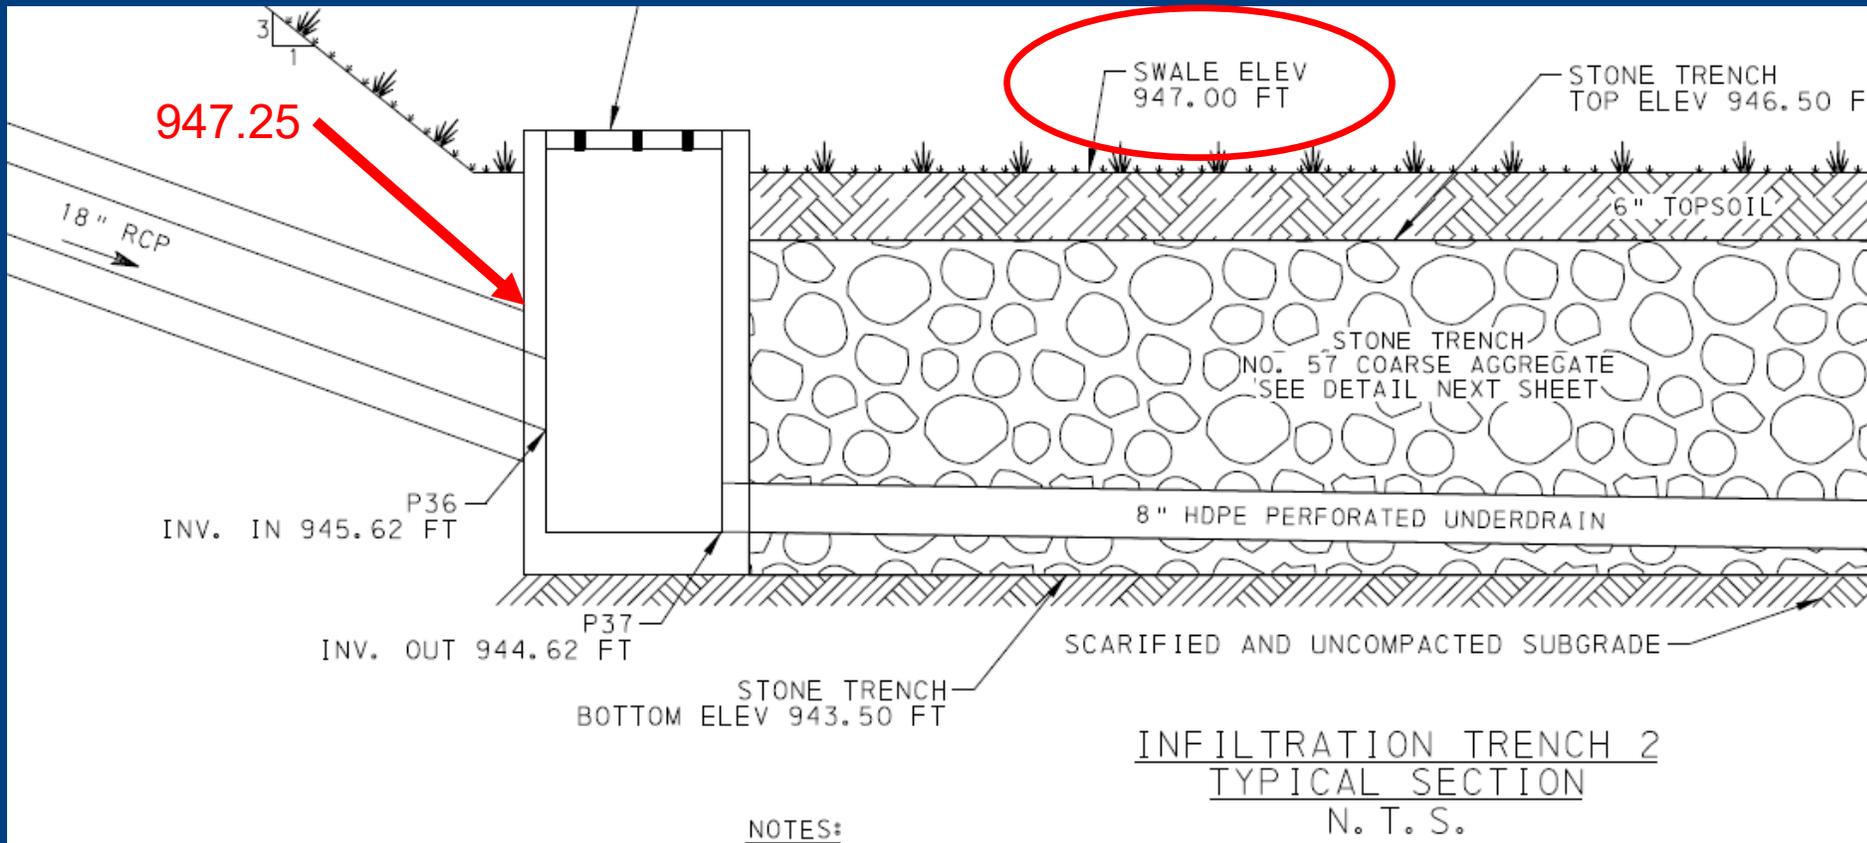
## EXAMPLE #1

- The top of this 18" pipe entering the manhole is 947.25 as designed (based on invert)
- The top of swale elevation is 947.00 as designed
- Therefore, top of pipe would be 3" above finished grade if constructed as designed
- This one issue affected multiple drainage locations and required drainage to be redesigned
- If the detail was drawn to scale, this issue would have been realized during drafting
