ASHE Altoona/ PennDOT 9-0 Workshop

Construction Update

April 16, 2024

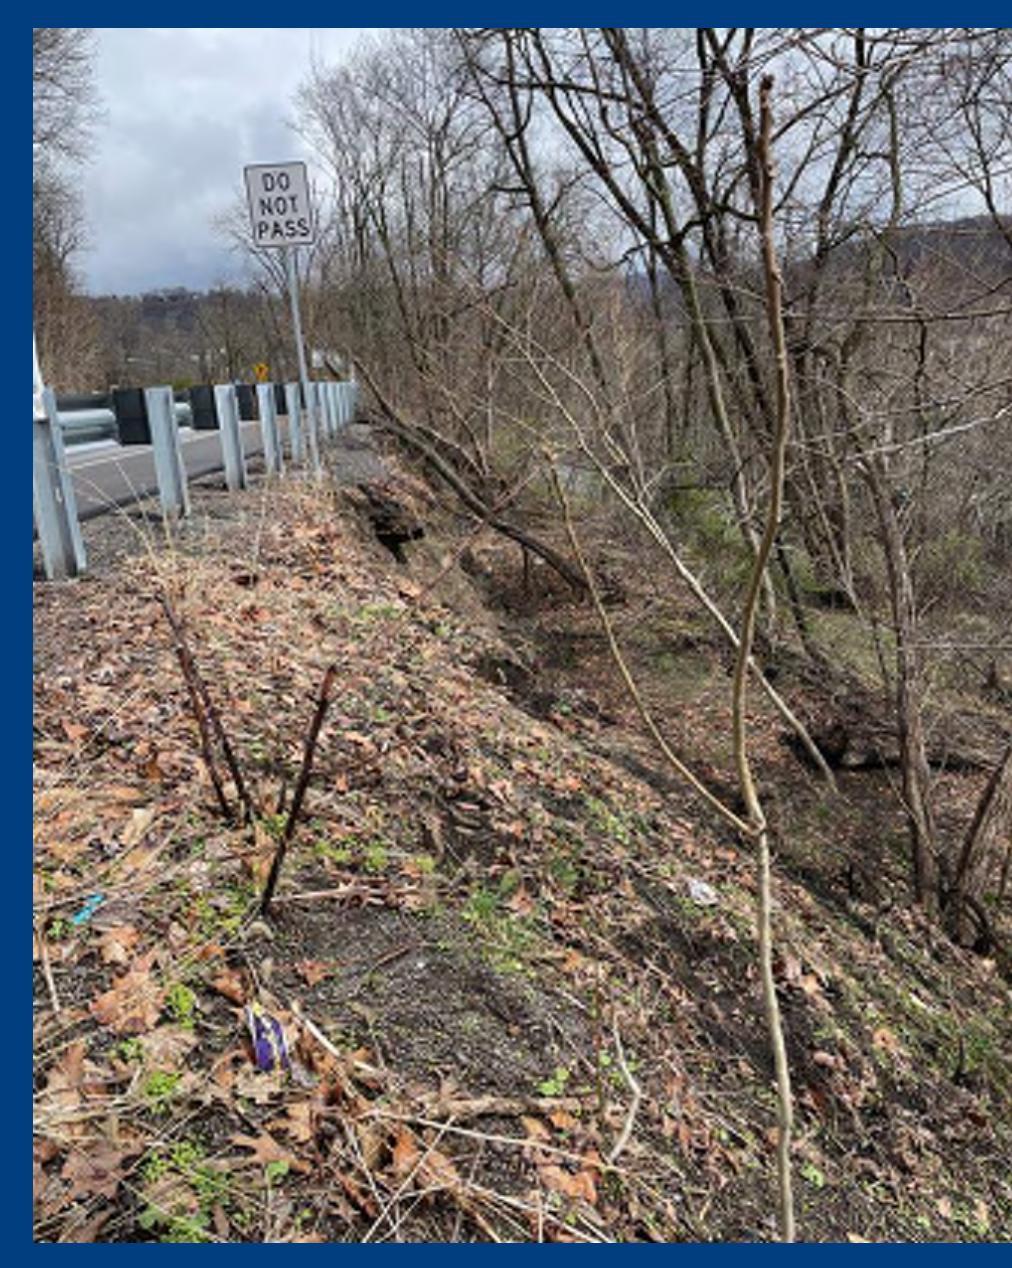
PA 271 (MENOHER BLVD) EMERGENCY SLIDE

- PA 271 (Menoher Blvd) southbound lane closed on Wednesday, April 3rd due to slope failure
 - Barnett Street also closed below PA 271
- Followed heavy rain from March 31st April 4th
- Emergency Declaration Approved: April 9, 2024
- **Scope:** Rock buttress/slope
- Traffic Control: Maintaining two-directional traffic along northbound side of PA 271
- Target Repair Completion: June 2024
 - Timeframe dependent on right-of-way, funding, and permitting
- **Contractor:** TBD (project to be bid using expedited procedure)
- **Construction Estimate:** >\$1 million

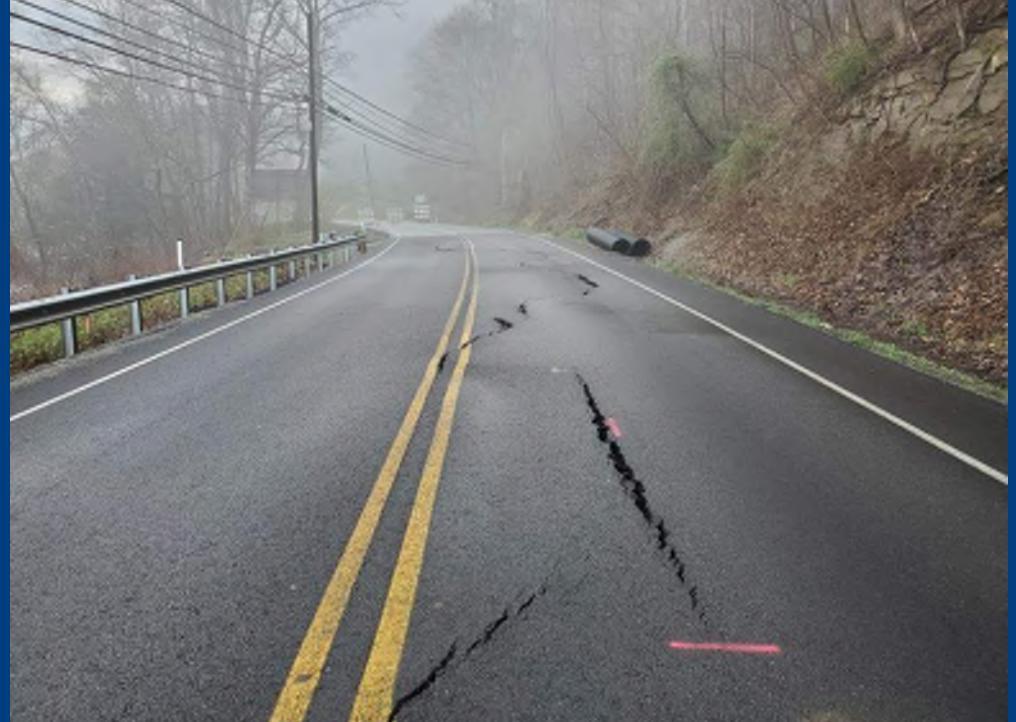
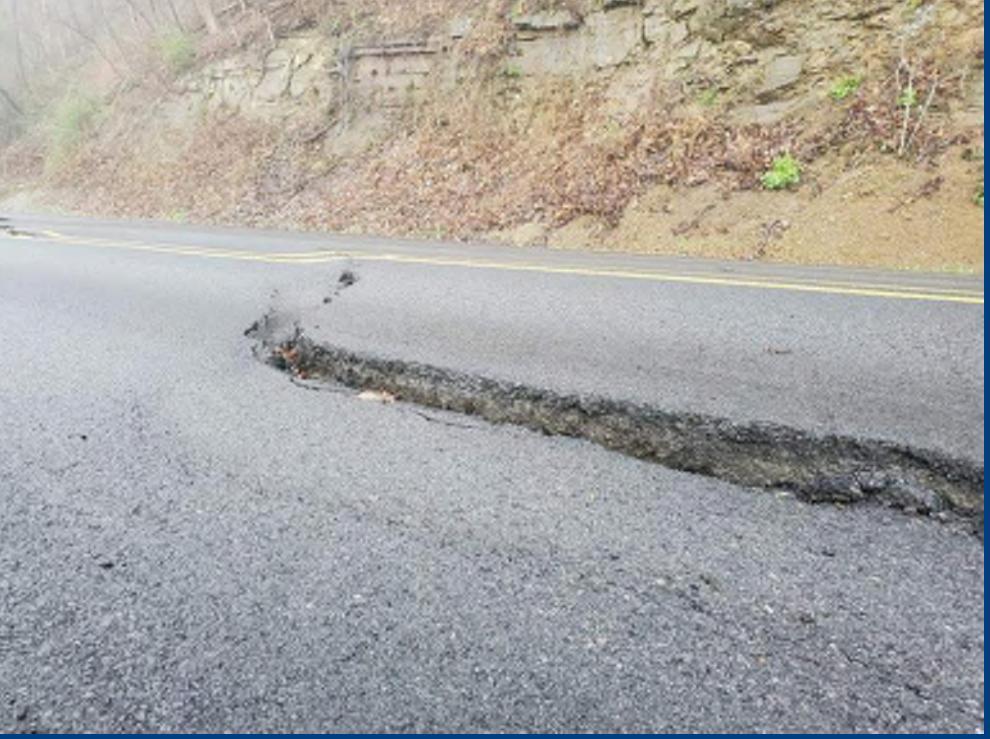
PA 403 TIRE HILL EMERGENCY SLIDE

- Road closed on Saturday, April 6rd due to roadway settlement/active sliding
- Followed heavy rain from March 31st April 4th
- **Scope:** Retaining wall (part of original project)
- Traffic Control: Detour
- **Original Wall Construction Timeline:** July to October 2024
- New Wall Construction Timeline: May to September 2024
 - Working through expedited supply issues with steel beam and precast wall panels with contractor and suppliers

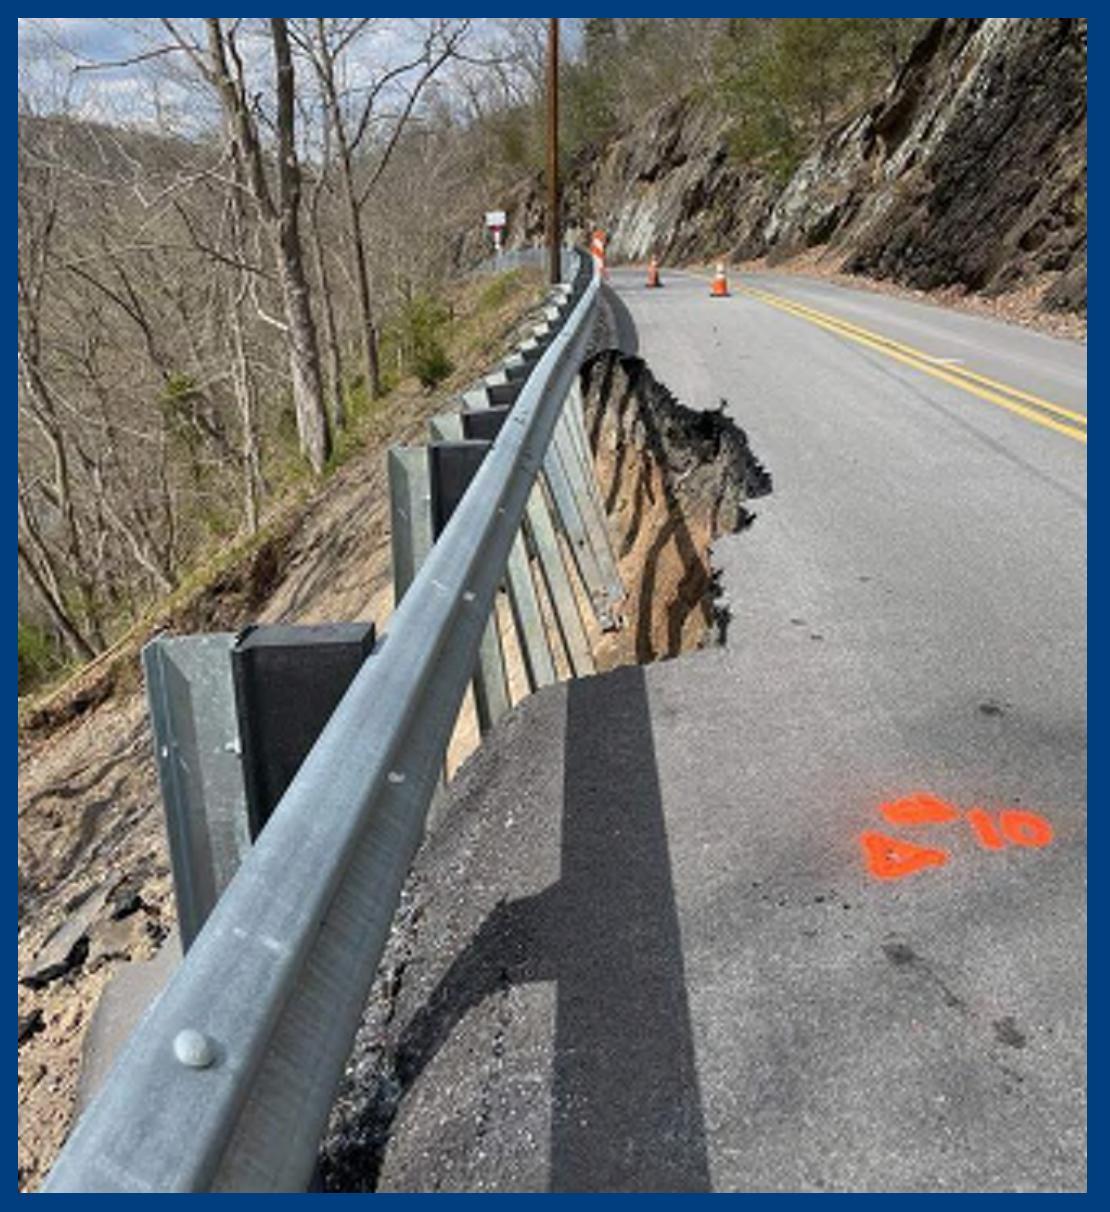
SR 103 EMERGENCY SLIDE

- Road closed on Wednesday, April 3rd due to slope failure (near Mifflin Line)
- Followed heavy rain from March 31st April 4th
- Emergency Declaration Approved: April 8, 2024
- **Scope:** Rock buttress/slope
- Traffic Control: Detour
- Target Repair Timeframe: April 22nd to May 3rd
 - Timeframe dependent on right-of-way, funding, and permitting
- **Contractor:** Grannas Bros., Inc.
- **Construction Estimate:** \$350,000

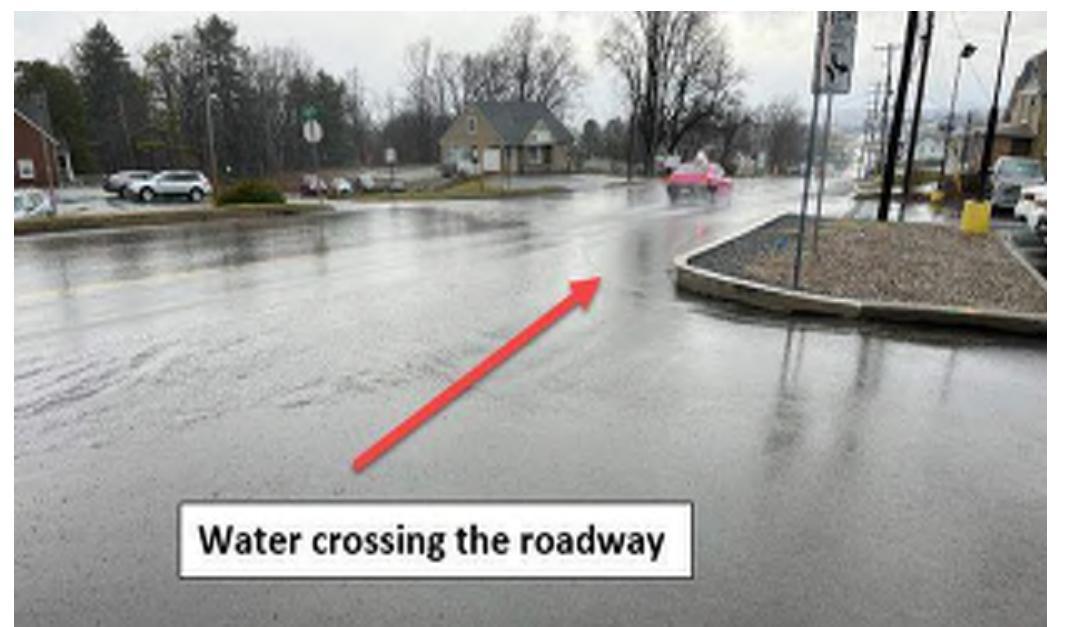
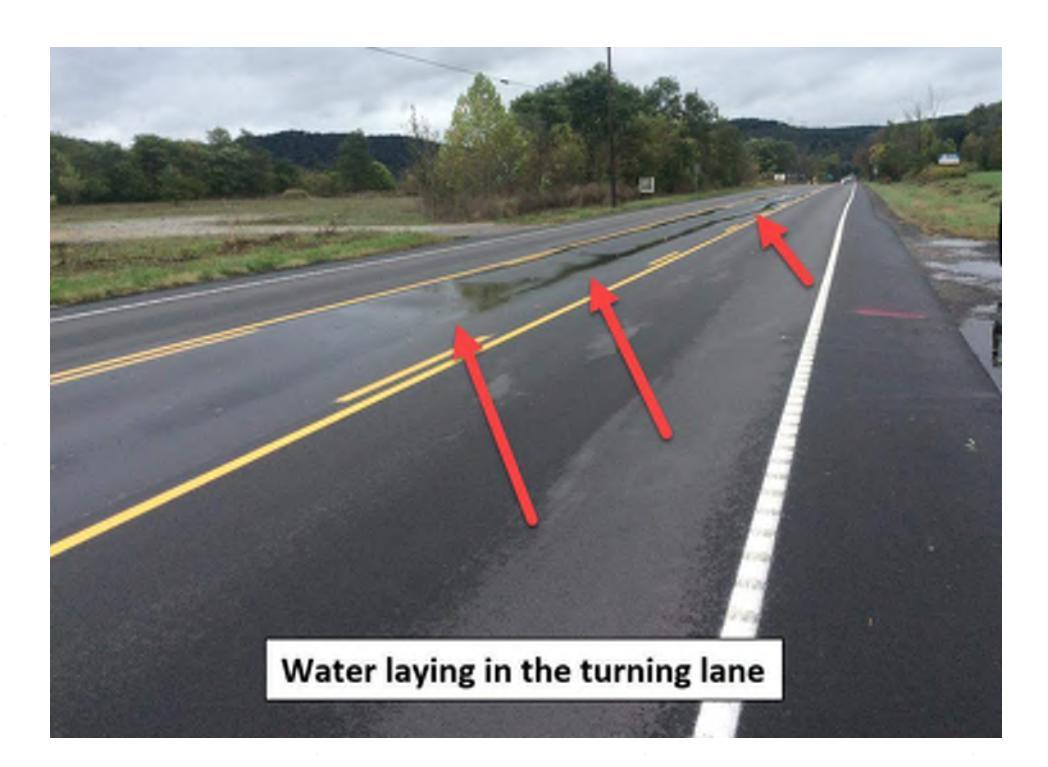
Positive Drainage of Asphalt Paving

- Multiple projects where final paved condition led to drainage crossing the roadway (adverse shoulder slope), ponding, or icing (not an issue pre-paving)
- Normal areas of concern:
 - Intersections coming in on a slope
 - > Turn lanes on three-lane sections with limited existing slope
 - High side of a superelevated section of roadway

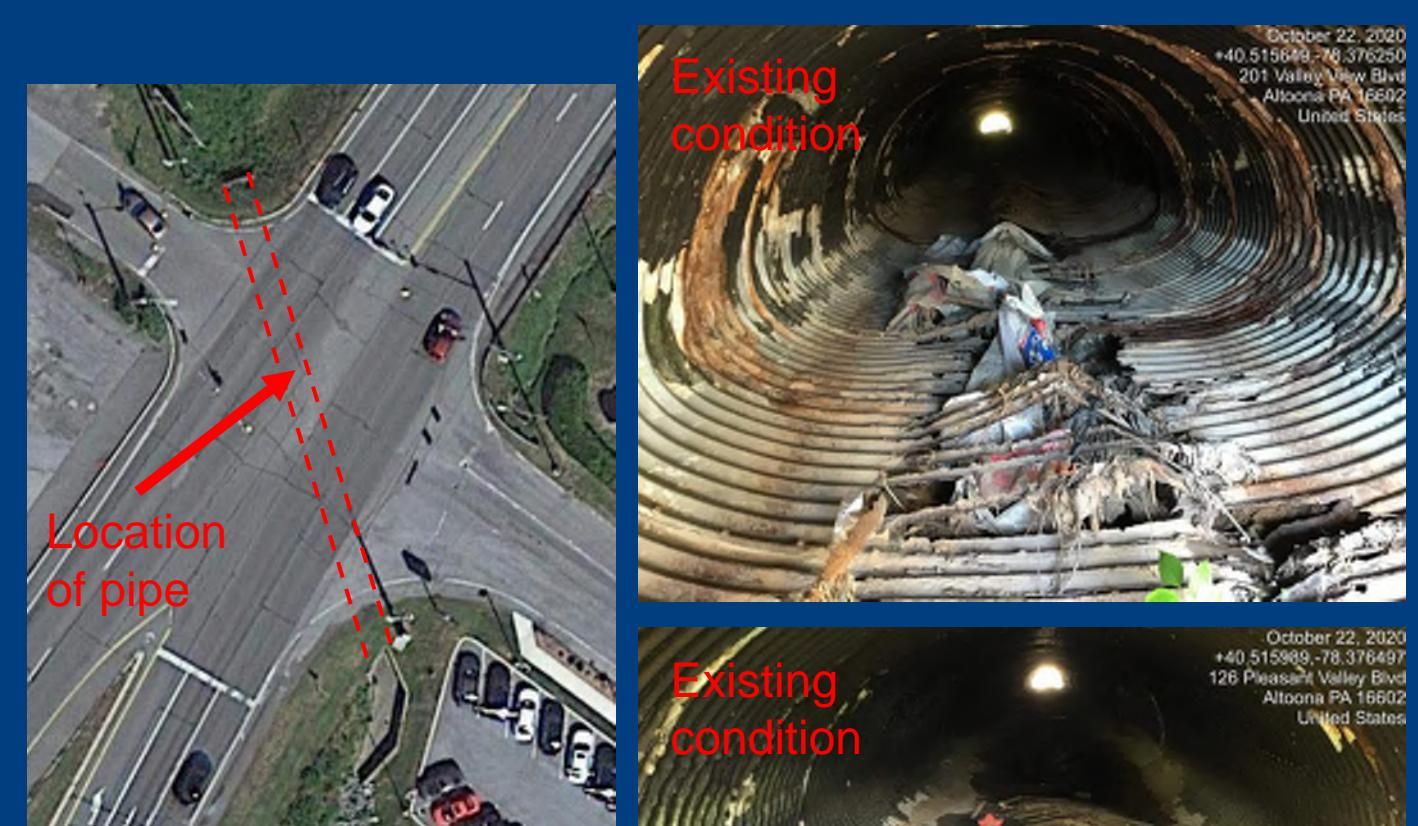
EXAMPLE #4

- During construction, the IIC was reviewing pipe cleaning locations and found a failing 46"x70" elliptical metal pipe
- This was a mill and overlay project and the paving was already complete, so replacement was not a desirable option
- The designer proposed to use a Geospray Pipe Liner to rehabilitate the pipe
- Cost to project: \$189,000

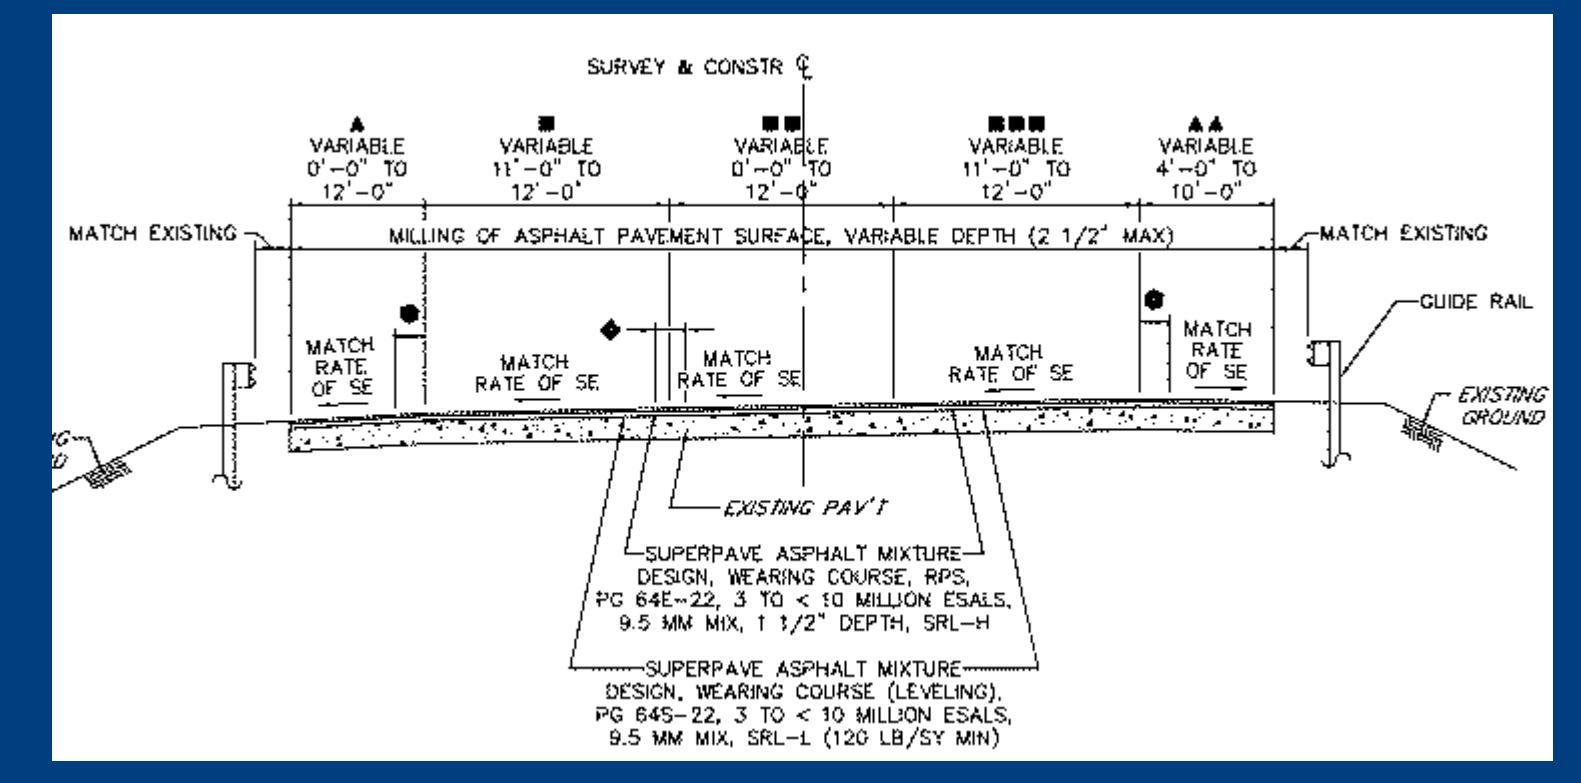
EXAMPLE #1

- Project scope was for milling and resurfacing to match existing elevations and cross slopes
- Based on mill and fill scope, no items for shoulder back-up were provided in the contract
- In reality, shoulder drop-offs were present throughout much of project corridor
- Item added via work order at a cost of \$26K

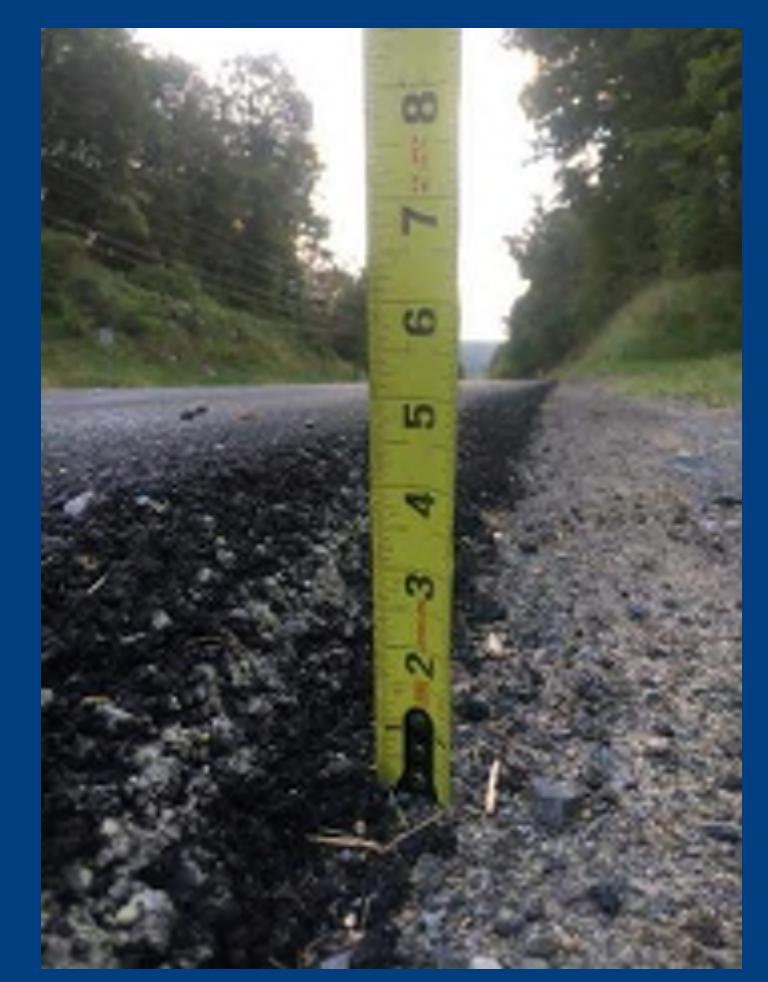
EXAMPLE #1 (cont.)

- Photo below represents some of the actual field conditions encountered
- When computing shoulder back-up, whether mill/fill or overlay, there are rarely cases where the existing road does not already have shoulder drop-offs that need accounted for

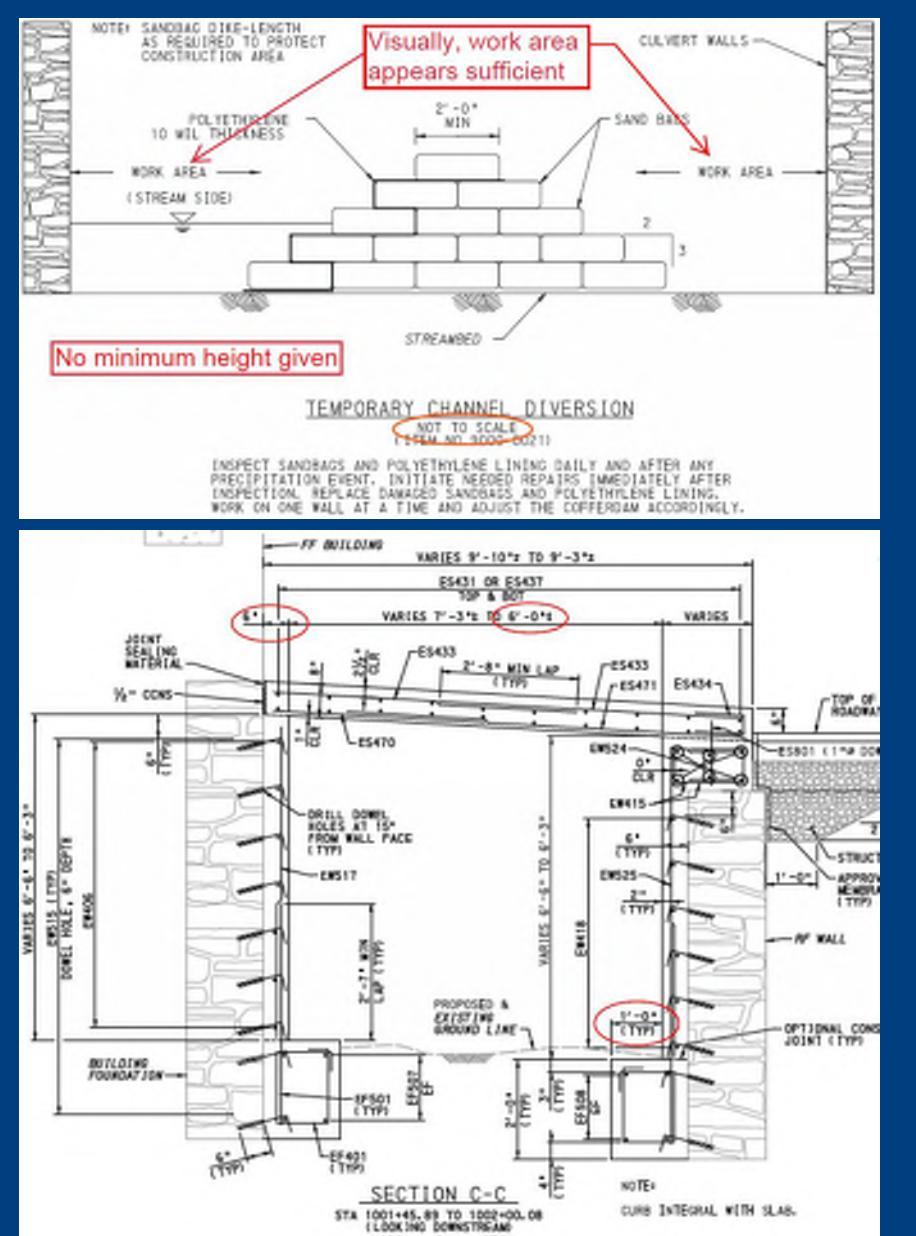
EXAMPLE #4

- Temporary Channel Diversion detail on E&S Plan appears to show adequate work area, showing a minimum diversion width of 2' (but no minimum height)
- 6'-0" minimum clearance after encasements shown on Section C-C of the structure plan
- Sandbags are shown set once down the middle of the stream and just switching the bags at upstream and downstream ends between each phase/ side of work
- Underpinning 1'-6" (1' beyond 6" encasement) on each side, so clearance between underpinning is 4' minimum
- Bags would need stacked vertically in order for contractor to have 1' work area on each side of diversion (4 '- 2'/ 2 = 1')
